Microbiologically Induced Corrosion

Sarah Bagnall

ICORR South Wales & South West England Branch

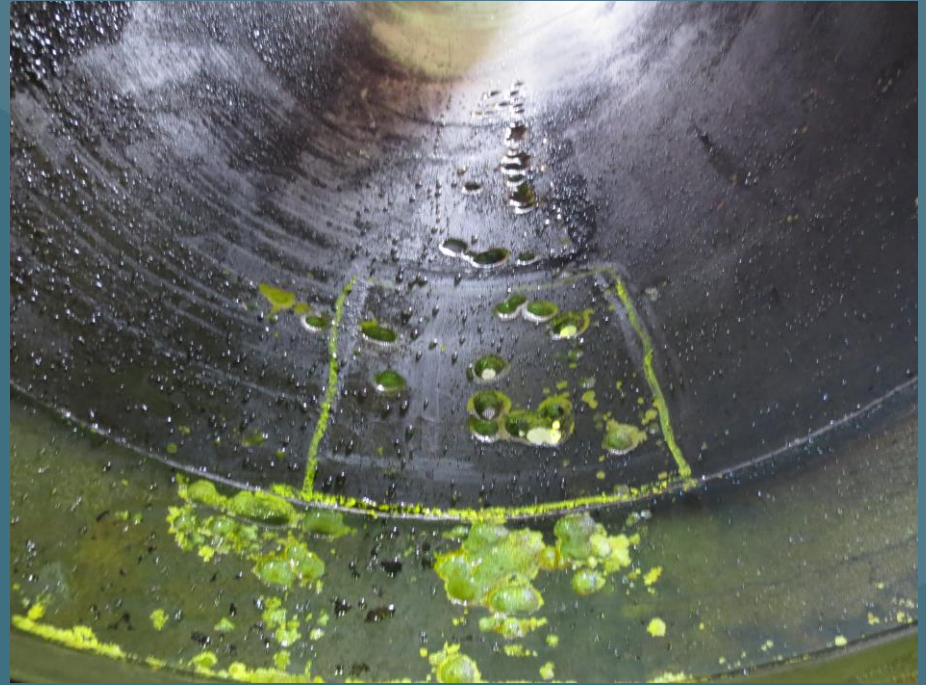
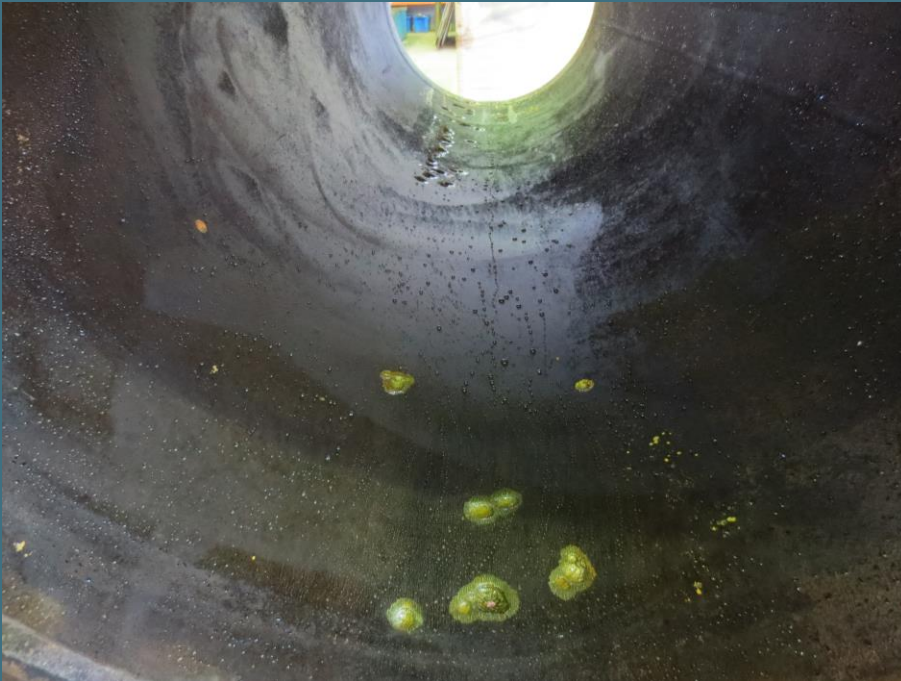
- Main crude feedline.
- In service for 31 years
- The pipeline had contained seawater at some point for approximately 10-12 months

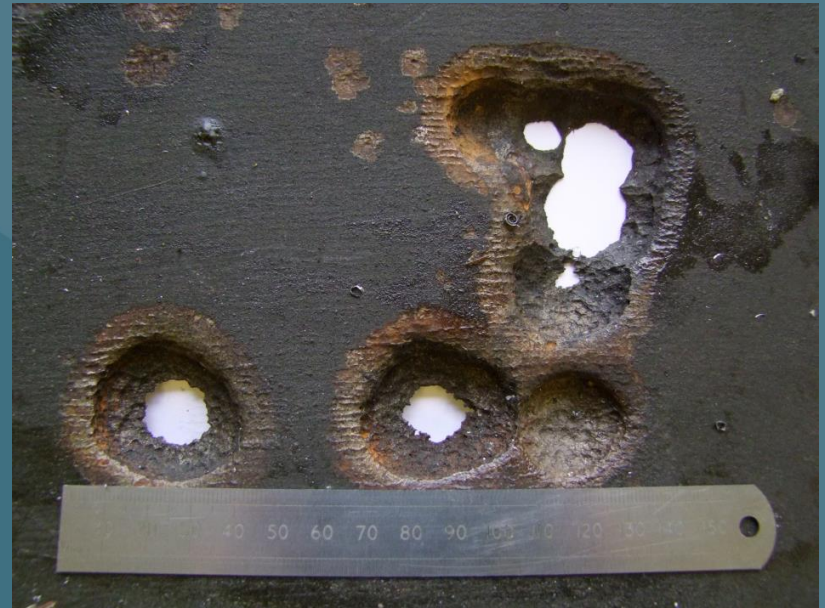
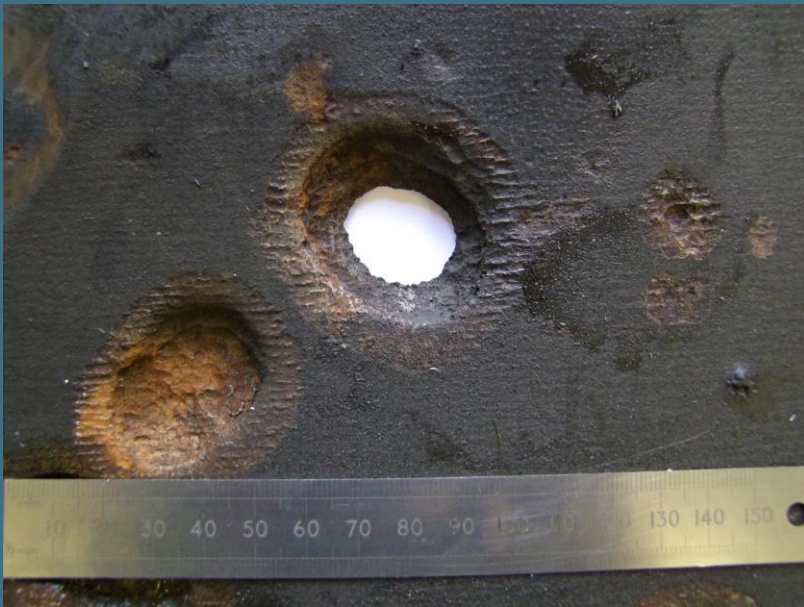
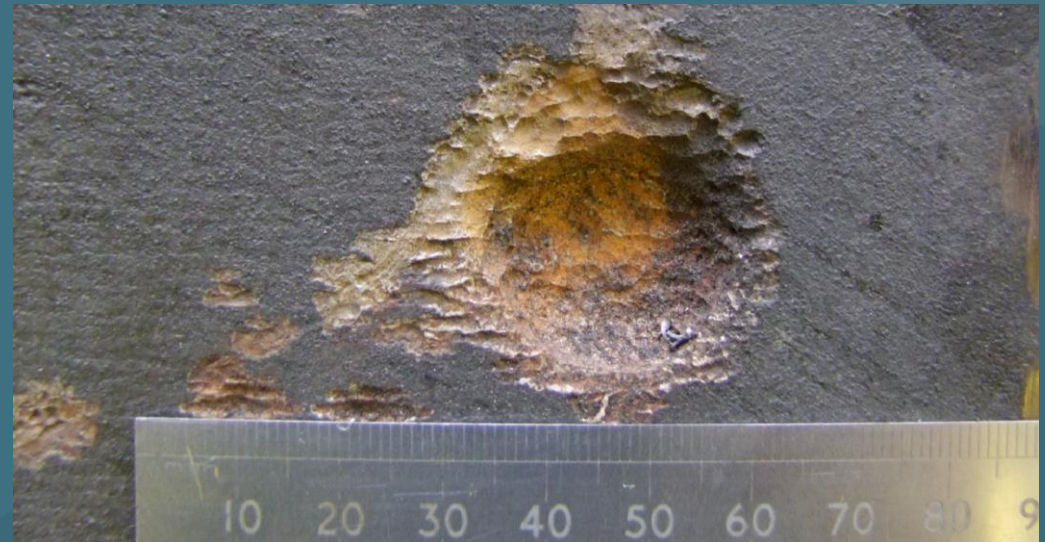
- Large pits which were clustered and overlapping.
- Lightly etched aureole around the pits.
- Pits exhibited a smooth and undulating appearance.

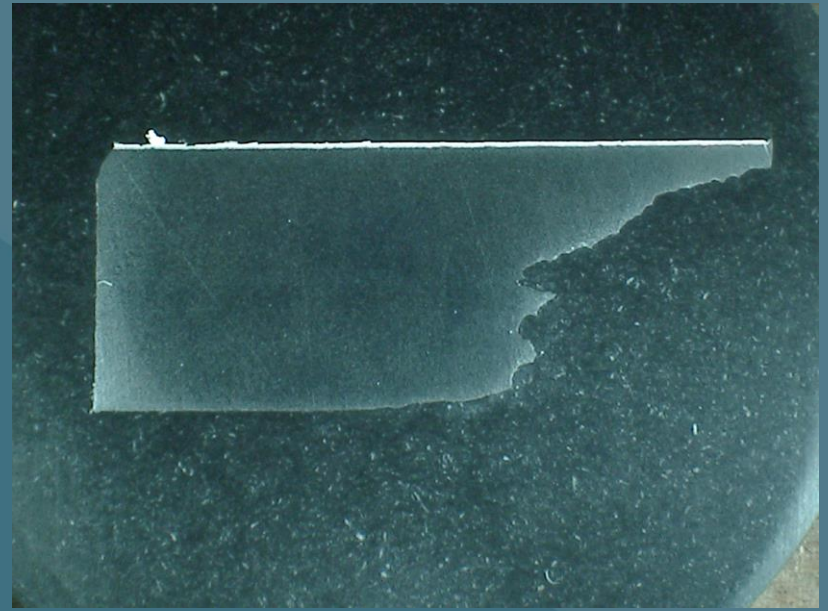
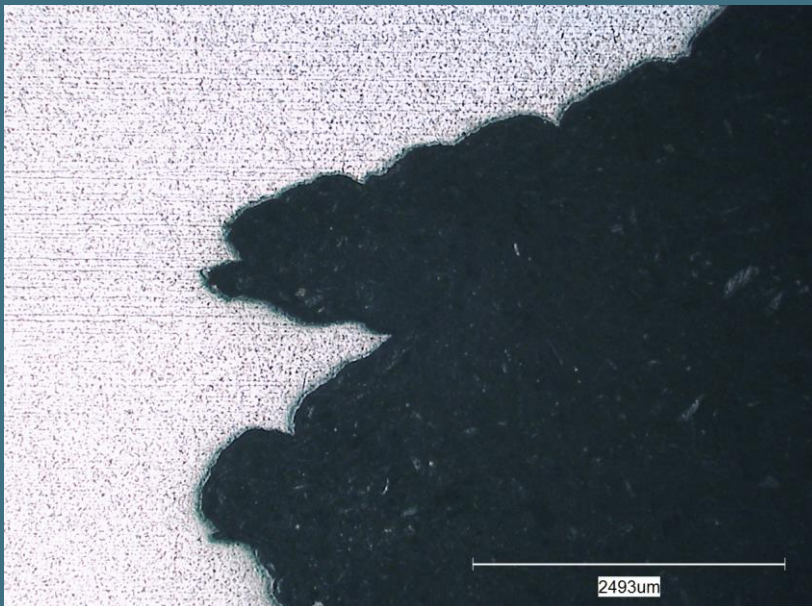
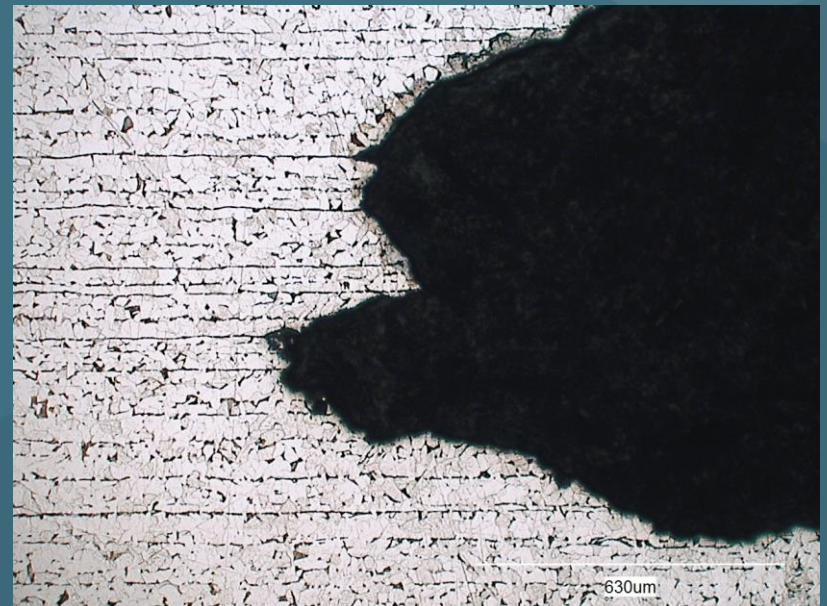
- Heavy contamination with Sulphate generating bacteria/sulphide reducing bacteria was detected.
- Corrosion deposit also contained significant levels of sulphur and chlorine.

- In pipelines containing crude oil, any water contamination settles along the bottom.
 - This stagnant water most likely containing organic material and deposits (from the crude oil) enable microbes to thrive.
- The presence of seawater would have exacerbated the corrosion rate.
- Recommendations:
 - To apply a high quality bacteria-resistant epoxy coating to the inner surface of the pipeline. Needs to be treated with caution.
 - Keeping the pipeline as clean as possible, avoiding accumulation of dirt, sludge and foul watery deposits.
 - Avoiding stagnant conditions.

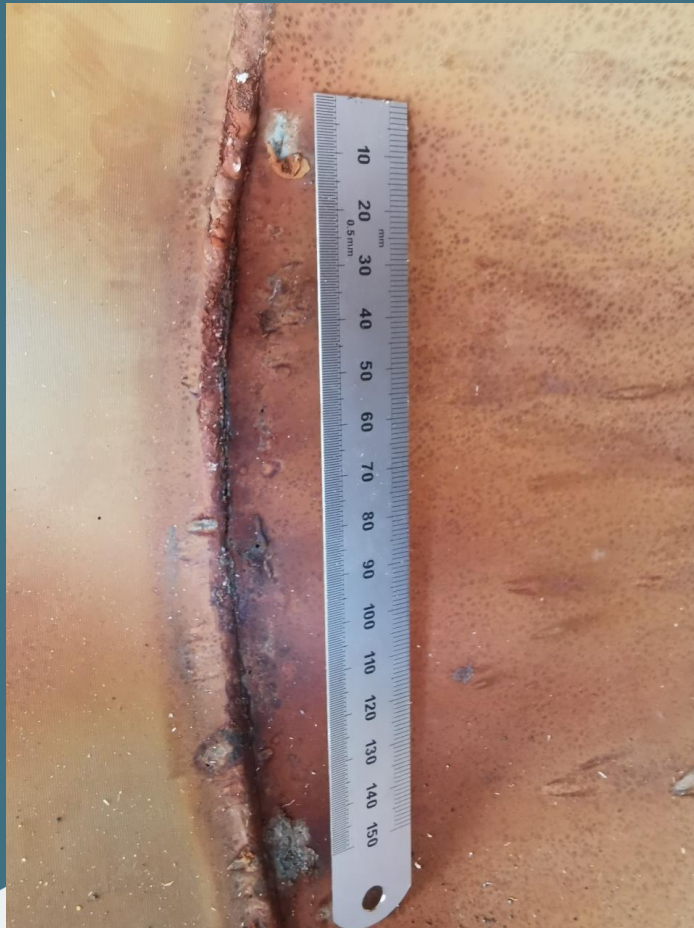
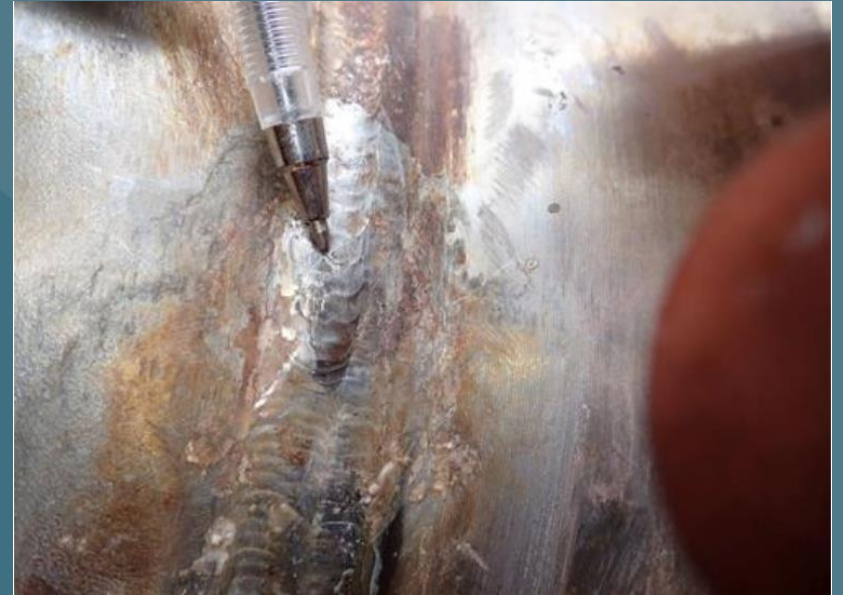
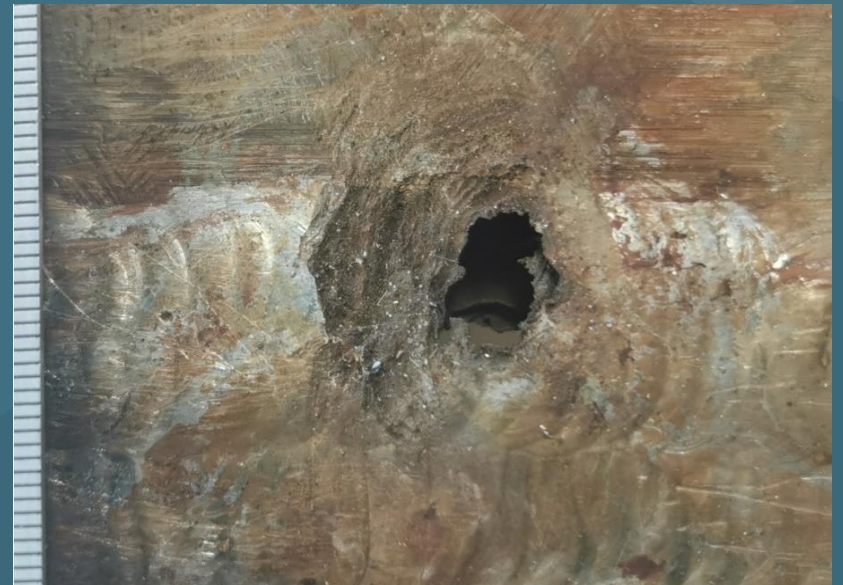
- Super duplex stainless steel pipework from a seawater injection system
- The maximum operating temperature of the outlet was 35°C.

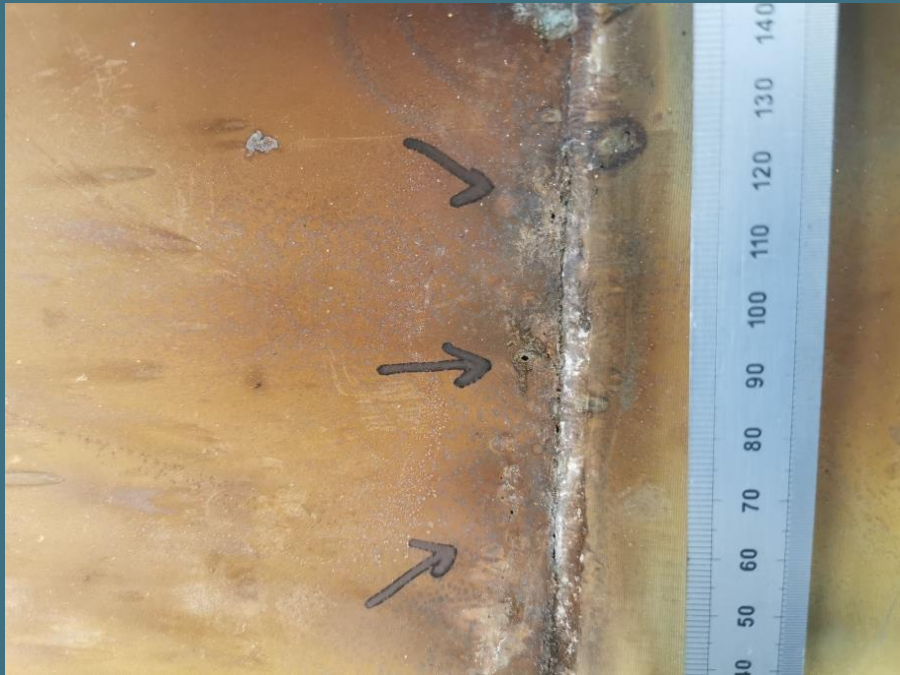
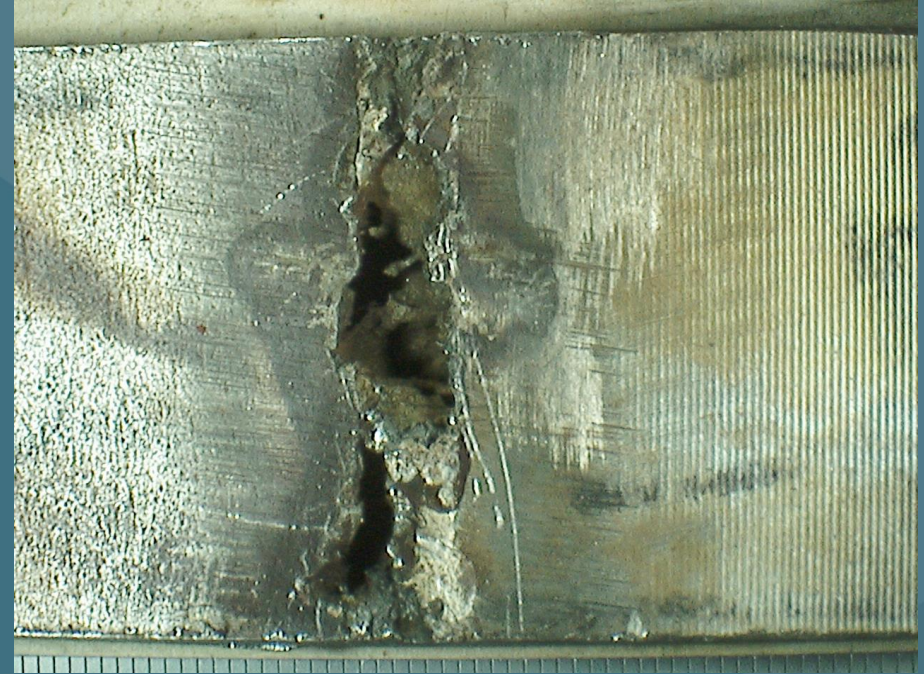
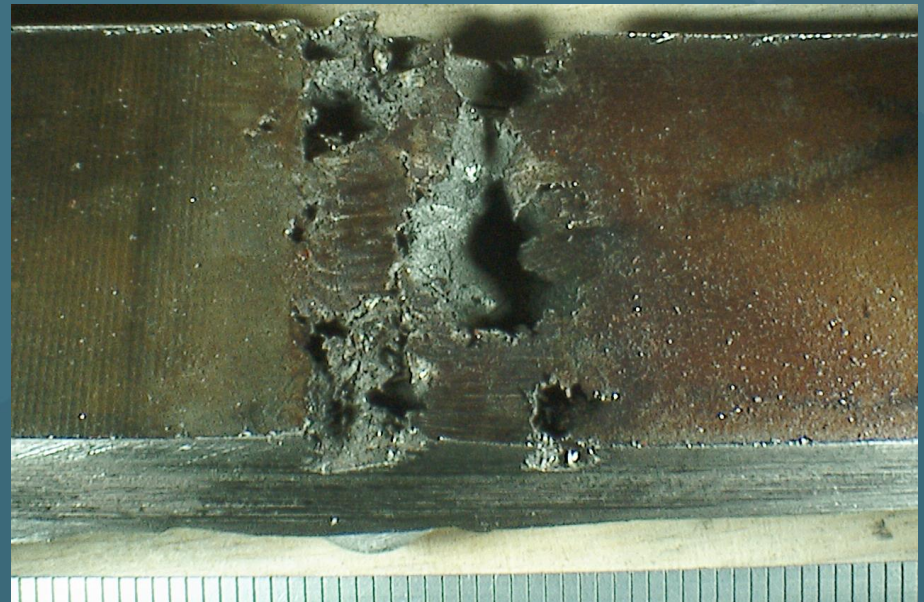
- Area of perforation evident within the weld
- At internal surface – significant metal loss was apparent below seemingly intact surface

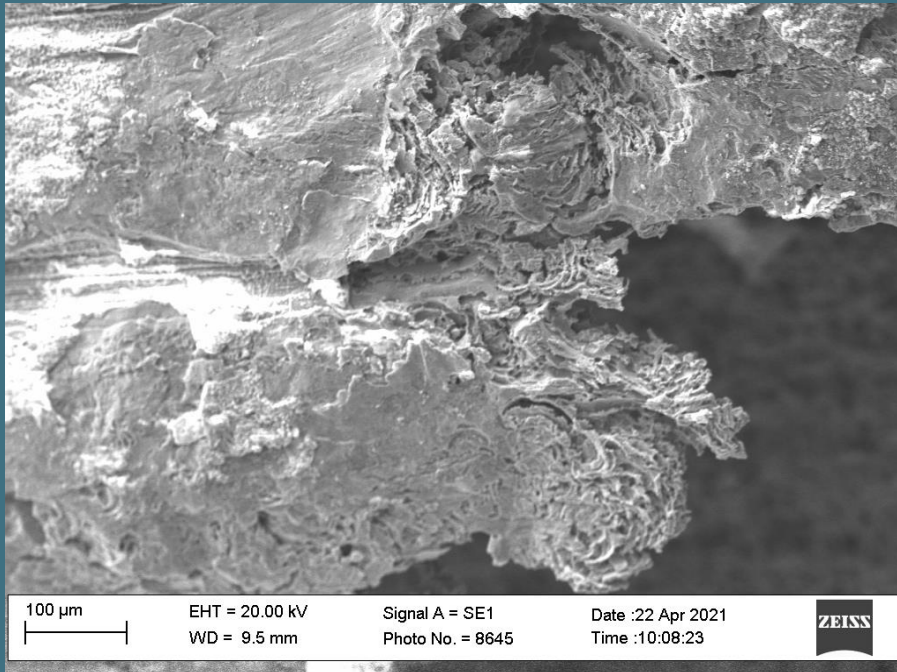
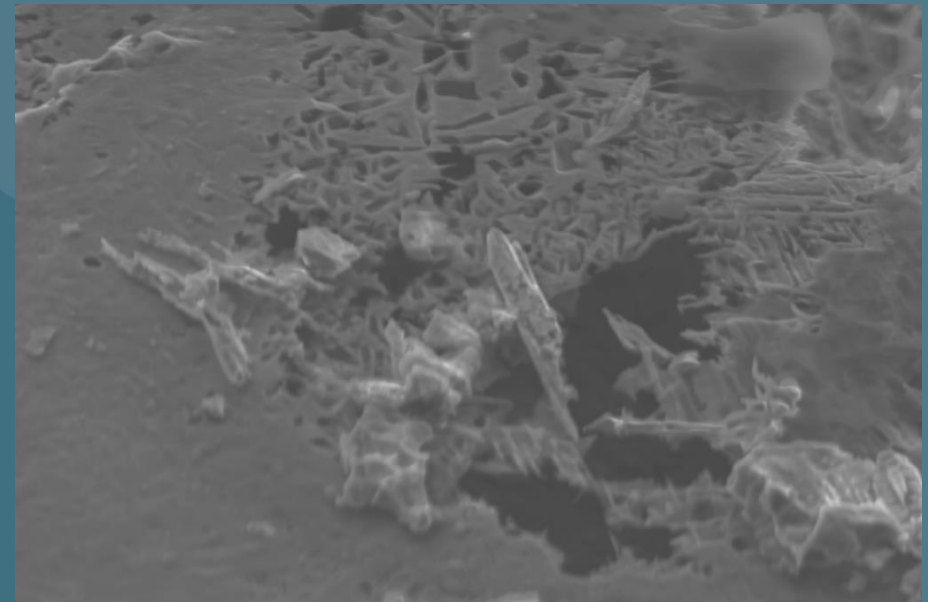
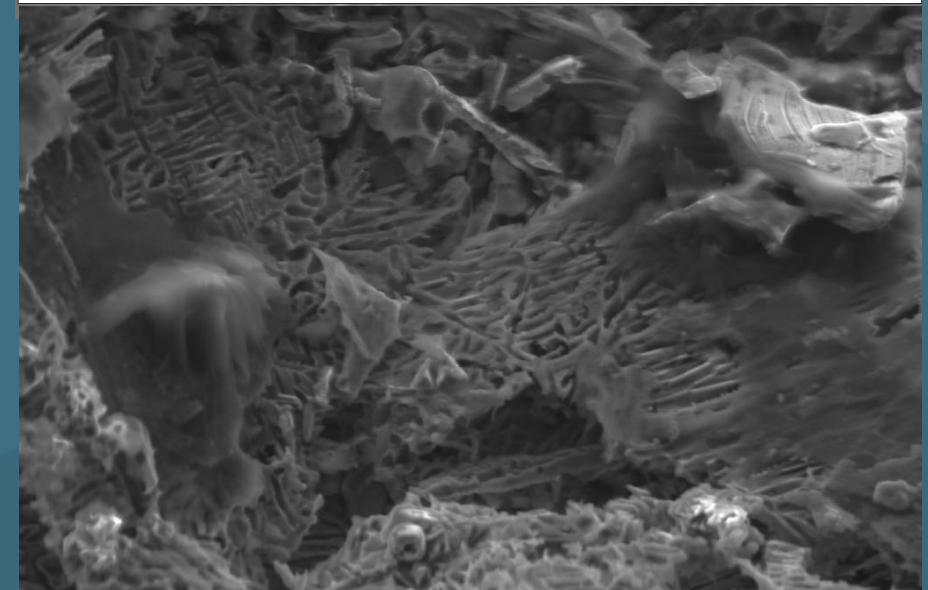
- SEM showed areas of selective attack in the vicinity of the hole
- Deposit contained significant levels of chlorine and sulphur

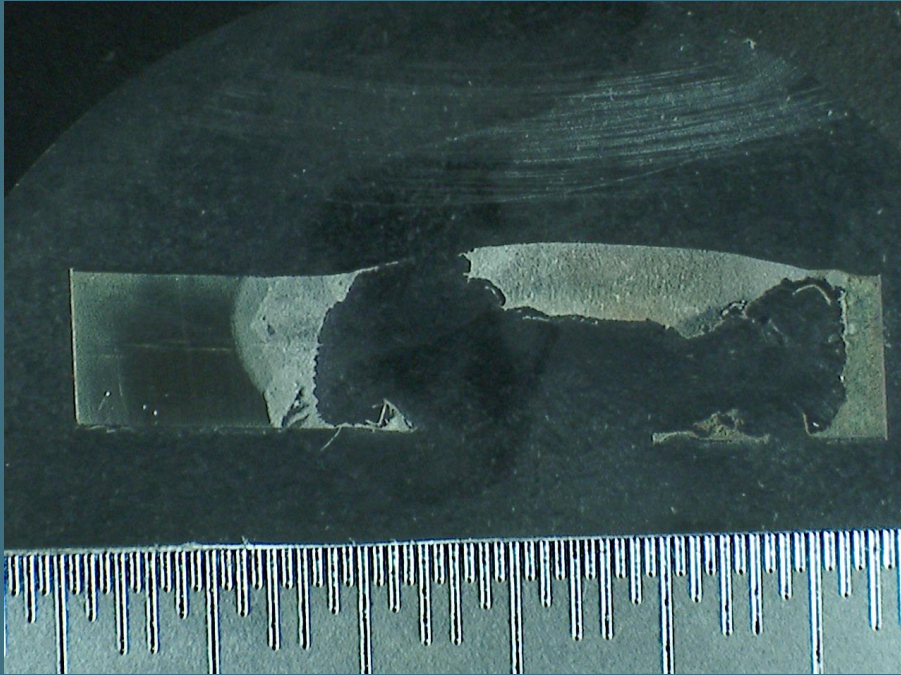
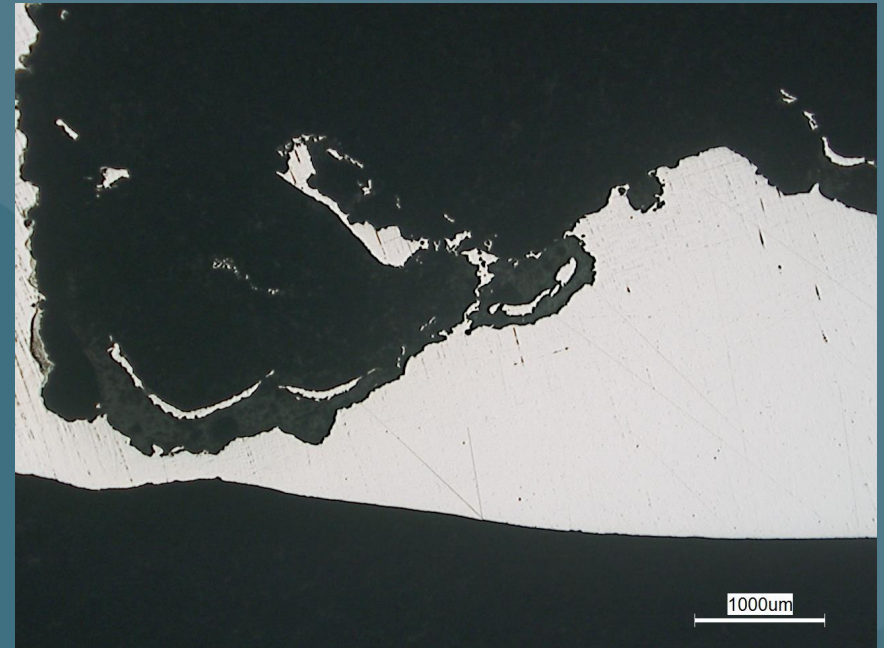
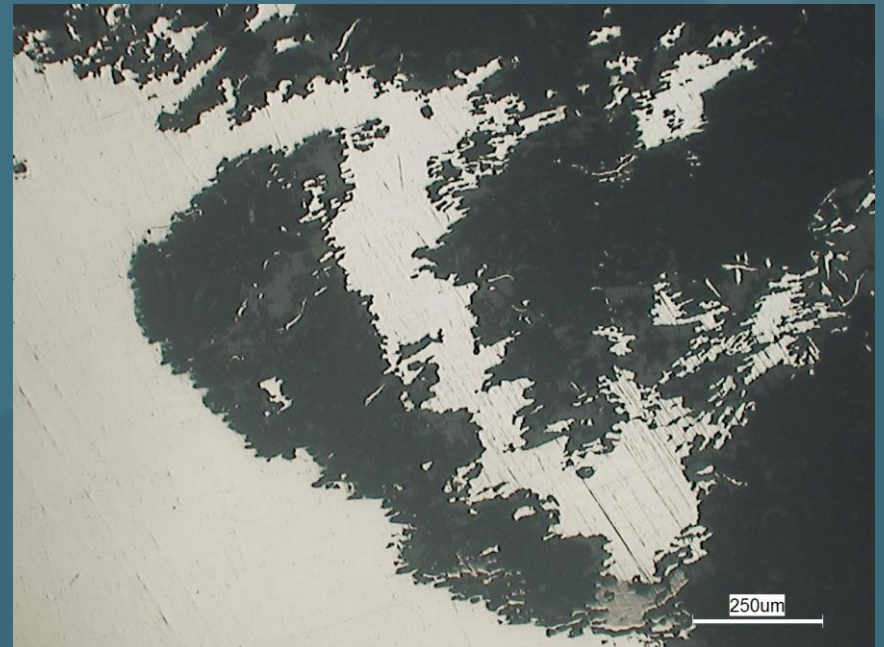
- Significant undercutting and hemispherical pitting evident within the weld metal

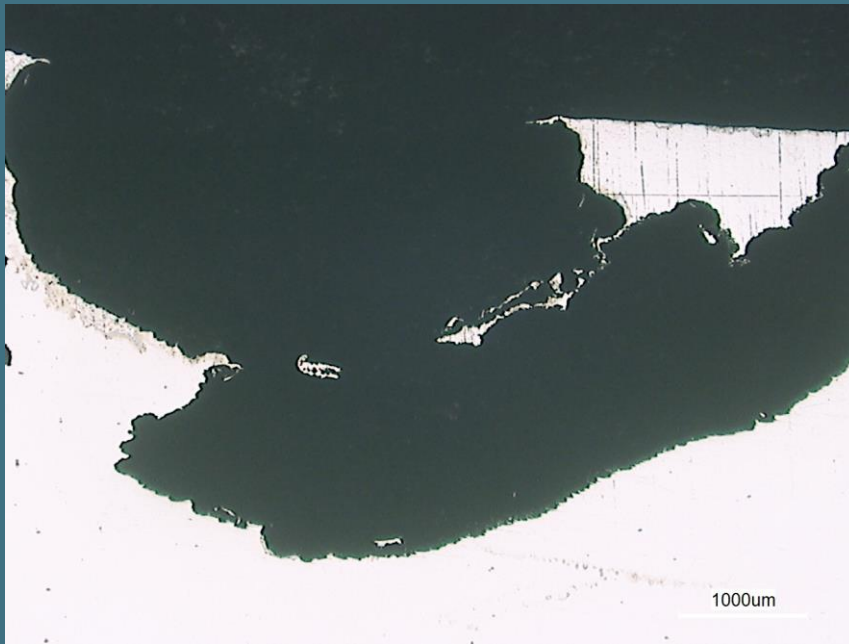
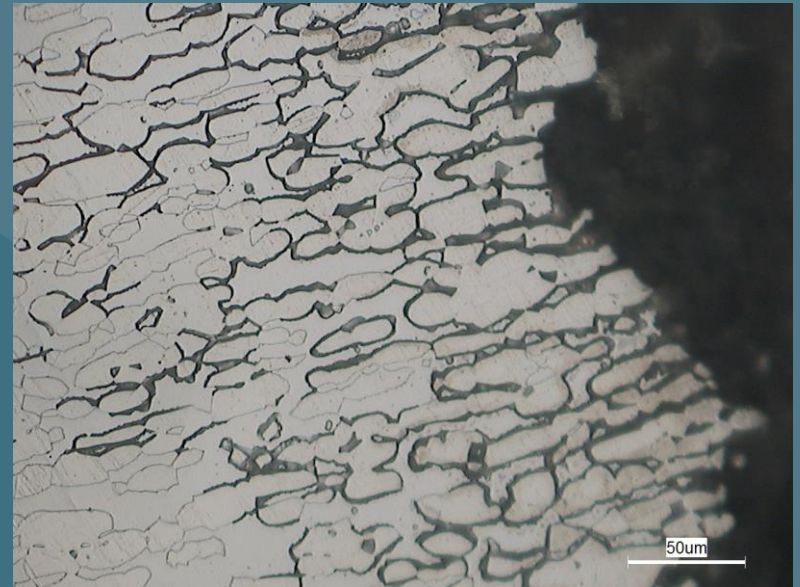
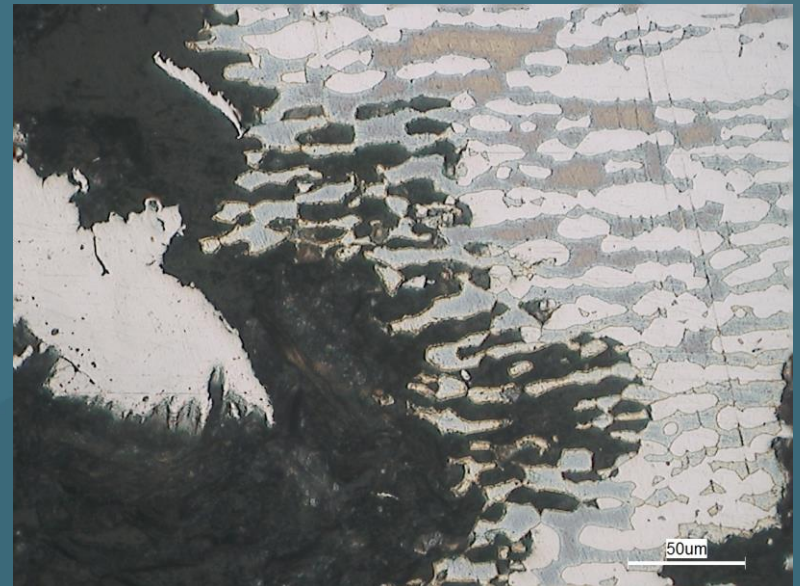
- Sigma phase & carbide was evident along the austenite/delta ferrite phase boundary
- Chemical analysis of the weld and parent materials were compliant with the specification

- Mechanism was deduced to be Microbial induced corrosion
- The presence of sulphur and the morphology of the pitting may indicate the presence of sulphate reducing bacteria. No sample was available to confirm this.
- The presence of carbides/nitrides along phase boundaries increases the likelihood of corrosion

- Water quenching after heat treatment eliminates the issue of carbide precipitation. It is important to keep the time between exiting the furnace and water quenching as short as possible.
- During welding, the heat input should be optimised so that the cooling rate will be quick enough to avoid these detrimental phases, though not so fast that there remains excessive ferrite in the vicinity of the fusion line.
- To maintain operational usage of the unit as far as possible in order to ensure continued flow through the elbow.
- If downtime for long periods is expected, adequate drainage and drying is necessary
- Culture live micro-organism samples in order to confirm the bacteria that has caused the damage to the elbow. This would enable the root cause of the problem to be determined.

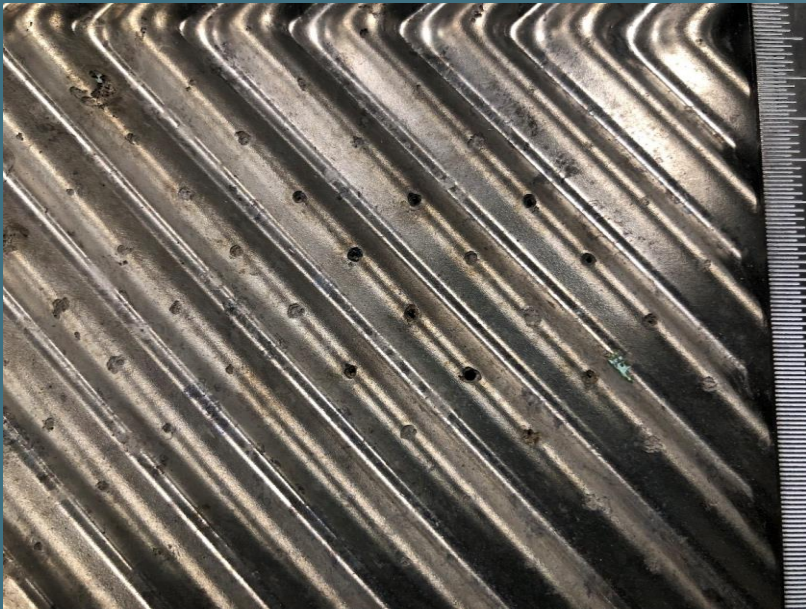
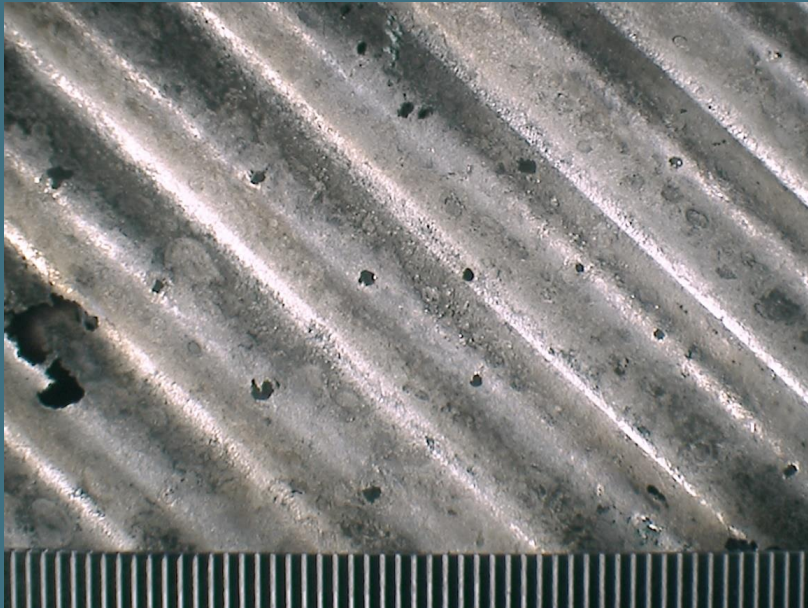
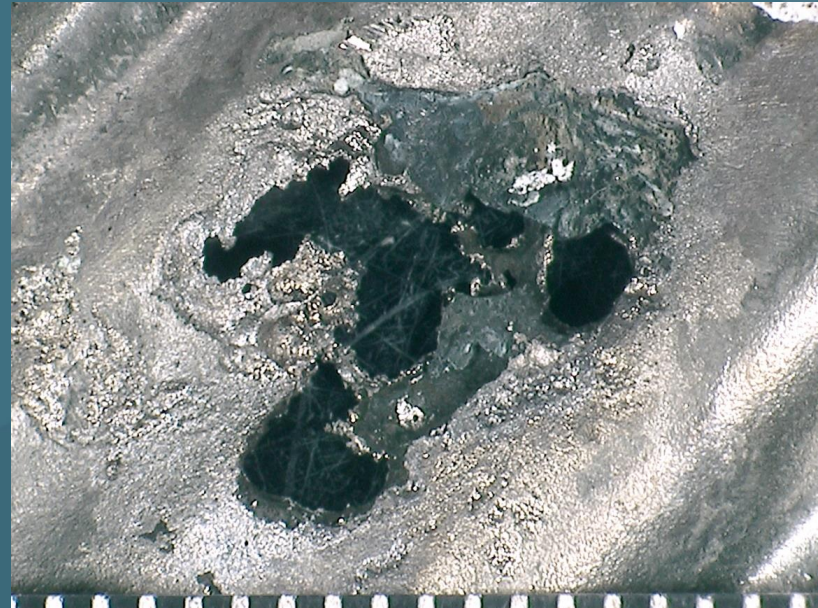
- Metal loss about the peaked regions.
- Concentrated about both peaks and troughs of the corrugated channels.
- Regions of gross metal loss were surrounded by instances of regimented pits situated about corrugation peaks at regular intervals (approximately 1cm apart).
- It is likely that these pits coincide with points of contact between adjacent plates.

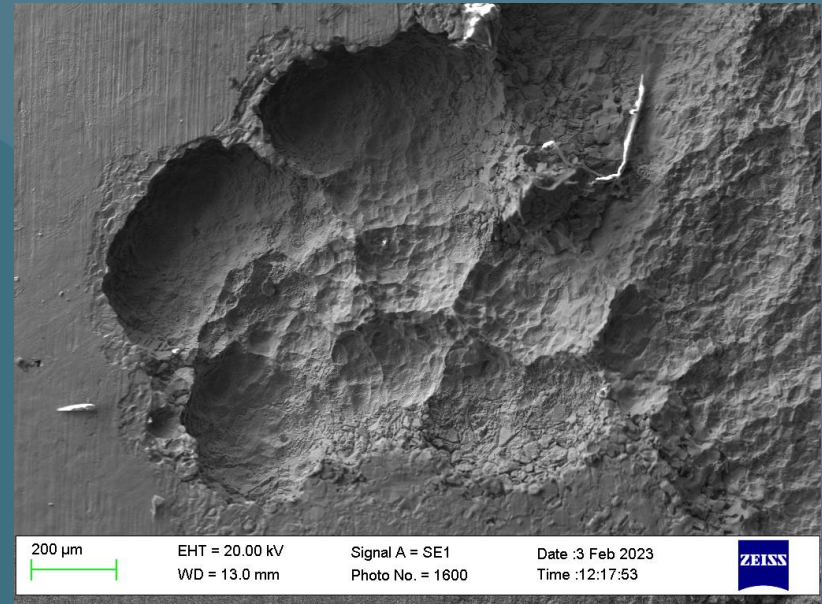
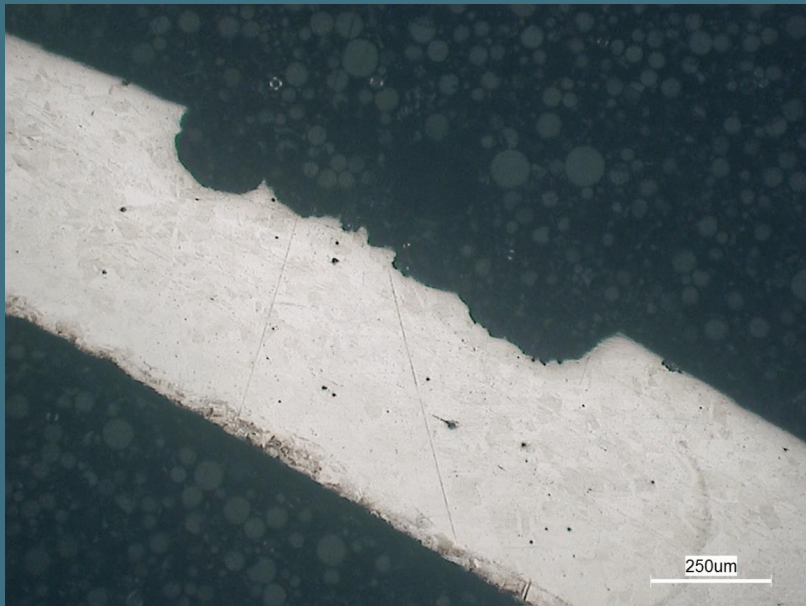
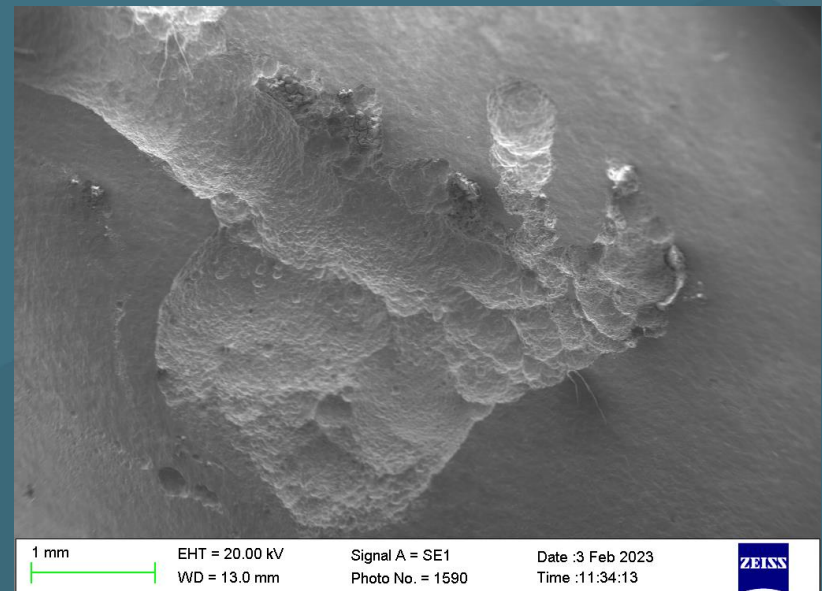
- Corrosion deposit contained significant levels of sulphur and smaller amounts of magnesium, sodium, potassium and phosphorus.

- The chief factor contributing to the outstanding performance of nickel 200 in highly concentrated caustic soda is a black protective nickel oxide film that forms during exposure.
 - In cases of MIC local breaks in the passive nickel oxide layer are produced; acidic metabolites secreted by bacteria either prevent passivation or destroy the existing passivating film. This results in more rapid local corrosion.
- The heat exchanger was off-commission for 6 – 8 weeks during turnaround, following a water flush.
 - This would have allowed for micro-organisms to grow at those points of contact between the adjacent corrugated channels, where sulphur compounds could have also collected during operation, resulting in MIC.
 - The literature recommends that a space of 1mm – 5mm should be applied between plates to enable fluid flow
