# Advisory – Corrosion in Pipelines

Corrosion Awareness Day, 2026

Luke Munro Pipeline Specialist –  
LR Offshore Technical Support Offshore

## Corrosion Defect Assessment of Thistle Alpha Export Line

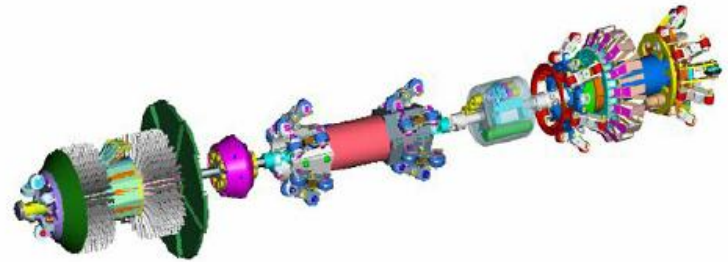
- 460 external corrosion features
- 63399 internal corrosion features

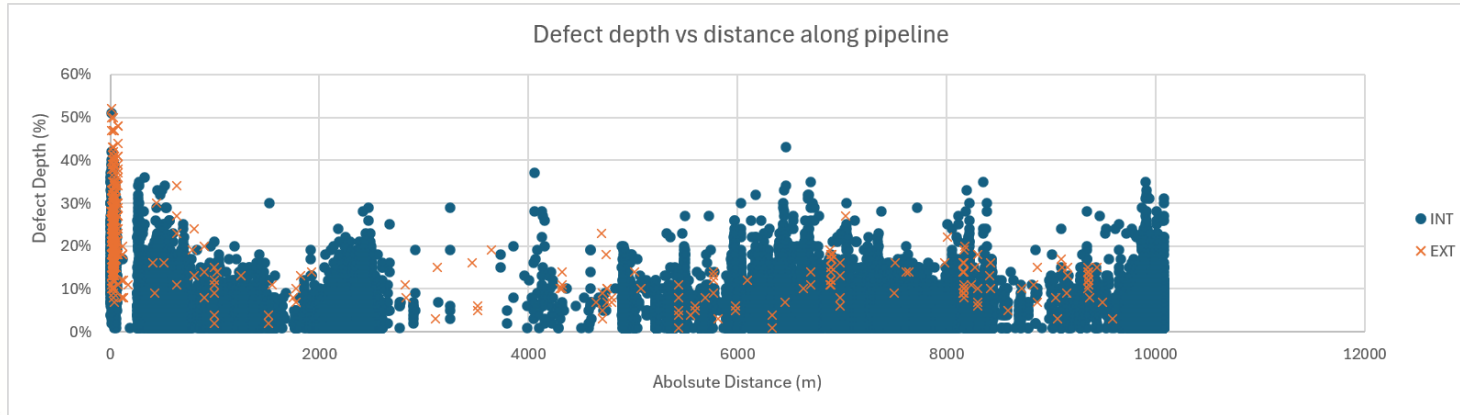
- Majority of external defects located within riser/topsides
- External defects located within subsea pipeline. Note the pipeline has a:
  - 9.5 mm thick corrosion coating
  - 36.6 mm CWC

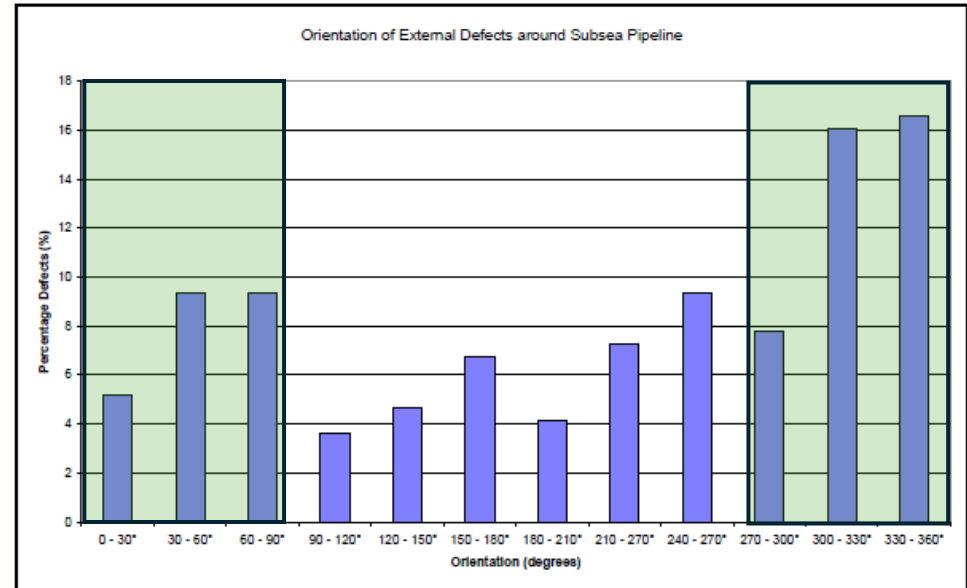
- Likely pipeline is not fully buried
- Likely CWC and corrosion coating damage
  - Majority of features located within top half of pipe

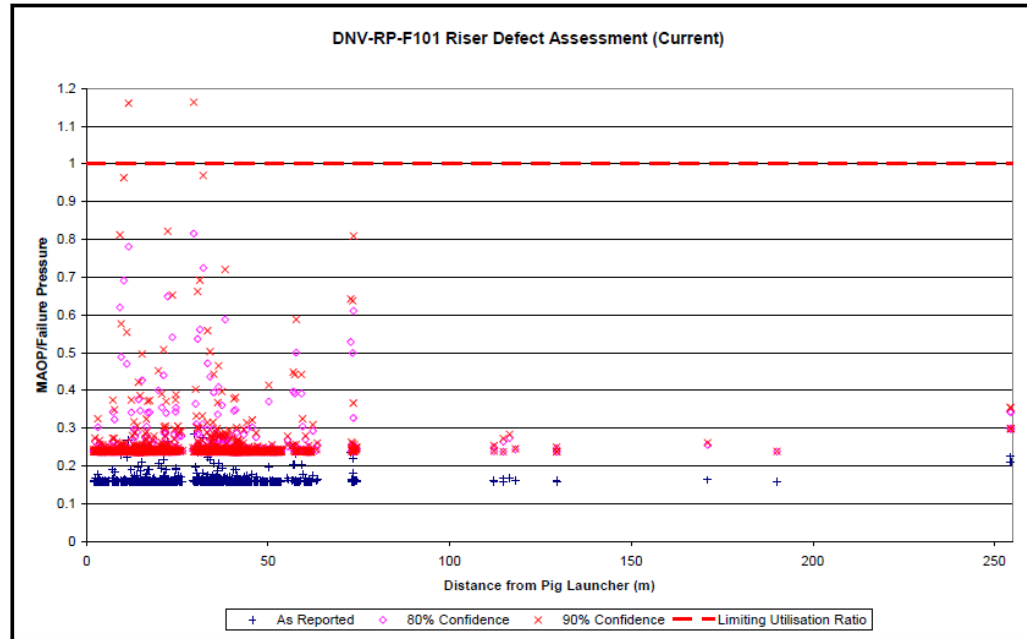
Results: DNV-RP-F101 topside and riser assessment  
(current)

- Governing external feature was located topsides
  - Defect dimensions at the time of measurement were beyond the allowable code limits
  - LR recommended an immediate repair of all external features
  - This was completed in 2010
- Governing internal feature was located topsides
  - Remnant life of 1.3 years
  - LR recommended that the 10 worst case topside features be inspected further
- LR recommend that ILI is reperformed as soon as possible
  - Missing 1.9 km
  - Possible inaccuracies

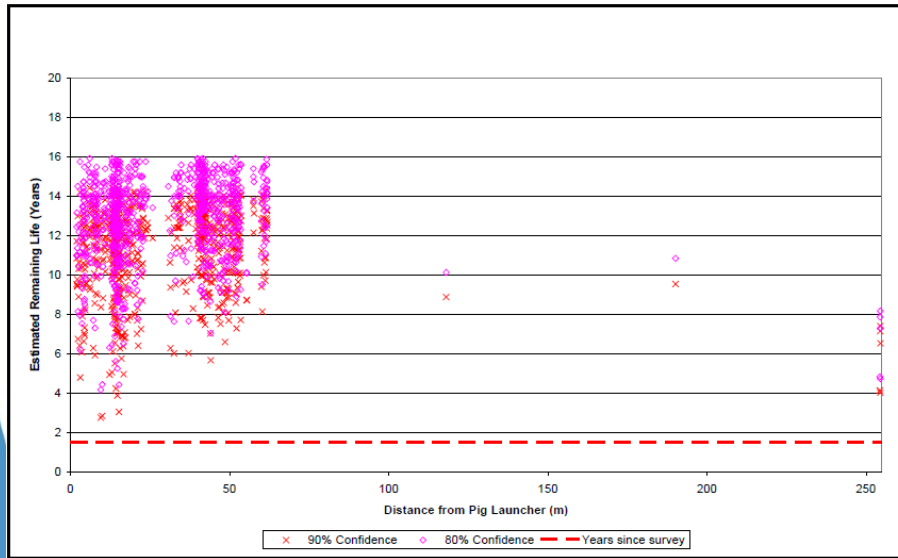
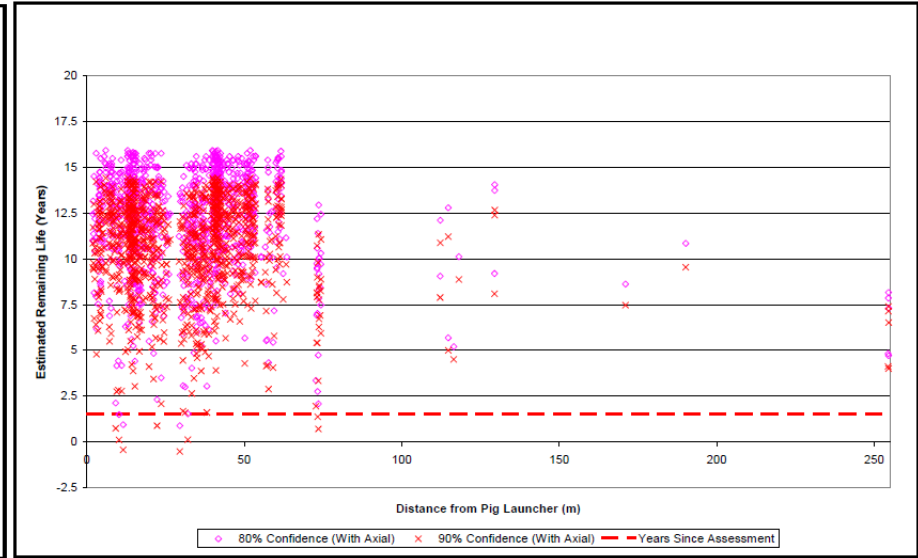
Results: DNV-RP-F101 topside and riser assessment  
(future)

- Once LR had reviewed current condition, the remnant life was determined.
- Features are “grown” until code violation
- Corrosion rate: 0.65 mm/year
- Based on max observed rate between 2001 and 2009
