# Development of coatings to last the life of the asset

# Hutton TLP Case History

# In service performance: Hutton TLP 1<sup>st</sup> Assessment

# Nov 2022 – Second Assessment Report Element Independent Test Company

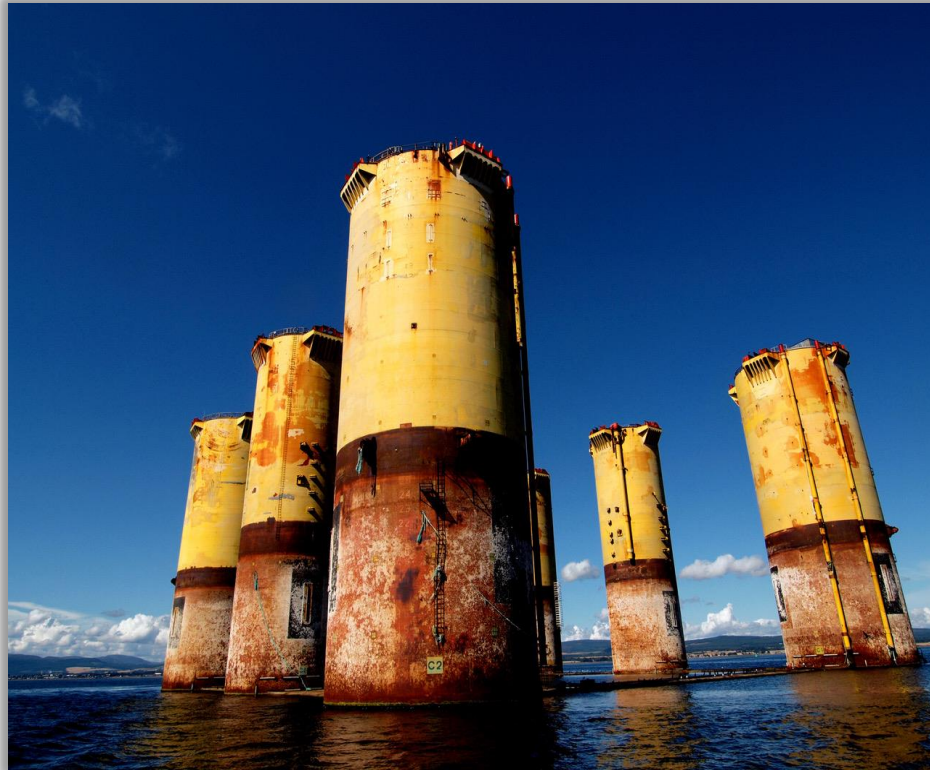
- First assessment in 2011 after almost 30 years in service
- The original coating in the splashzone was found to be in excellent condition
- At this time in 2011, Chris Jordan, Coatings Specialist for Conoco, during construction of the Hutton TLP was quoted to say:

***“It is clear that after nearly 30 years in service the high loaded glass flake epoxy is still performing very well on the painted tubular splashzone sections of the Hutton TLP hull. Estimated corrosion is less than 1% over the coated splashzone”.***

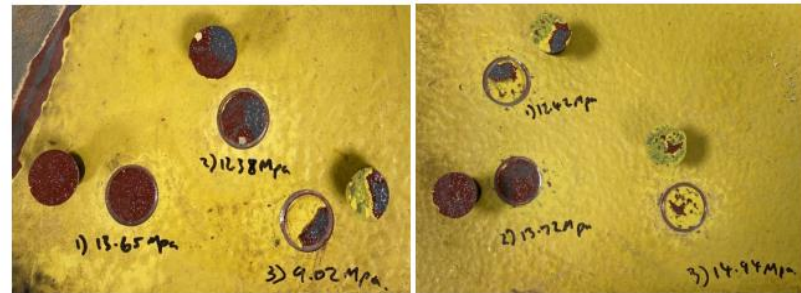
Figure 6. Pull-off adhesion

Adhesion checks were performed in accordance with ISO 4624 using a self-aligned automatic adhesion tester.

Sample Reference	Adhesion Value (MPa)	Mode of Failure
1	13.65	10%D 90%E
	12.38	10%B 50%D 40%E
	9.02	10%D 10%E 80%F
	Average – 11.68	
2	12.42	10%D 10%E 80%F
	13.72	50%D 50%E
	14.94	10%E 80%F 10%YZ
	Average – 13.69

Table 2. Pull-off Adhesion in accordance with ISO 4624.

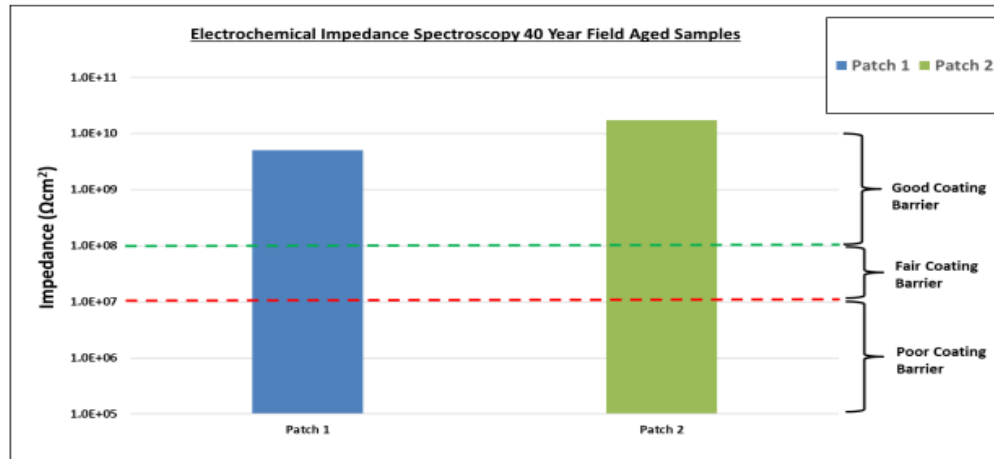
Figure 7. Graph of EIS Data

Electrical Impedance Spectroscopy is a non-destructive method for determining the barrier properties of a coating

EIS location	EIS at 15°C
1	$5.1 \times 10^9$
2	$1.7 \times 10^{10}$
