Integrity Management Lecture 14th October 2020.

Presented by Stephen Tate – Technical Services and Projects – TOTAL E&P UK Limited, Total House, Tarland Road, Westhill, AB32 6JZ

Frequent Causes of Loss of Integrity – Oil and Gas Production

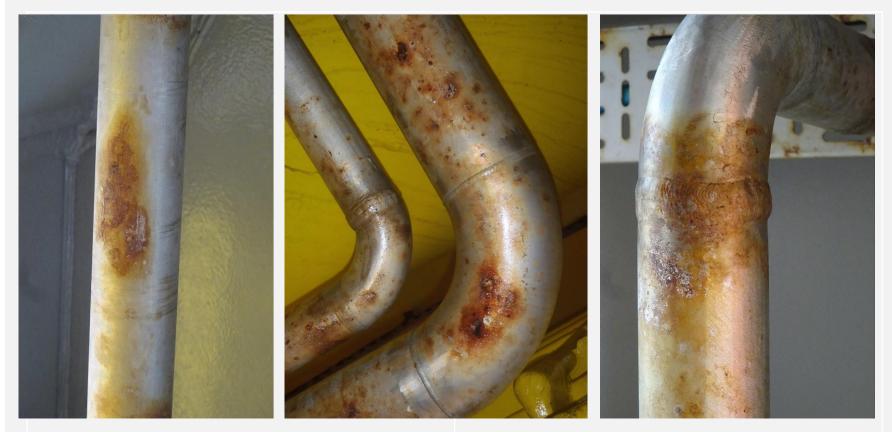
Poor Fabrication / Material Selection Practices – Uncoated 316L in Marine Environment

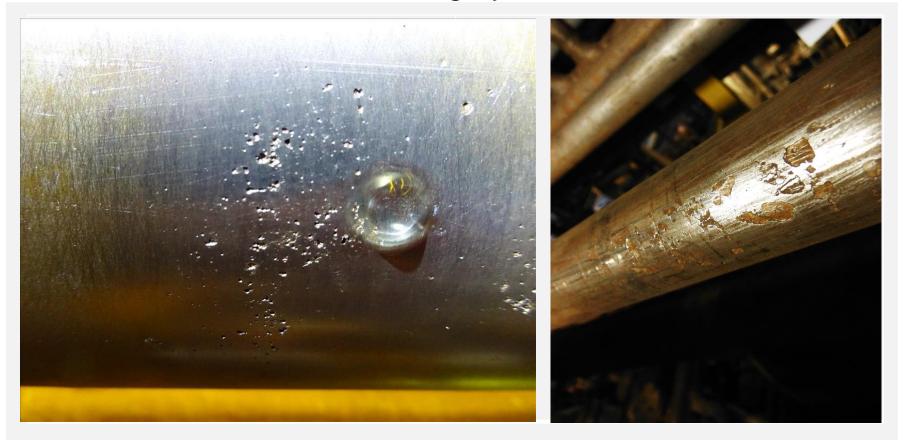
Poor Fabrication / Material Selection Practices – 316L Weeps + Pitting under ID Labels

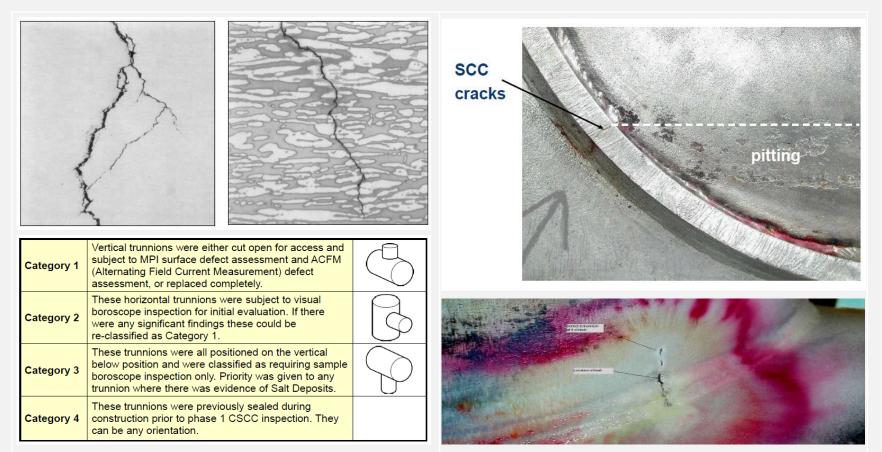
Pipe Trunnion Salt Water Ingress / Corrosion / Cracking Risks to HT Duplex Lines

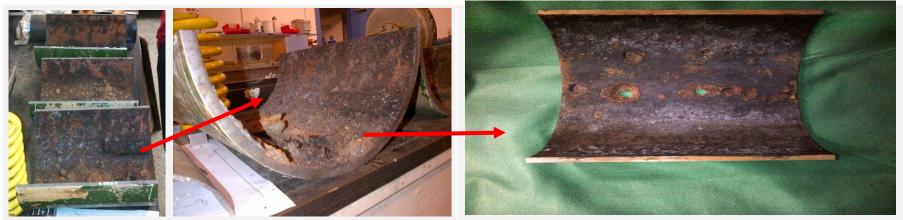
Examination after Intermittent Use

Post-Cleaning BOL – UDC / MIC

The Pipework from both First Stage Separators to the Second Stage and from Second to third was subject to severe internal pitting partly due to being shut in and not drained for quite long spells 6-12M. The failed spool had **many pits which were not reported from previous manual UT** Inspections. **Phased Array** scanning of the 3-9 o'clock parts of the horizontal pipework gave a more definitive view of the status (where accessible).

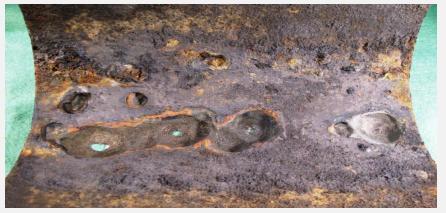
Holes – Visible Externally after Scale Rem.

Close-Up of Pitting

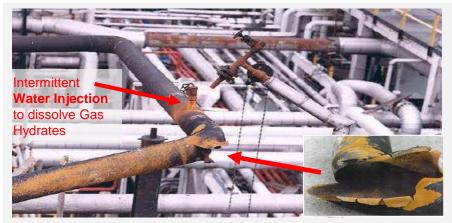
Humberside 2001 – Int. Erosion (New WI Pt)

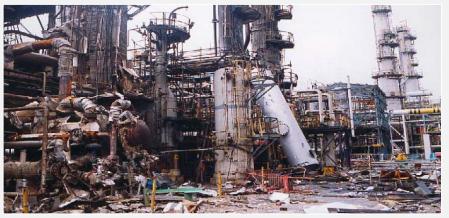
Gas Explosion – Damage Adjacent Plant

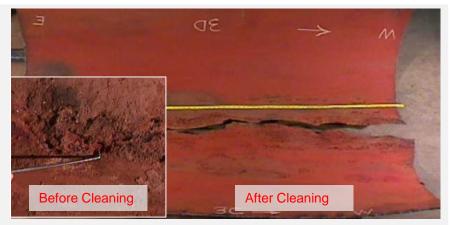
Internal BOL Corrosion – Common Cause

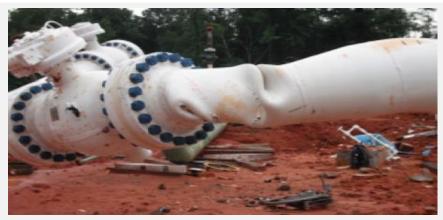
Resulting Hydrotest Failure

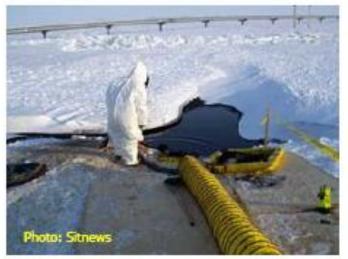
- Leak from Trans-Alaska pipeline
- At least 190000 litres of oil released onto tundra
- Corrosion at a point where line dips for Caribou to cross,
- corrosion rate had unexpectedly accelerated
- Prudhoe Bay oilfield closed down on 9th August 2006 losing 400000 barrels of oil/day production
- US\$12 million federal criminal fine,
- US\$4 million in criminal restitution to the state
- US\$4 million for Arctic research.
- BP Exploration (Alaska) Inc. on probation for three years.

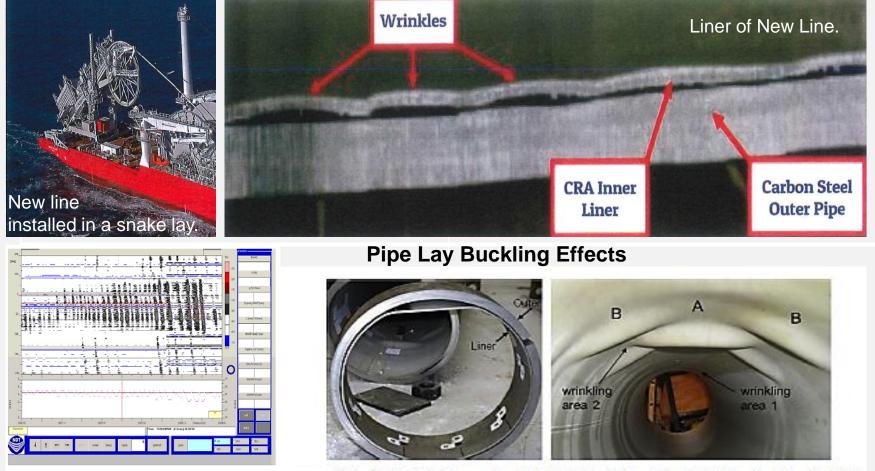
Lined pipe, (a) photo after experimental testing (Focke, 2007) and (b) wrinkled liner pipe (Hilberink, 2011).

Replacement Line has not leaked but requires careful Cleaning / Monitoring.

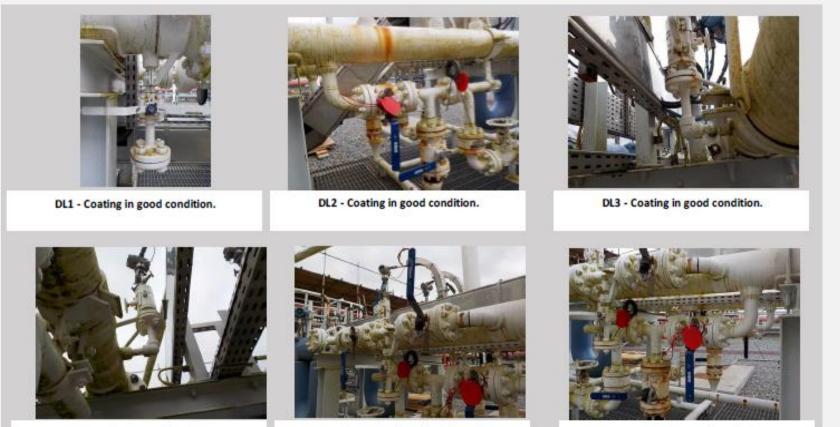
DL4 - Coating in good condition.

DL5 - Minor isolated CD/CR throughout.

DL6 - Coating in good condition.

10-12 Piping Deadlegs per P&ID can be expected with Internal / External Corrosion Risks

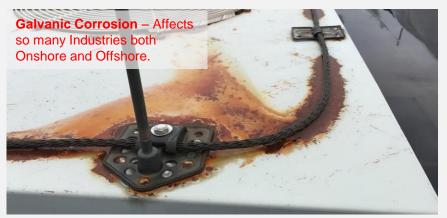
Safety Earthing – Typ. Galvanic Corrosion

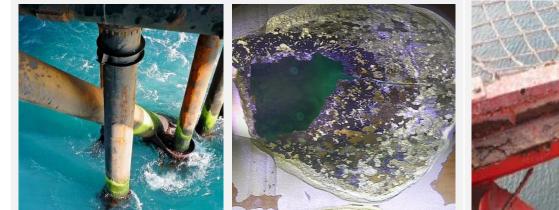
Caisson Failures – Pump and Drains

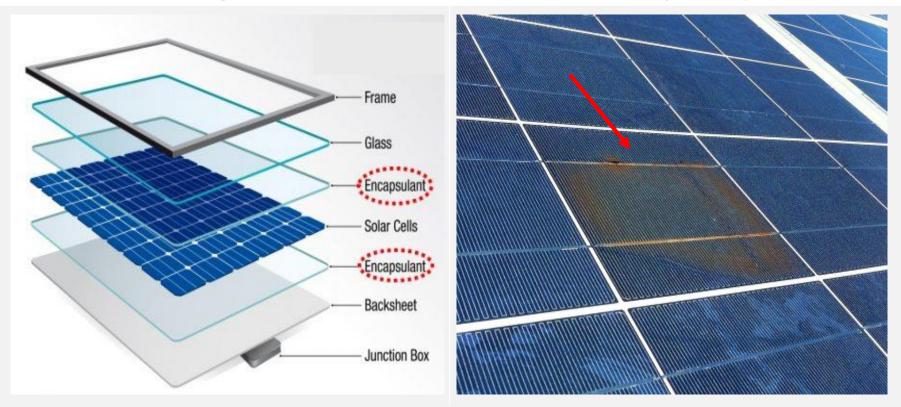
Browning is a change in color of the EVA film and occurs when certain additives used to prevent browning and enhance UV resistance, start to disappear. This can cause bleaching and blistering at the EVA film and the solar back-sheet, resulting in **Solar Cell Corrosion**.

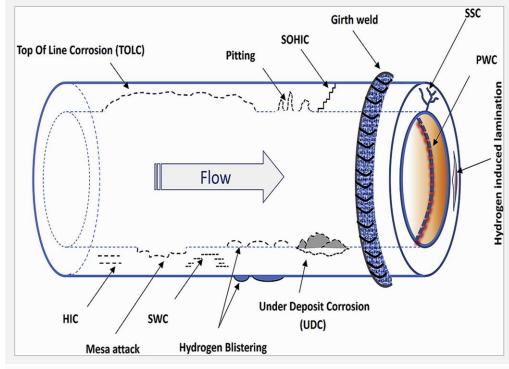
Lower Risk – Blending with Natural Gas (up to 15%) but this does not move much product !

Higher Risk – Single Product / Hydrogen use. Essential to under take full threats analysis and ILI run (ideally including some material sampling) if re-using a line. Historical records are often poor !

Pipelines used (or Re-used) for Hydrogen Transportation have many potential failure modes – both Internal and External. Worldwide there are more than 5000 km of hydrogen pipelines in total, the vast majority of which are operated by Hydrogen producers. **The longest pipelines are operated in the USA**, in the states of Louisiana and Texas, followed by Belgium and Germany. <u>https://hydrogeneurope.eu/hydrogen-transport-distribution</u> The most common causes of hydrogen-related hazardous failures are: **mechanical damage or damage due to material defects (from original manufacture), corrosion, enhanced embrittlement of storage tanks in low temperatures and human error (in operations).**

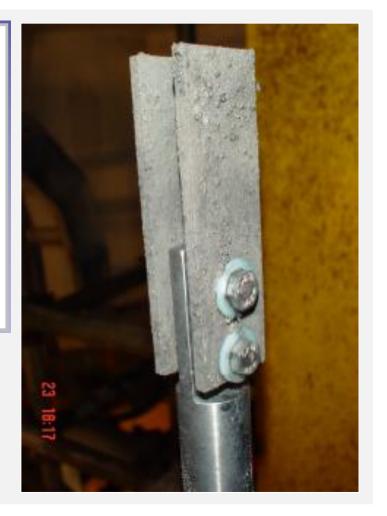
Corrosion Coupons

- 1. A Coupon is not a direct measurement of wall loss but remains a useful guide to process trends and process 'corrosivity.
- 2. An insulating washer separates the test coupon from the coupon holder and the pipe wall itself.
- Coupons should be pulled at least annually for Examination / Weight Loss Measurement / Micro Swabbing.

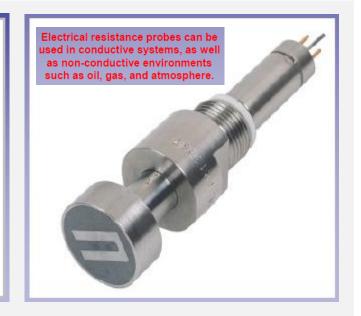
Corrosion Probes

- Electrical Resistance probes (when used for Corrosion Monitoring), monitor material loss directly* and do not require a continuous conductive path. Therefore the ER technique can be used to monitor corrosion in areas where water wetting is not continuous or under deposits where conductive may be limited.
- The replacement interval for electrical resistance probes is dependant on probe sensitivity and the corrosion rate. Readings from ER probes will be obtained manually or automatically via an offline or online logging system (PI).

ER Electrical Resistance Probe – is used to track rates of metal loss. The probe directly measures the <u>increase in resistance</u> of a metal as its <u>cross-sectional</u> area is reduced by corrosion. At suitable times, after probe bedded-in readings can be converted into corrosion rates

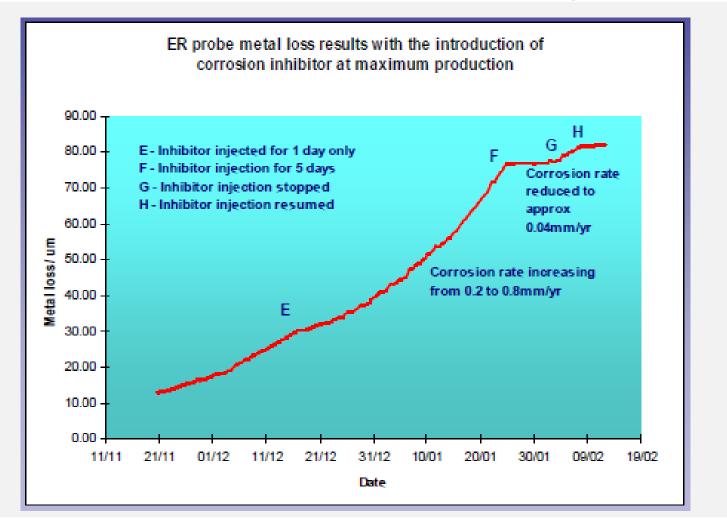
ER Probes used for CI Dosing Op.

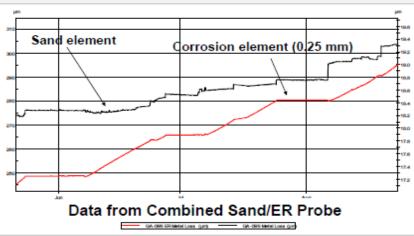
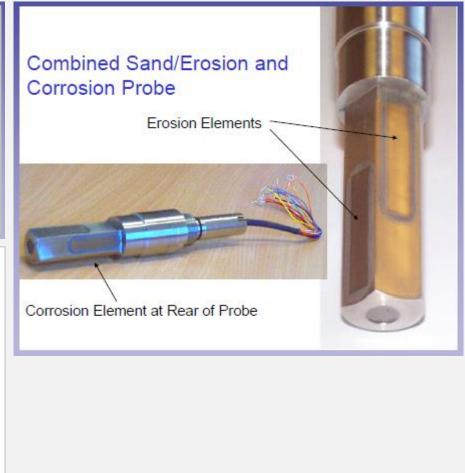
- ER probes of stainless steel, with similar mechanical properties as for the pipe that is the subject for monitoring. Hence the erosion sensors will not corrode and all material loss and can then be attributed to erosion.
- 1. Often there is little general evidence of solids posing a serious problem, other than very locally at Choke Valves / Sudden Geometry Changes.

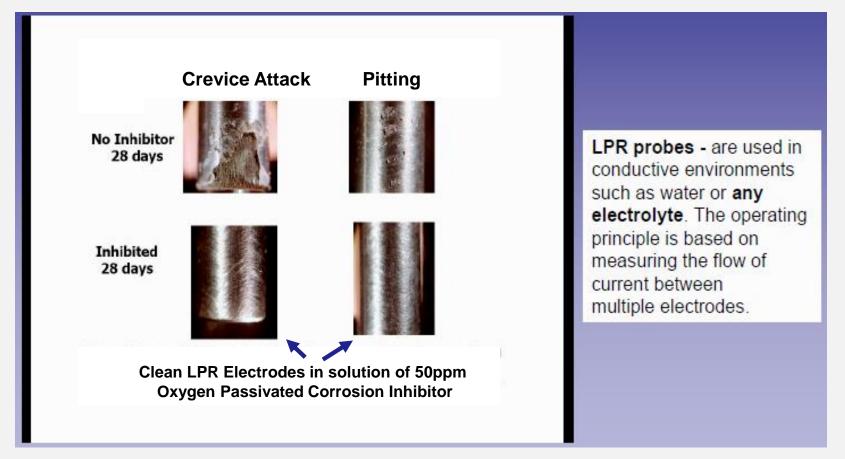
Linear Polarization Resistance (LPR) Probes

Less Commonly Used – More for Laboratory Use

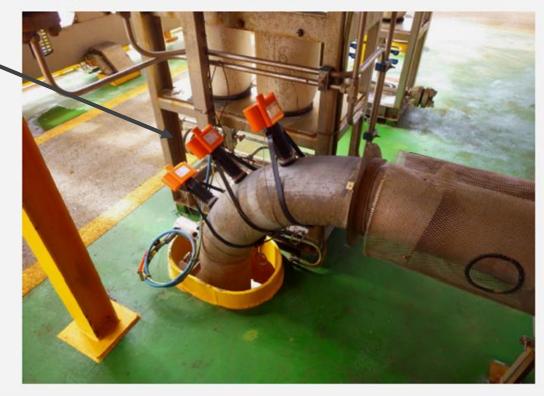
Permasense Trials – Probes (West Franklin)

Extremely useful on Flowlines of NUI's – Normally Unmanned Installations (where the Cost of sending UT Inspector is very High)

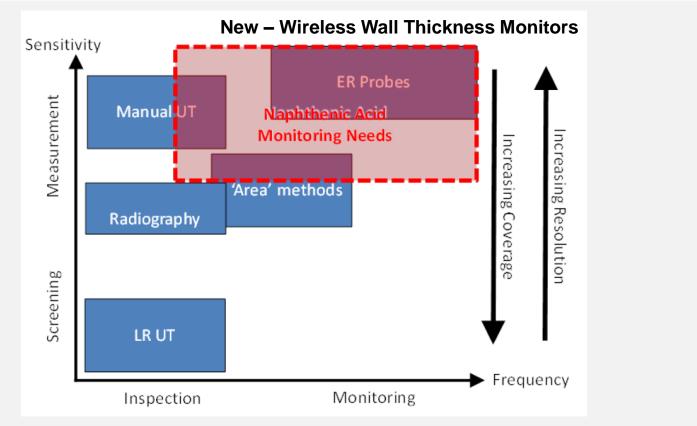
Novel NDT Wall Thickness Monitors

The diagram above shows this categorization of the various technologies, including intrusive (ER) corrosion probes and manual ultrasound (UT) described in the previous section, according to whether it is a screening or a measurement technique, and whether it can be used for inspection purposes or for monitoring purposes.

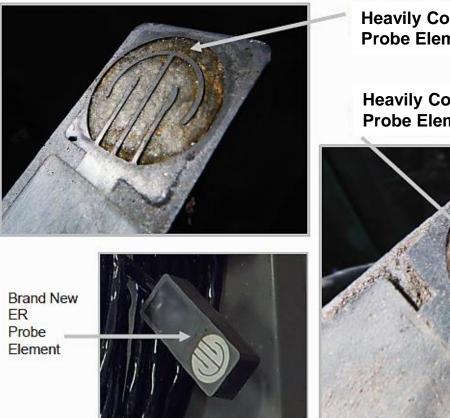
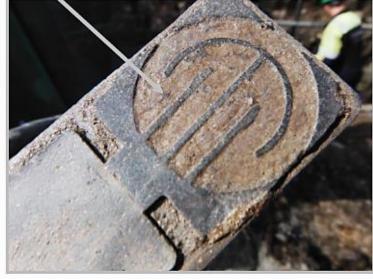
AFTER ~ 6M BURIAL

Heavily Corroded / Dissolved ER Probe Element

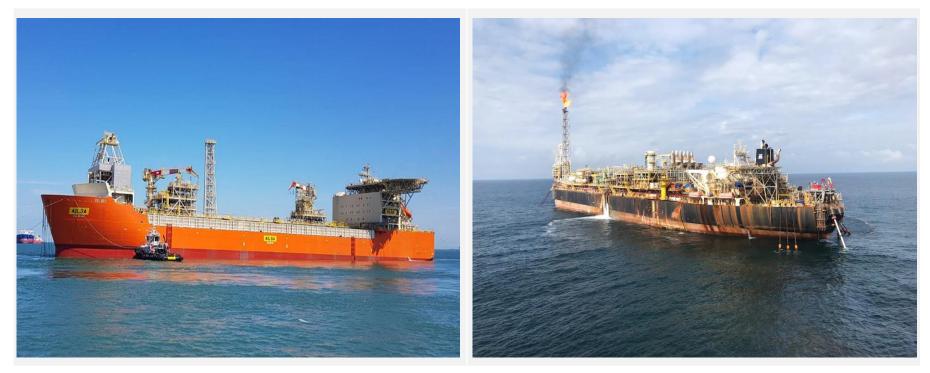
Pre – Service Condition

Post – Service Condition
