**Delivering Real  
Time Condition  
Monitoring of  
Subsea Pipelines**

# Technology overview

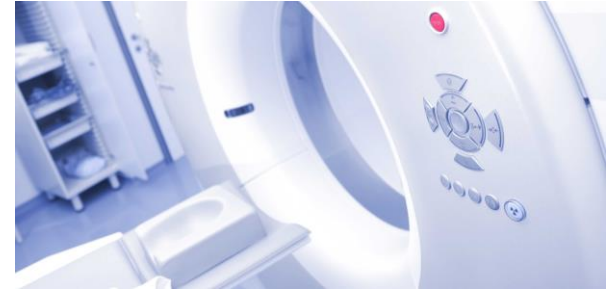
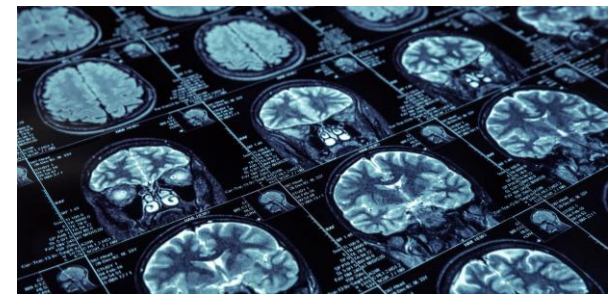
- Same principle as medical CT scanner
  - Reconstruct image from a series of line measurements
- One key difference
  - Target is mostly steel, not body tissue ( $\sim$ water)
- Therefore using gamma rays instead of X rays

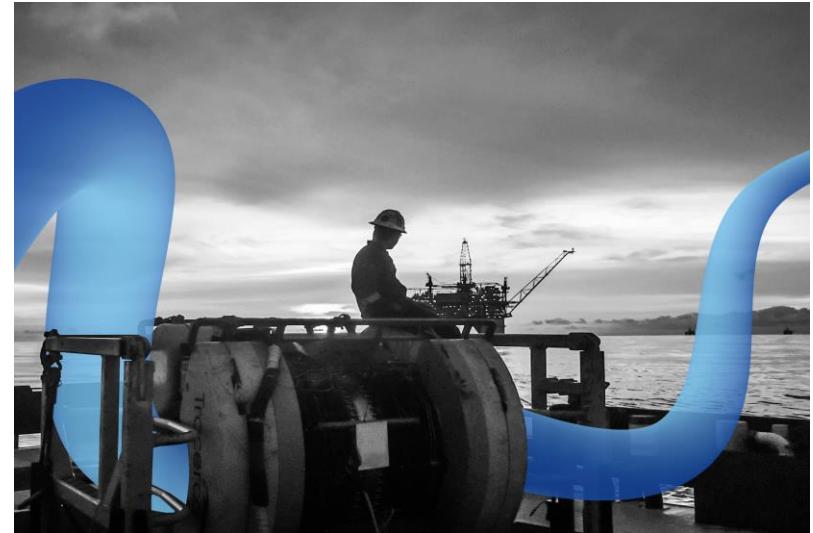
- Truly non-intrusive technology
  - Scan through any coating
  - No coating damage
  - No interference to production
- Integrity and flow assurance data in a single scan
- Real time data
- 0.05g/cc density resolution
- 10,000' water depth
- 6"-26.5" Total OD capabilities
- Work class ROV

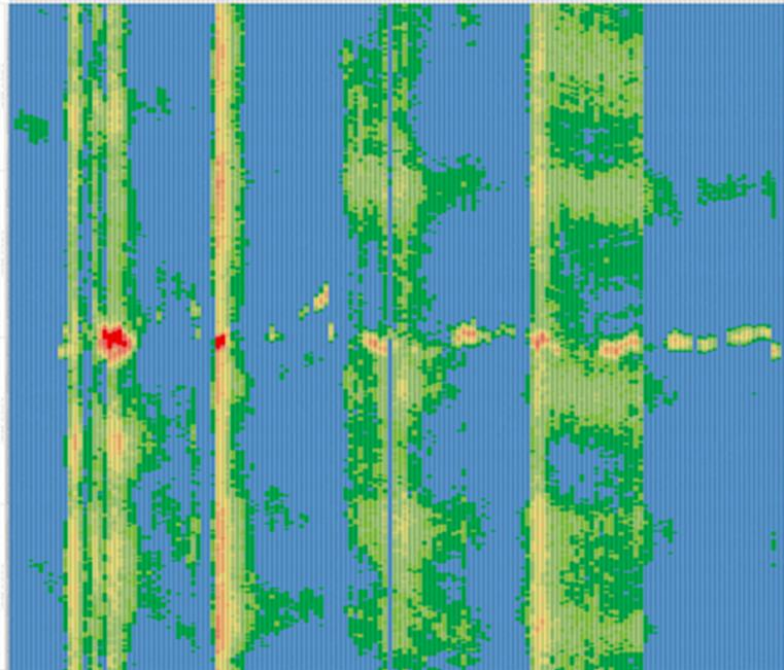
- Truly non-intrusive technology
- Pre project FAT & Calibrations possible
- Techniques comparisons & Validations
- Eg small pinhole

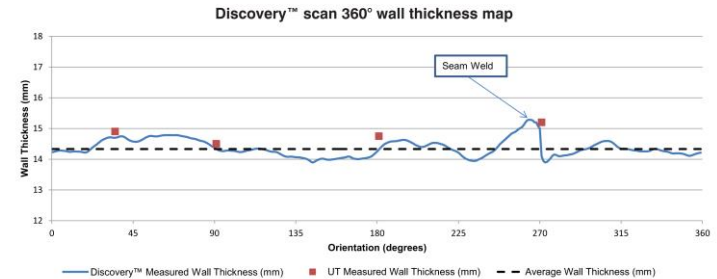
- 16" concrete weight coated pipeline (5mm polyurethane under 63mm concrete)
- Consistent wall thickness of approximately 14mm obtained
- No requirement to remove coating or rebars to obtain the data

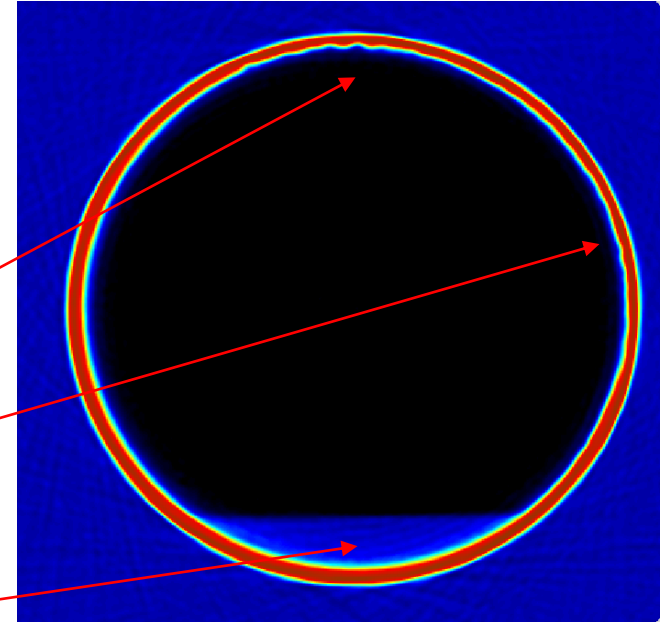
- Large diameter gas line
- Major wall loss observed in multiple locations around the pipe
- Condensate in the pipe - a possible contributing factor to internal corrosion

Severe wall loss

Condensate

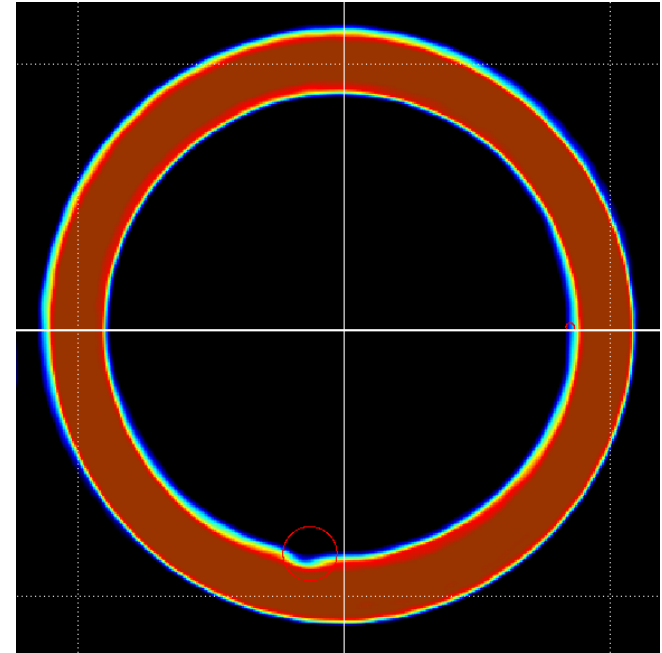
- Bacteria / microbial induced corrosion
- Potential corrosion hot-spots can be identified through modelling
- Localised inspection was used to check for pitting

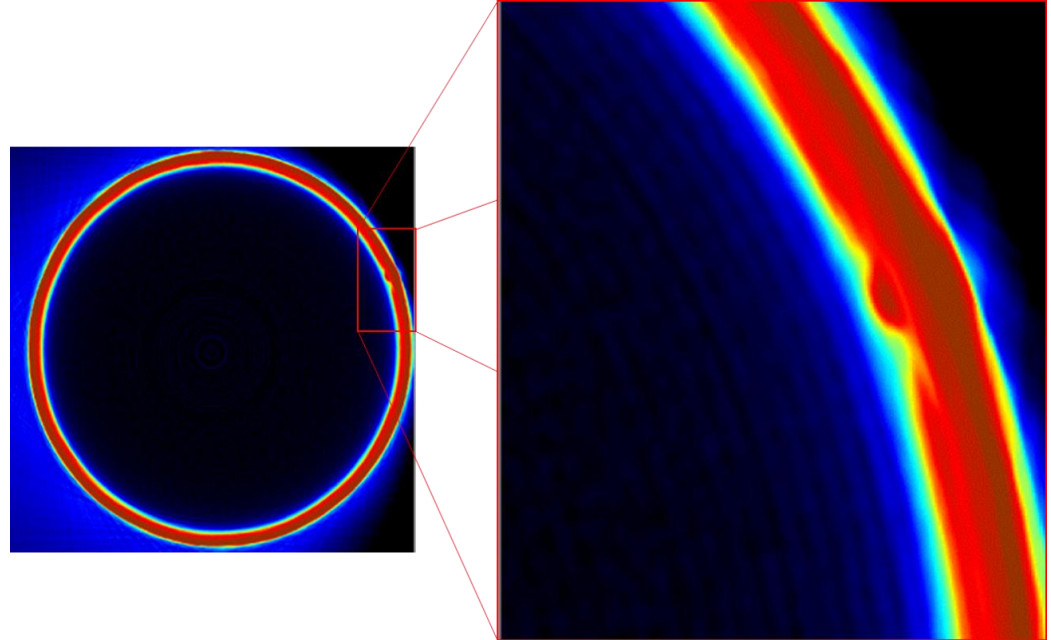
- Preferential weld corrosion (PWC) is a threat to welded joints
- Localised inspection was used to check a seam welded pipe for evidence of PWC
- Results used to determine pipeline life extension

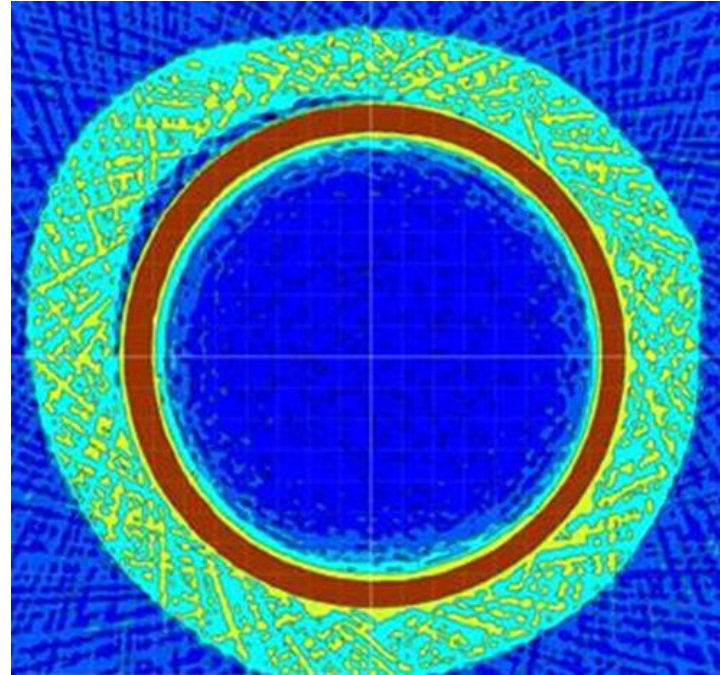
- Fusion Bonded epoxy coating
- Generally expected to be in good condition
- Discovery – Pipe wall in good condition
- Problems with coating revealed

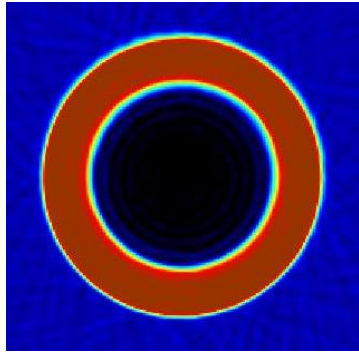
- Riser integrity – corrosion depletion
- Major wall loss observed in two sections of the riser

Good  
condition

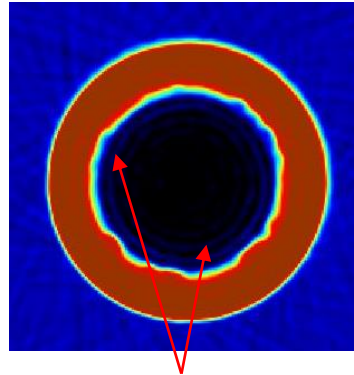
Major wall  
loss

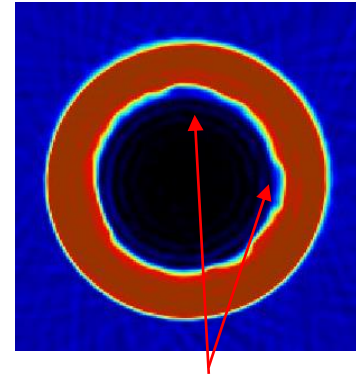
Major wall  
loss

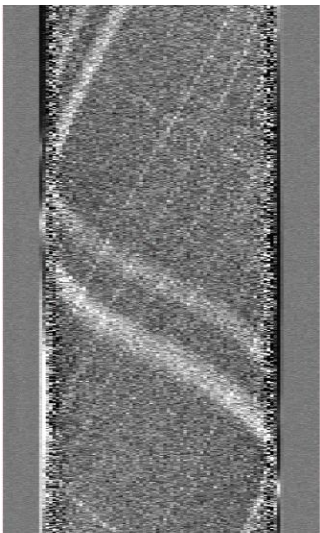
Raw data after 1 full lap

Anomalies detected in raw data

- Real time visualisation of raw projection data enables the operator to detect presence of metal loss anomalies
  - Even after just one lap!
- Where an anomaly is detected the scan continues to increase the signal-noise ratio to acceptable level to enable image reconstruction
- If no anomalies are identified the instrument quickly steps on

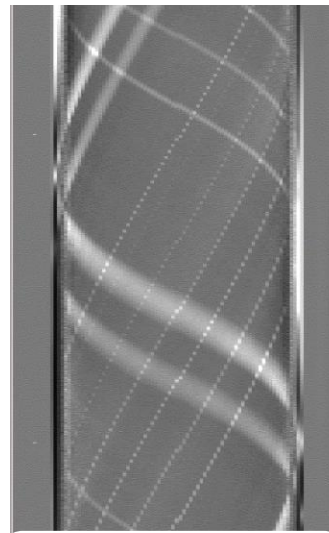
Raw data after >20 full laps

Sufficient data acquired for image reconstruction

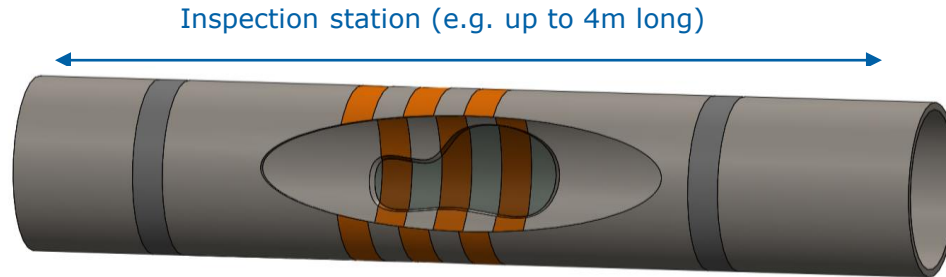
- In total, 4 locations were inspected following a typical fast screening approach as shown below:
- Minimum 1 full duration scan per 20 screening scans

Occasional full duration scans for general wall thickness measurements and deposit assessment

Full duration scans wherever an anomaly is identified

Quick screening scans; instrument quickly steps on if no anomalies are identified

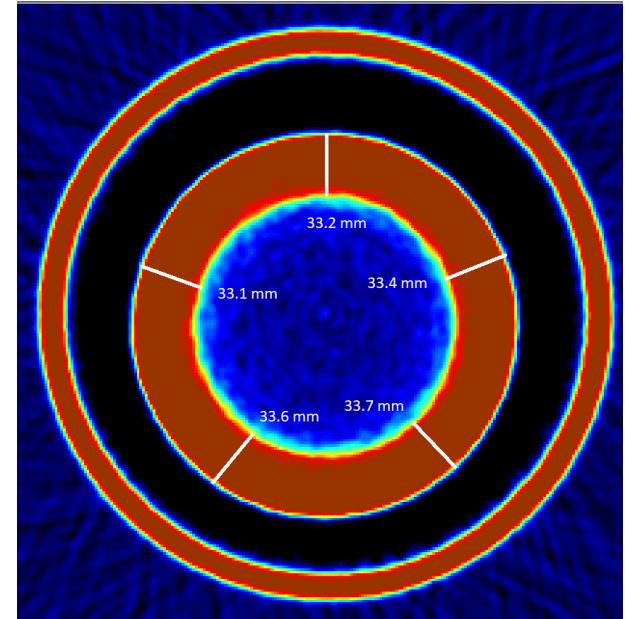
- Discovery™ deployed to obtain critical baseline data
- Accurate integrity data on areas of future potential concern, gave the operator confidence that their pipeline system meets all safety and regulatory requirements
- Discovery™ will be deployed annually to reinspect the new pipeline system to measure corrosion growth rates

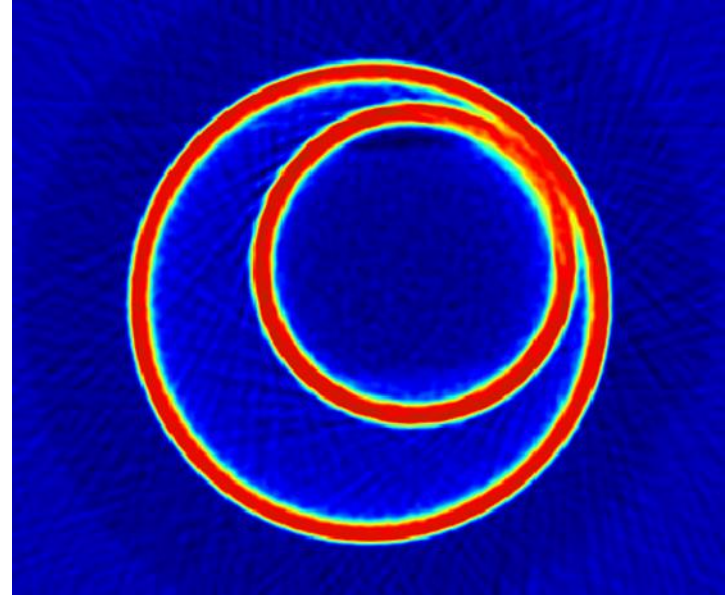
- Thermal expansion can overstress a flowline
- Ineffective thermal expansion design can also cause flow assurance issues
- In this case local inspection was used to check the effectiveness of the thermal expansion design

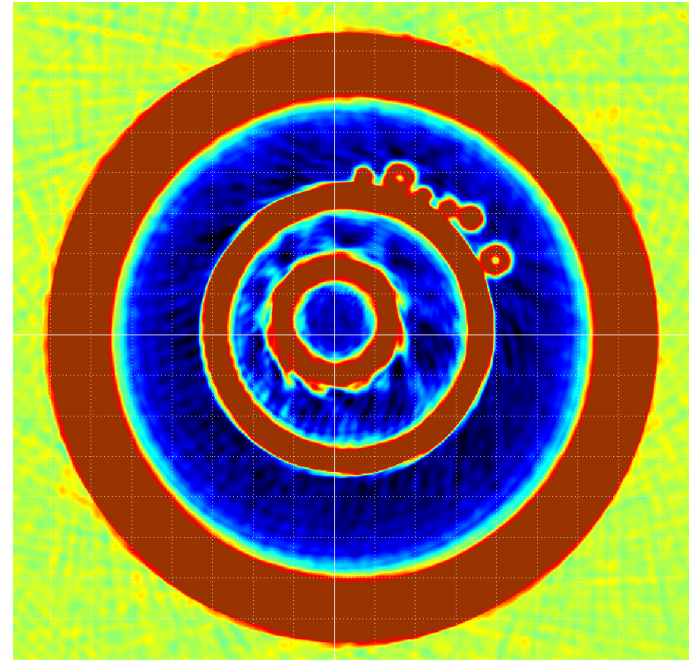
- Potential corrosive atmosphere
- Gas lift riser was observed to be moving
- Risk of fatigue damage

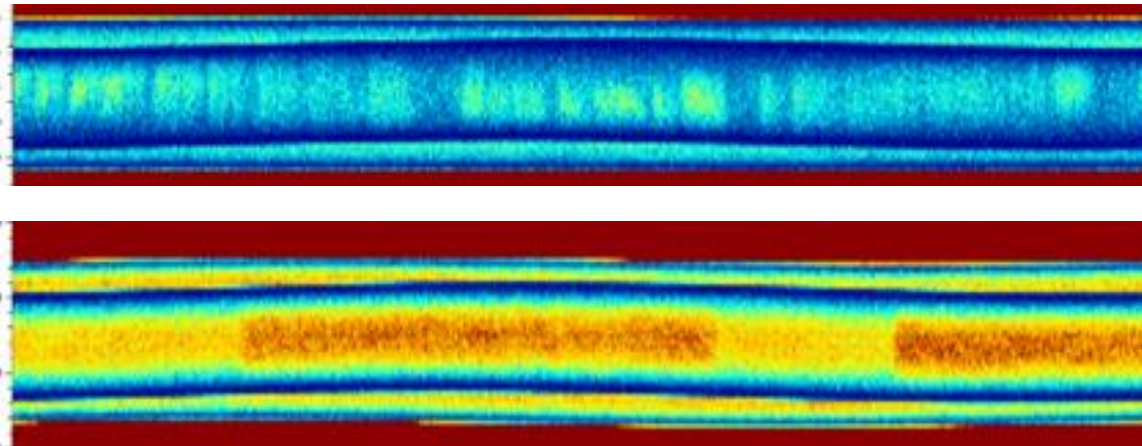
- Sensors (strain gauges) can be used to identify potential overstress situation in a riser system
- These are caused by flow regime (e.g. slugging) which was characterised in this case using local inspection

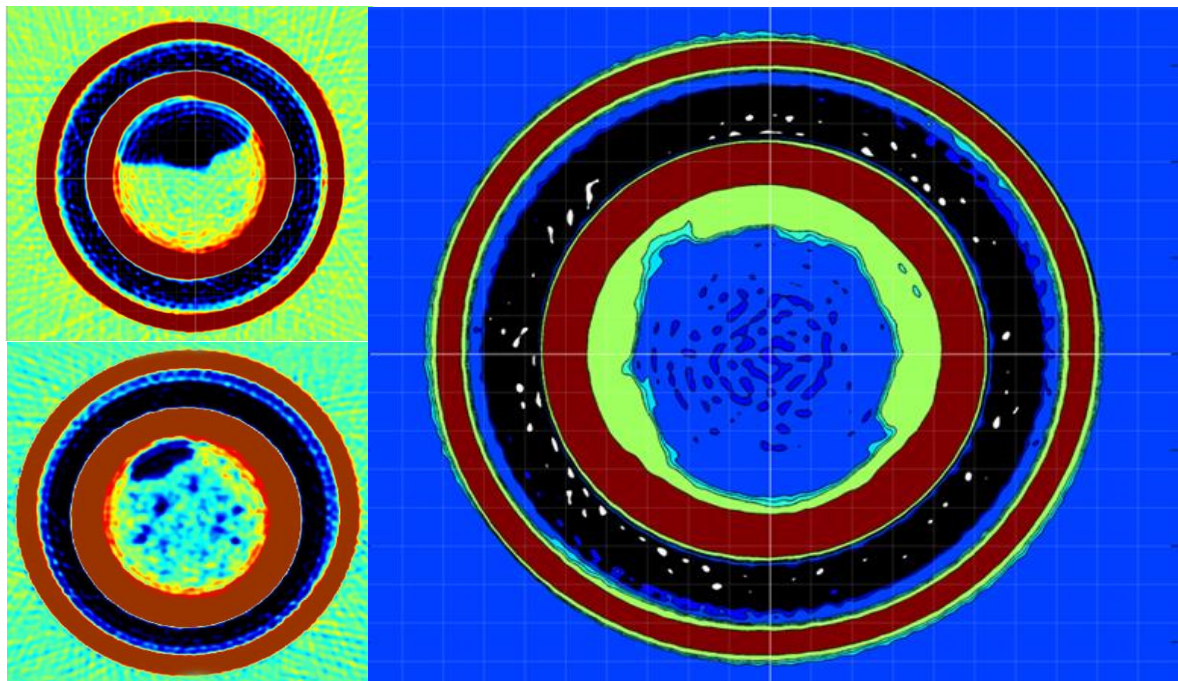
- Determine the exact location of any build-up
- Quantify and characterise deposition build up (asphaltene, sand, scale, hydrate, wax)
- Select the correct remediation approach first time

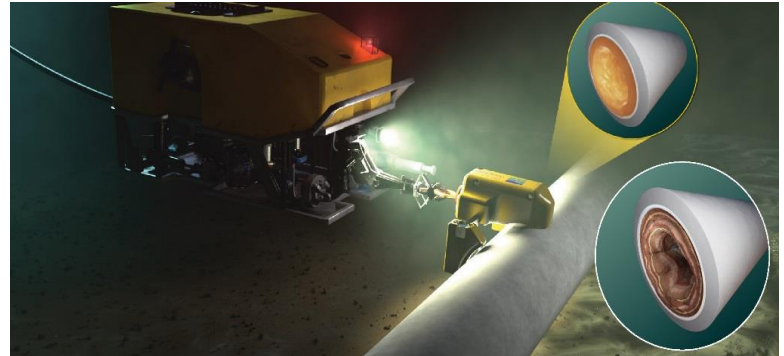
- Truly non-intrusive technology
  - Scan through any coating
  - No coating damage
  - No interference to production
- Fast screening flow assurance data to locate suspect areas
- Real time data
- 0.1 g/cc density resolution
- 10,000' water depth
- 6"- 60+" Total OD capabilities
- Most size ROV's

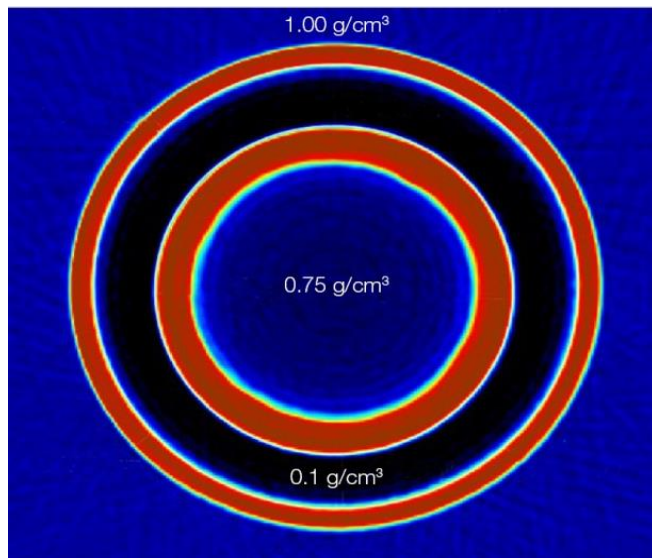
Clean PiP

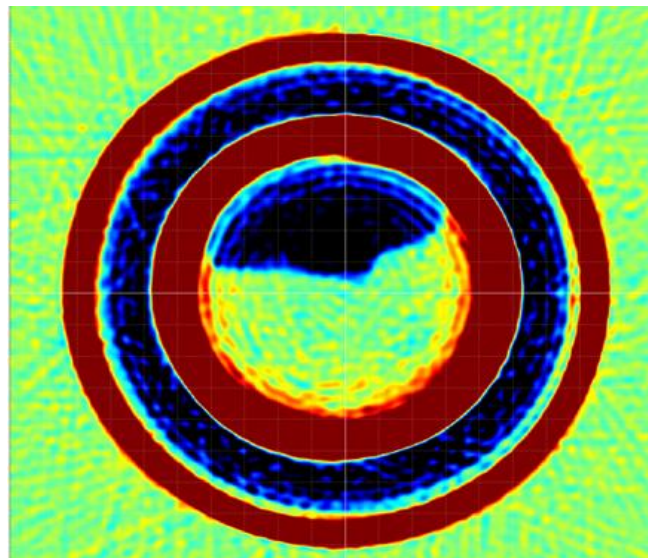
Asphaltene @ 1.2g/cc

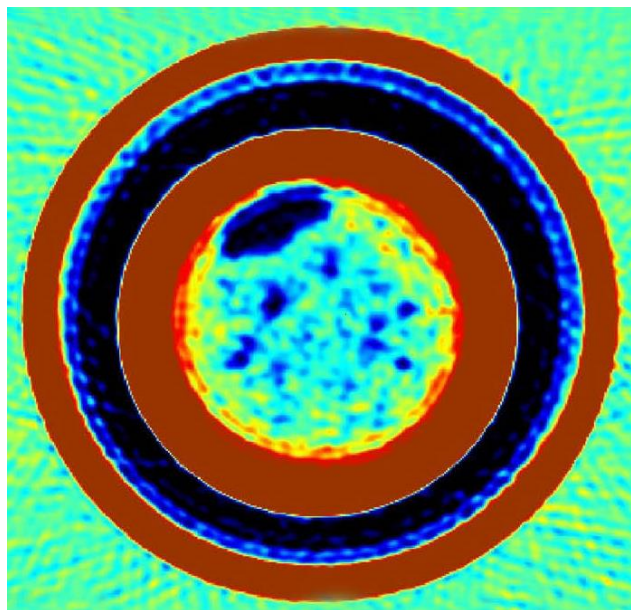
Asphaltene @ 1.2g/cc & Gas  
Pockets

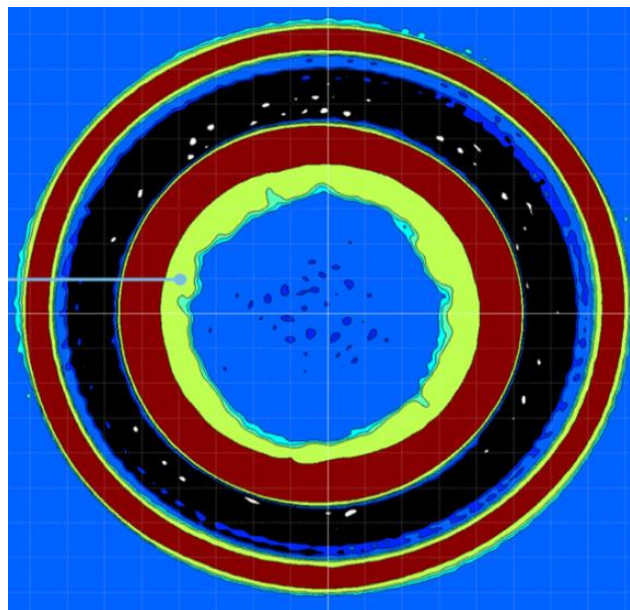
Scale @2.3g/cc
