Stress Concentration Tomography

Developments in SCT Inspection of carbon steel pipelines.

Hamed Habibi – Speir Hunter Limited

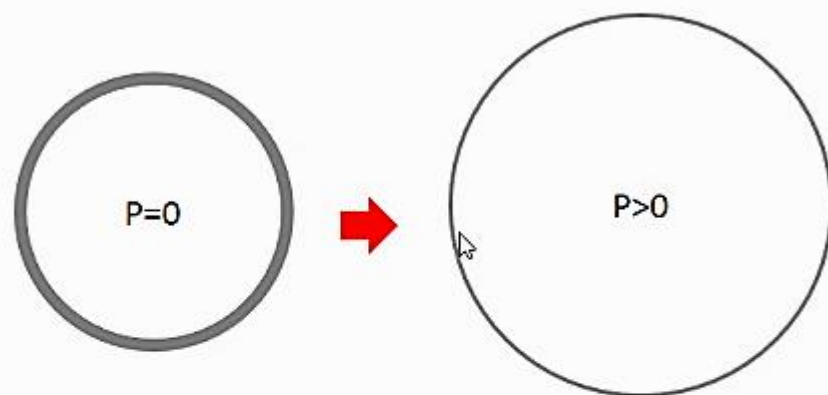
How SCT works?

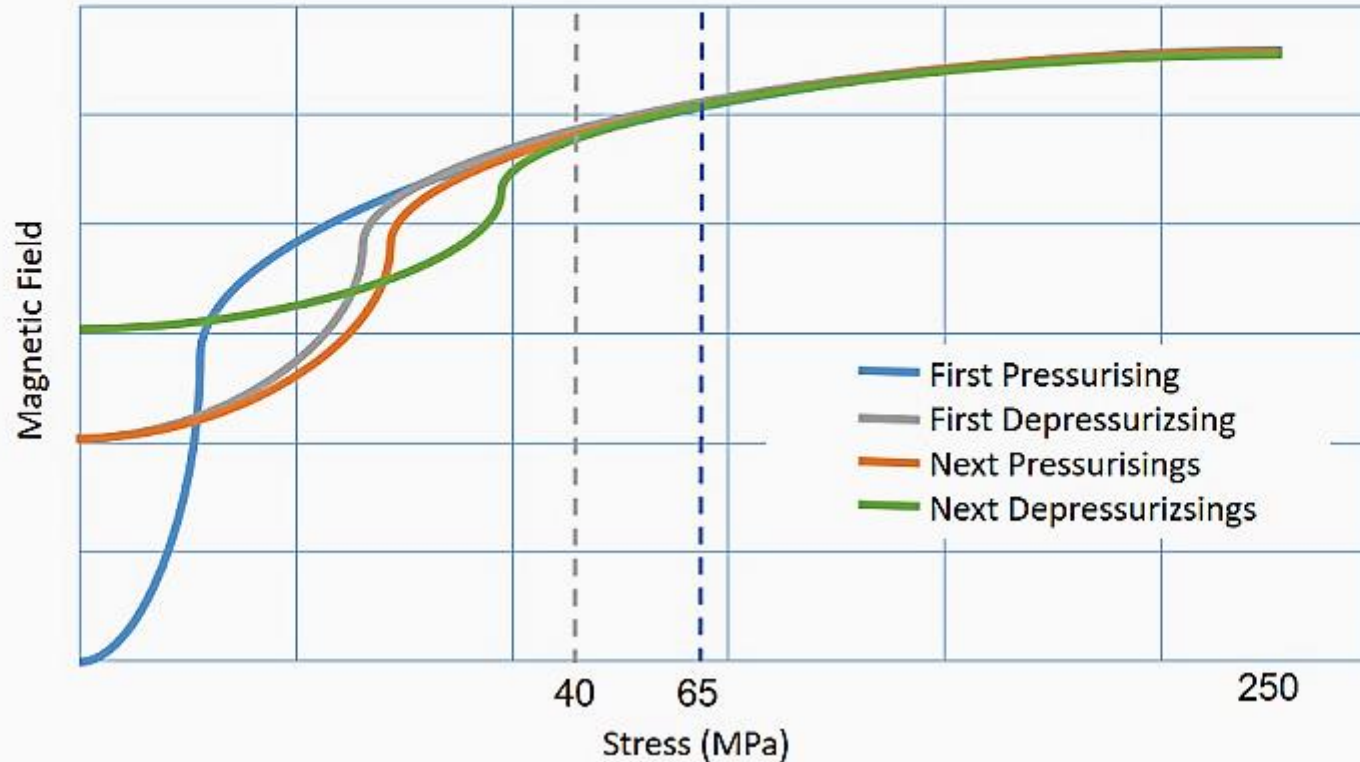
Stress-Magnetization Relationship

Reverse-Magnetostriction Curve

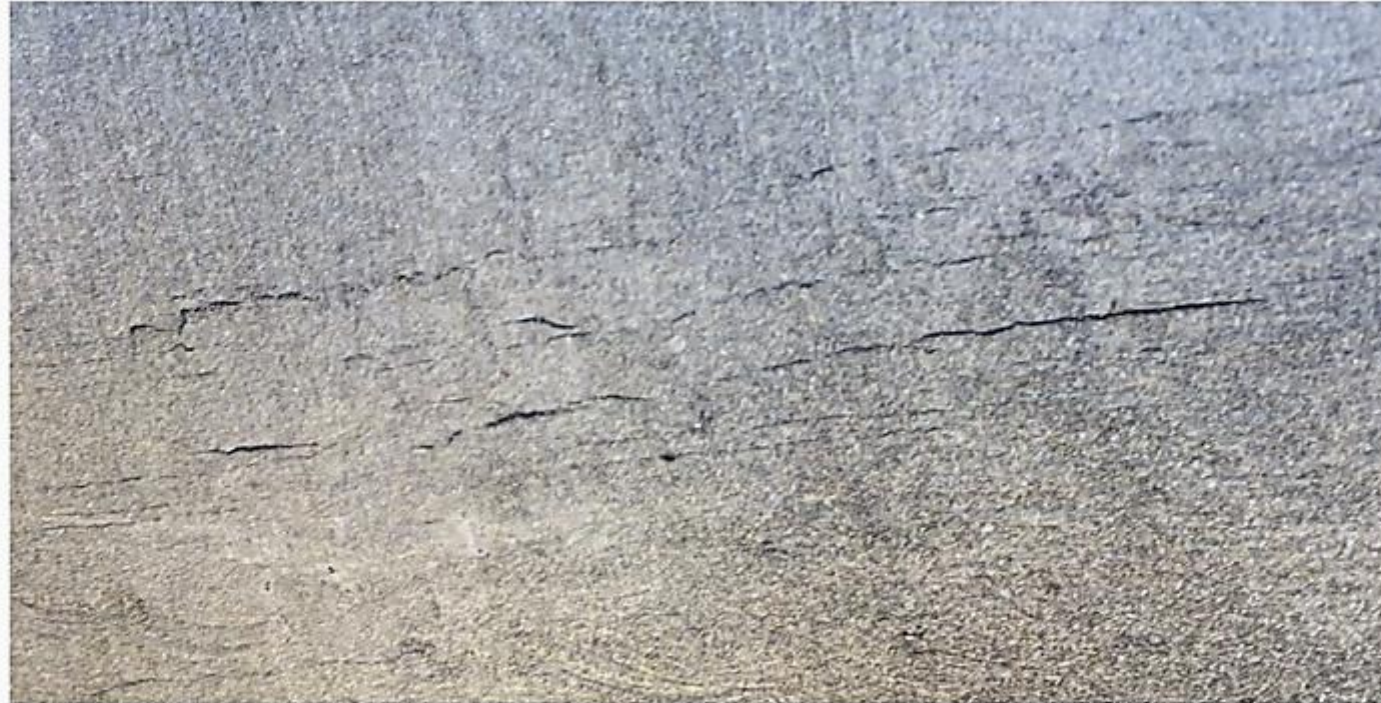
SCC

140mm long

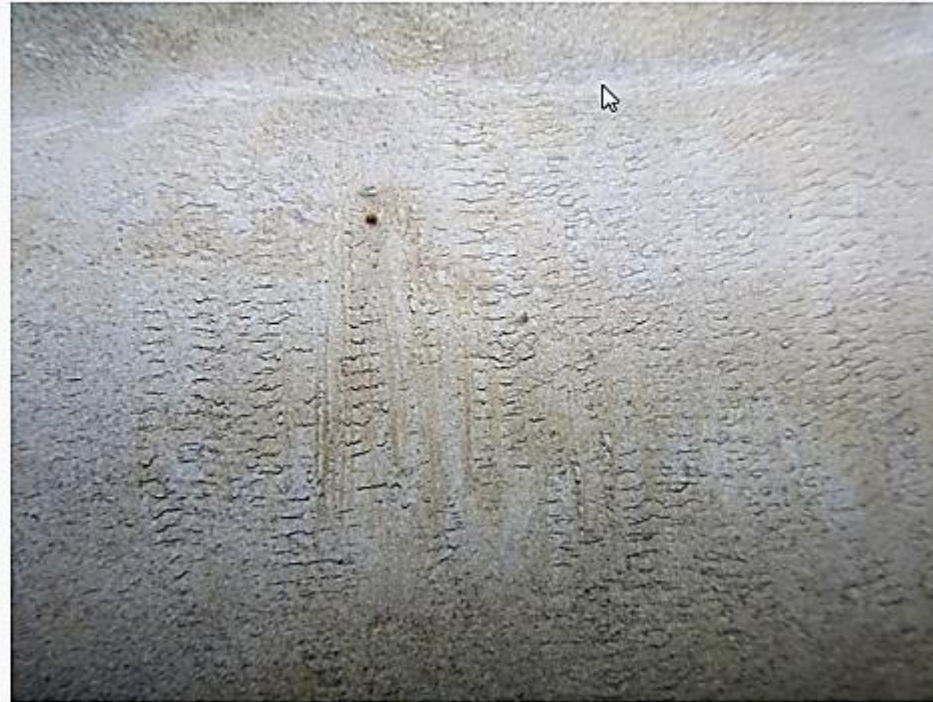
Micro-Cracks

200mm x 220mm area

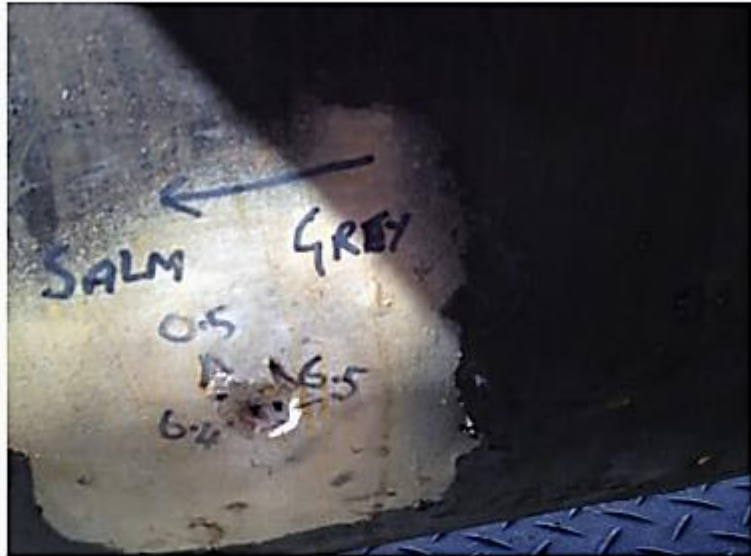
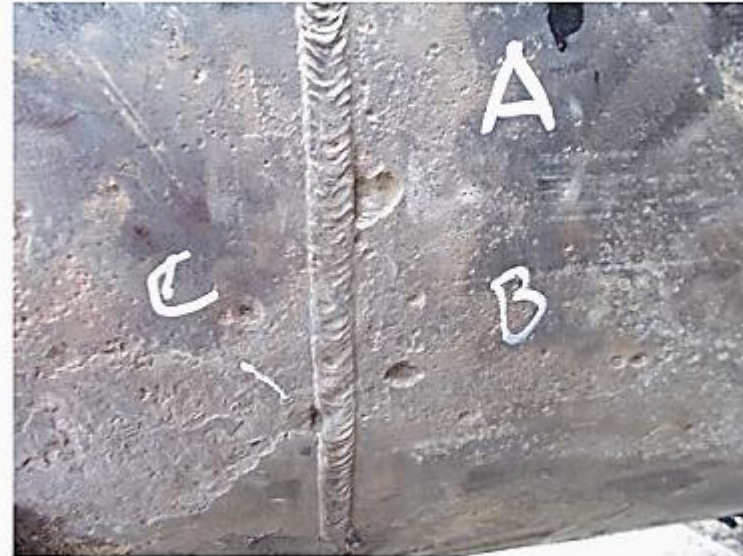
Metal-Loss

22% WT

Diameter	35.4 inch
Wall thickness	0.5 inch
Pressure	59.6 Bar
SMYS	413 MPa

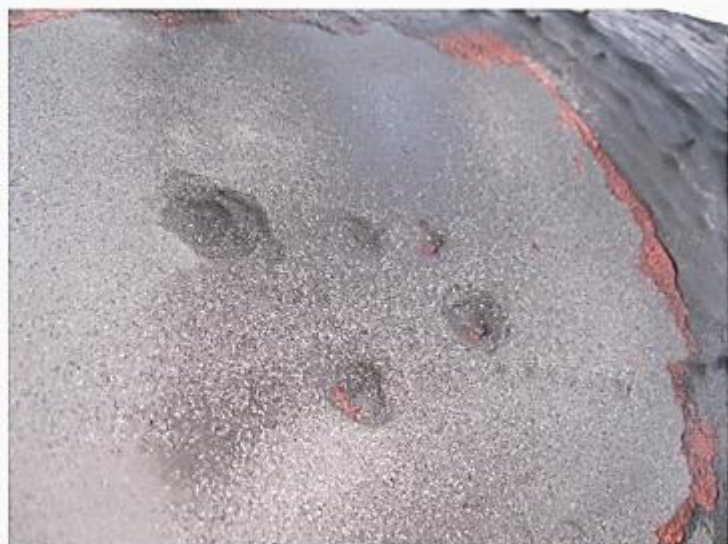
ILI 1. Condition prior to repair (MFL1)

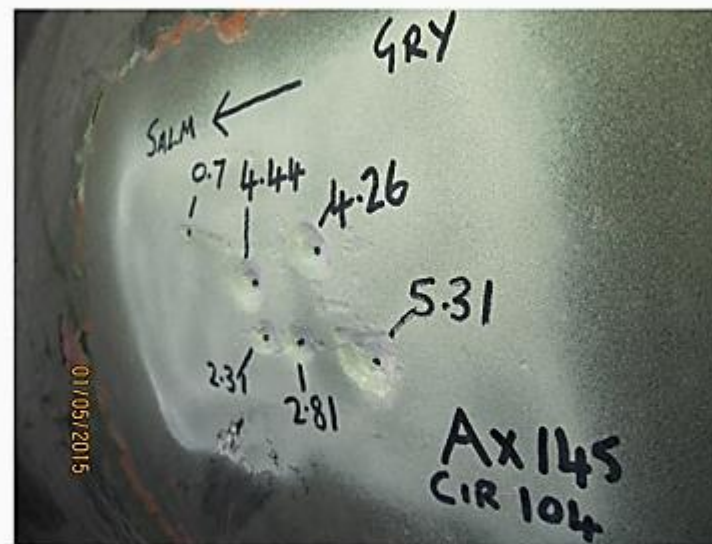
ILI 2. Condition following repair (pre MFL2)

19% WT

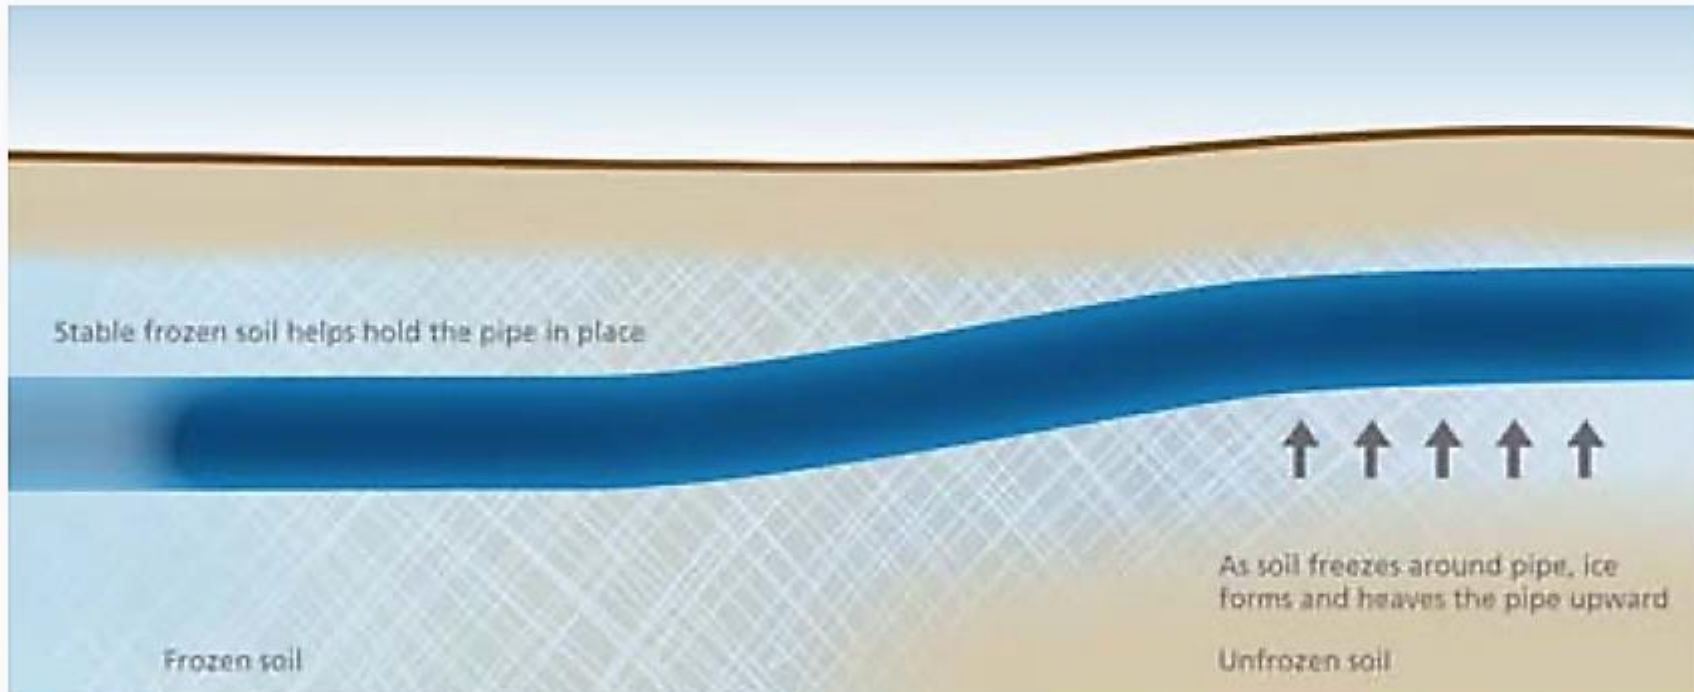
Frost-Heave

Diagram courtesy of Canada's National Energy Board

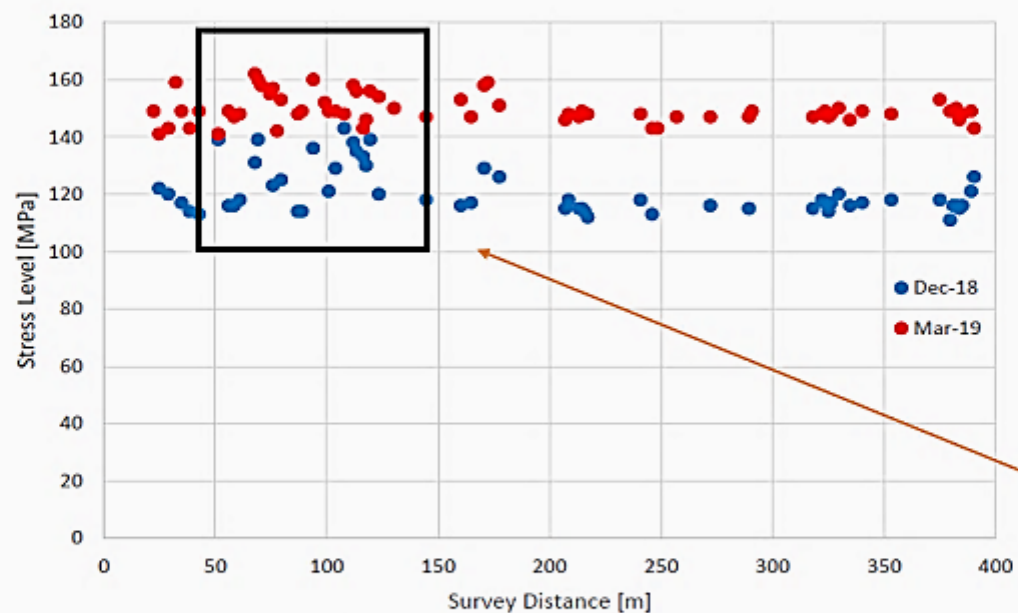
Frost-Heave

Localised Detected Stress is less dependent on operational condition suggested geo-hazard area.

Date of SCT Survey	Operating Pressure at time of inspection [bar]	Nominal Hoop Stress [% of SMYS]	Minimum Detected Localised Stress Level [% of SMYS]	Maximum Detected Localised Stress Level [% of SMYS]
19 Dec 2018	60.0	29%	25%	32%
20 Mar 2019	71.4	34%	31%	36%

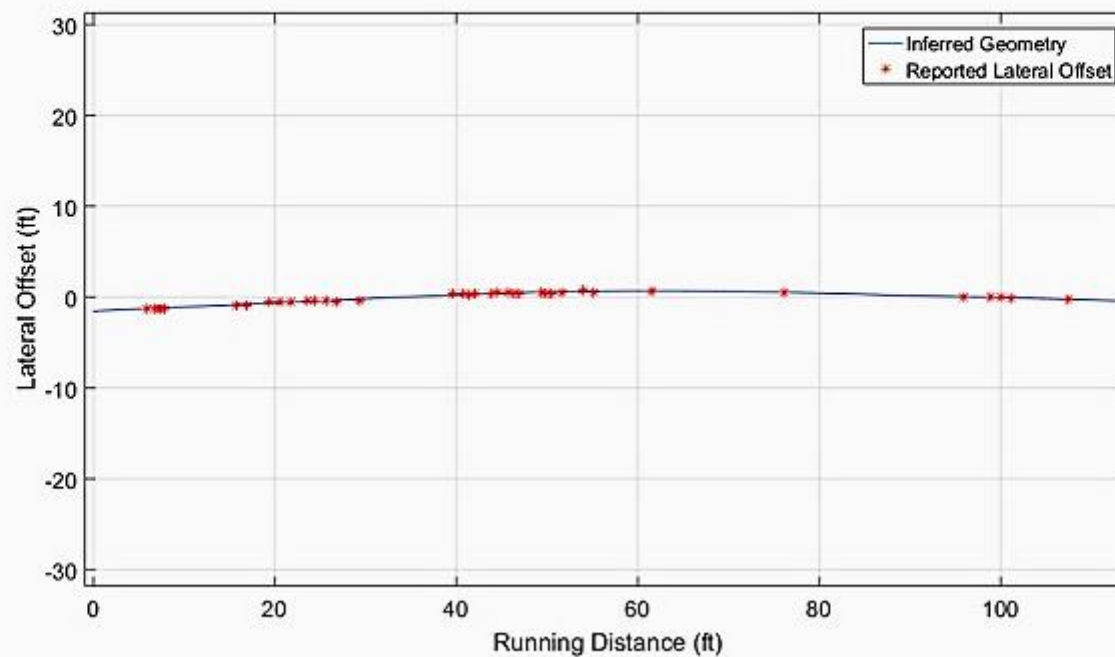
R9

Lateral Offset Results

R9- 12" deflection – 73" height

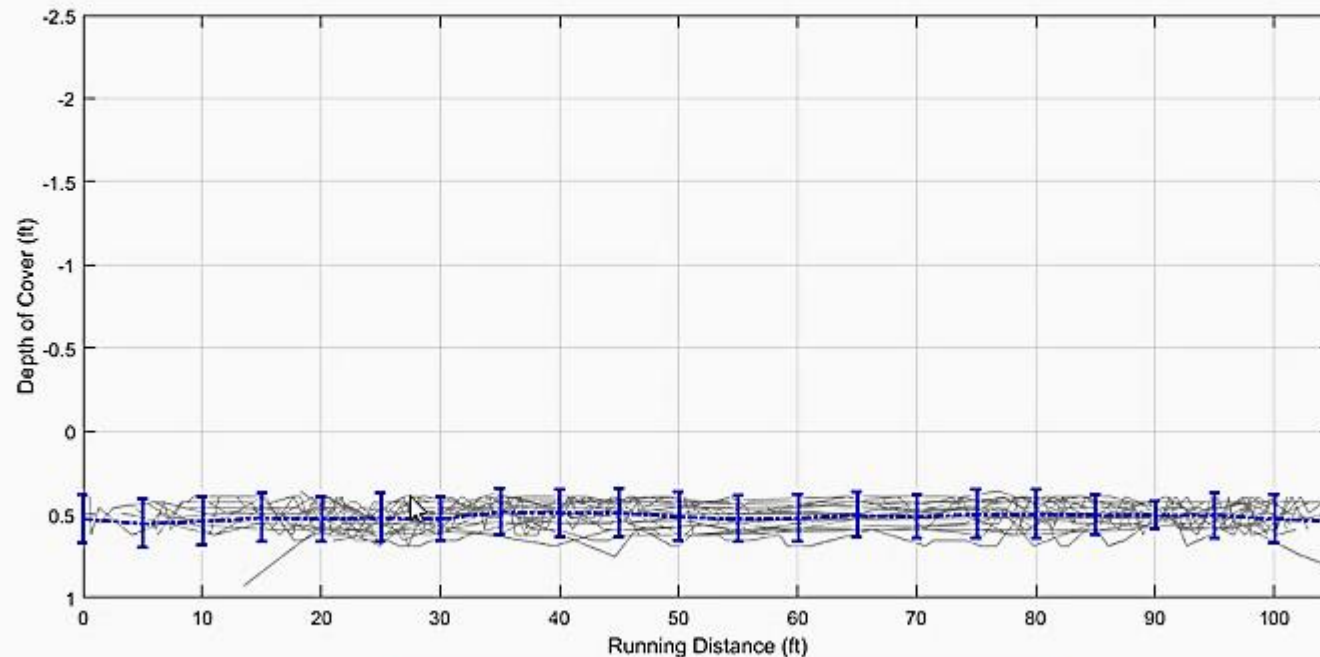
Results - Depth of Cover

Mean error is 0.86" i.e. 2.3% of truth data

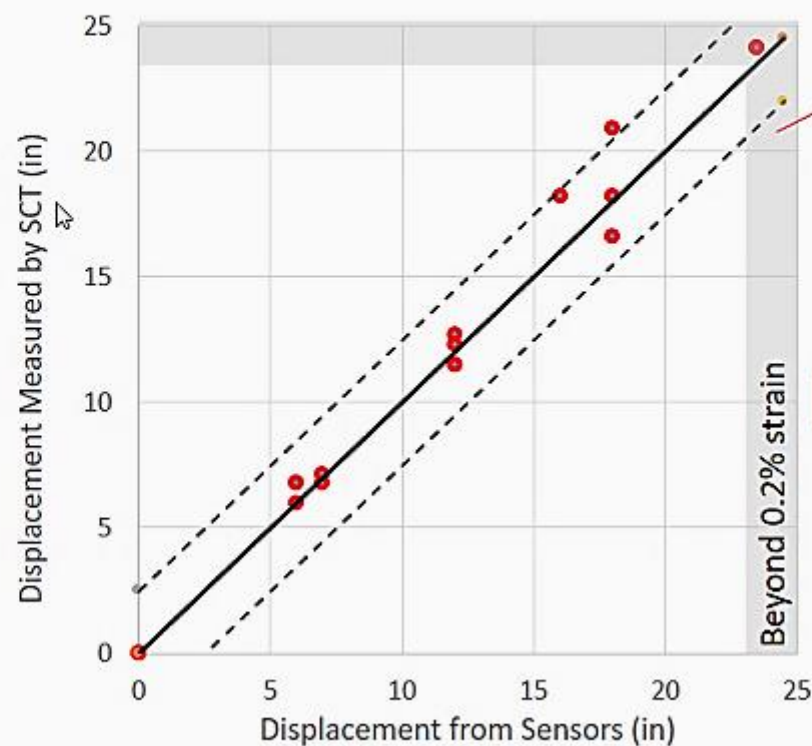
Results - Unity Plot

Maximum Displacement at Centre of Span

Black Margin is set at 2.5"

Mean Accuracy is 0.78"
i.e. 6% of truth data

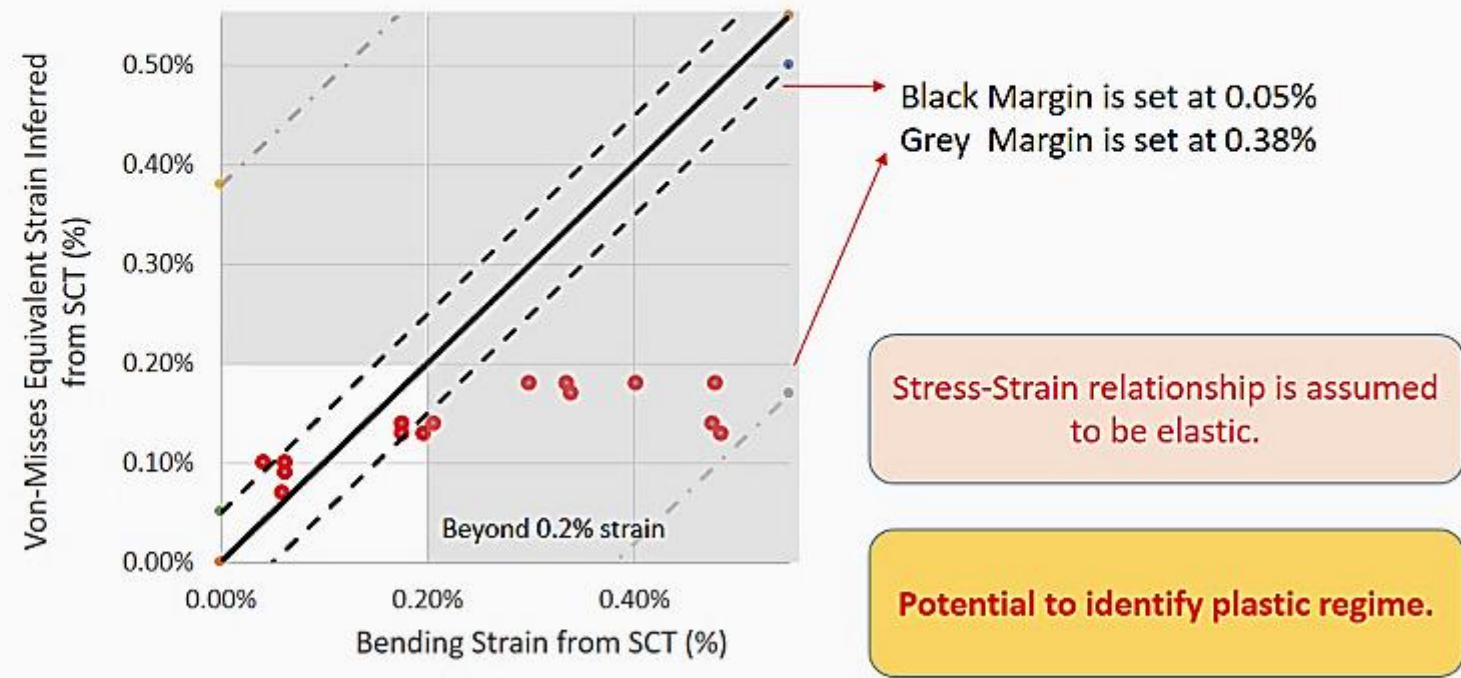
Results - Unity Plot

Max. Von Misses Equivalent Strain vs Max. Bending Strain

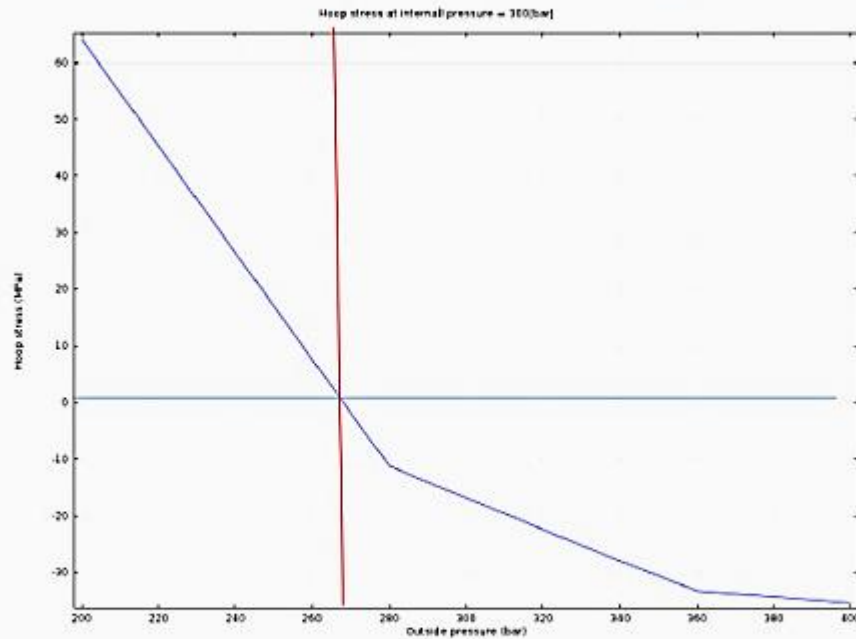
Sub-Sea Stress-Magnetization

External Pressure of 270bar at ~2700m depth
Internal Pressure 300bar

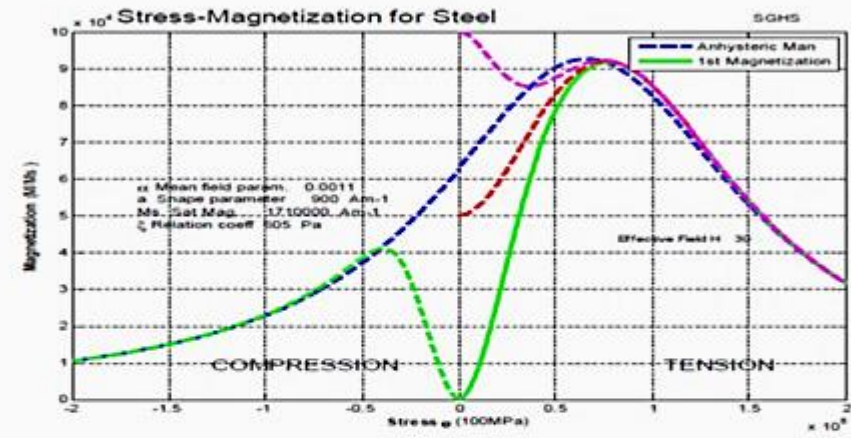
Jiles-Atherton Stress Magnetisation
