Webminar | Addressing the risk of Hydrogen-Induced Stress Cracking in pipelines

Dr Daniel Sandana . 30th April 2021

ROSEN
empowered by technology

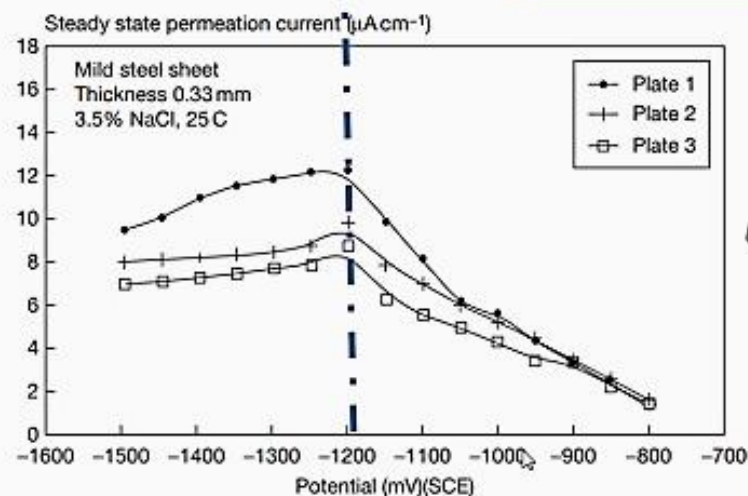
Umist, Obuzor, PhD1989

Permeation falls / remains constant
At large overpotentials
And in very alkaline solutions

Electrochemical desorption takes over

Membrane Permeation
 $\propto \sqrt{ic}$

*Assumes H Permeation current
< H₂ evolution*

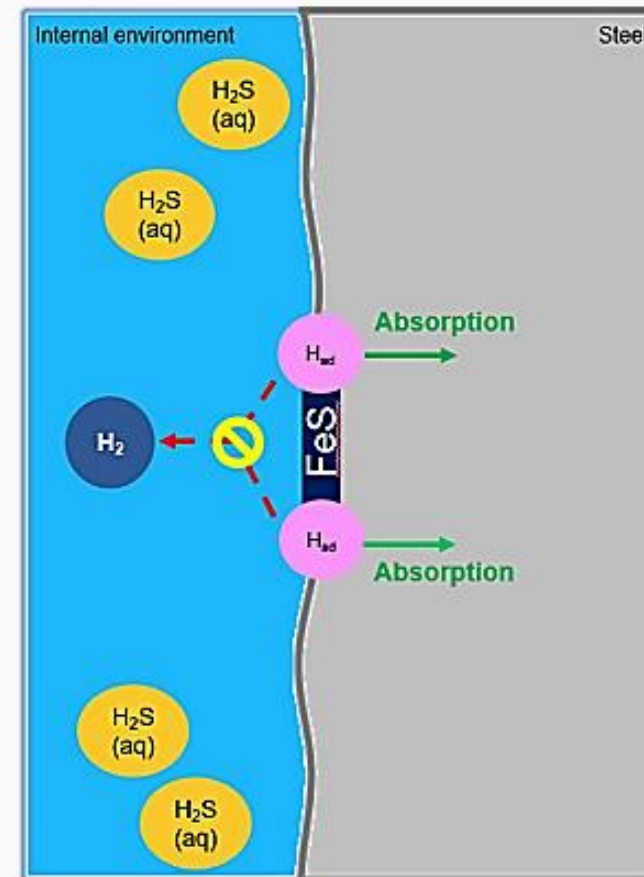
- Steel materials
- H₂S environment

- $H_{2S(g)} + H_2O \rightarrow H_{2S(aq)}$
- $Fe_{(s)} + H_{2S(aq)} \rightarrow FeS_{(s)} + 2H_{(ad)}$
- $2 H_{(ad)} \rightarrow H_{2(g)}$

Kinetically very slow
H₂S poisons recombination

Adsorbed concentration of atomic H increases
More Atomic H enters Metal

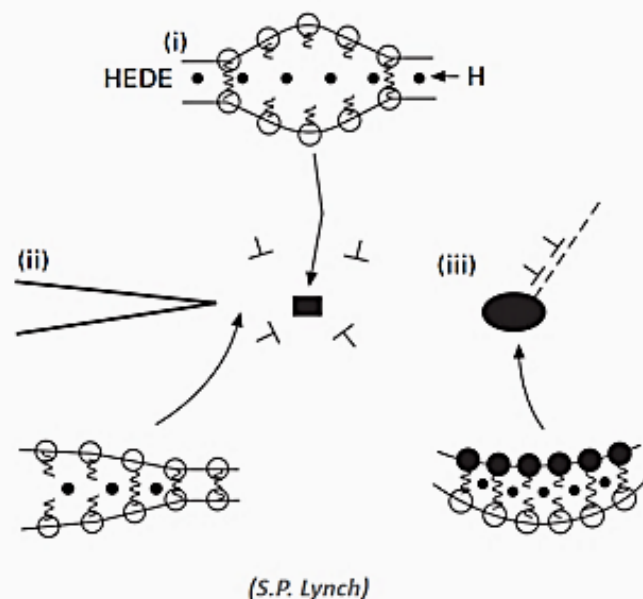
1960s -1970 s ... Oriani, Troiano...

*Role of hydrogen is to weaken the interatomic bonds (...)
facilitating GB separation or cleavage crack growth*

- ✓ Supported by Quantum-mechanical Calculations
- ✓ High H concentrations observed at GB and particle/matrix interfaces
- ✓ Direct fractographic evidence is lacking...
Featureless Fracture surface? ... Shallow dimples? ... SEM resolution?
- ✓ How to explain T.g. cracking?.. *H concentration at triaxial tensile stress?*

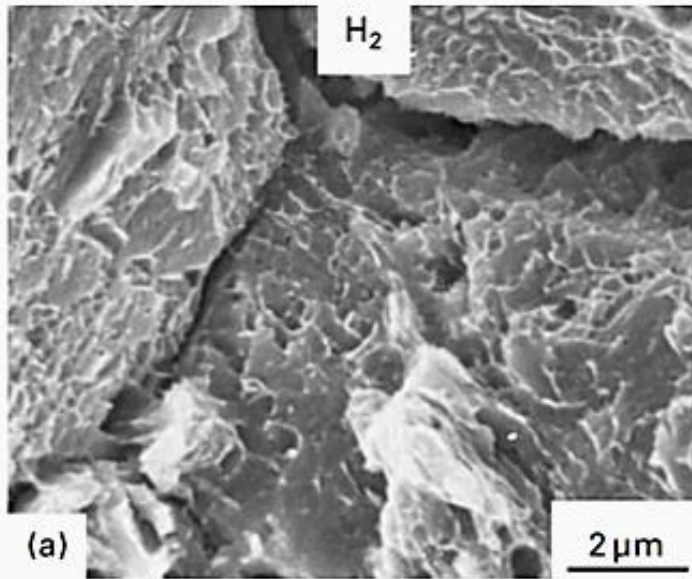
- ✓ Intergranular fracture occurs by localized ductility in the region adjacent to the grain boundaries

(S.P. Lynch)

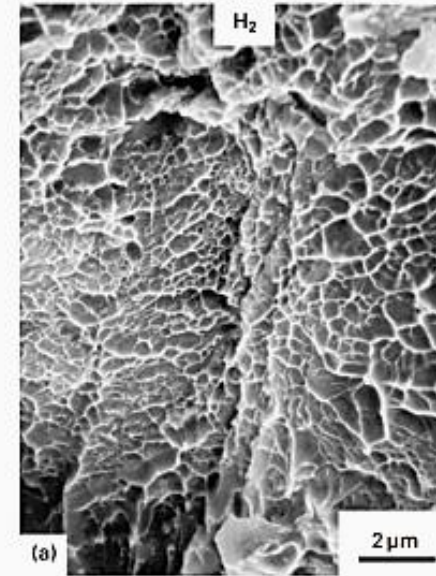
- ✓ Transgranular fracture surfaces are highly deformed **despite the fact macroscopic ductility is reduced** (localized shear processes occurring along slip planes)

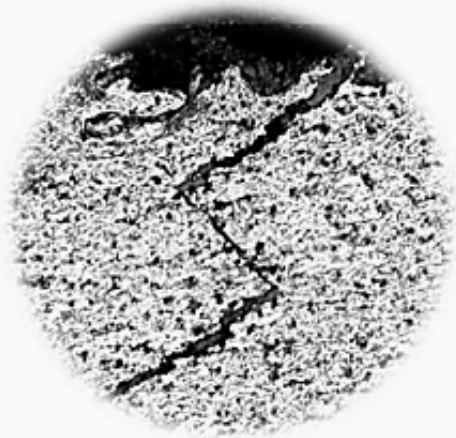
...CP overprotection... < -1.2 V OFF CSE

...AND Presence of substantial plastic deformation...

Micro & Macro

...Presence of hard spots... HV >400

Steel materials with high YS >550 N/mm²
(X80)

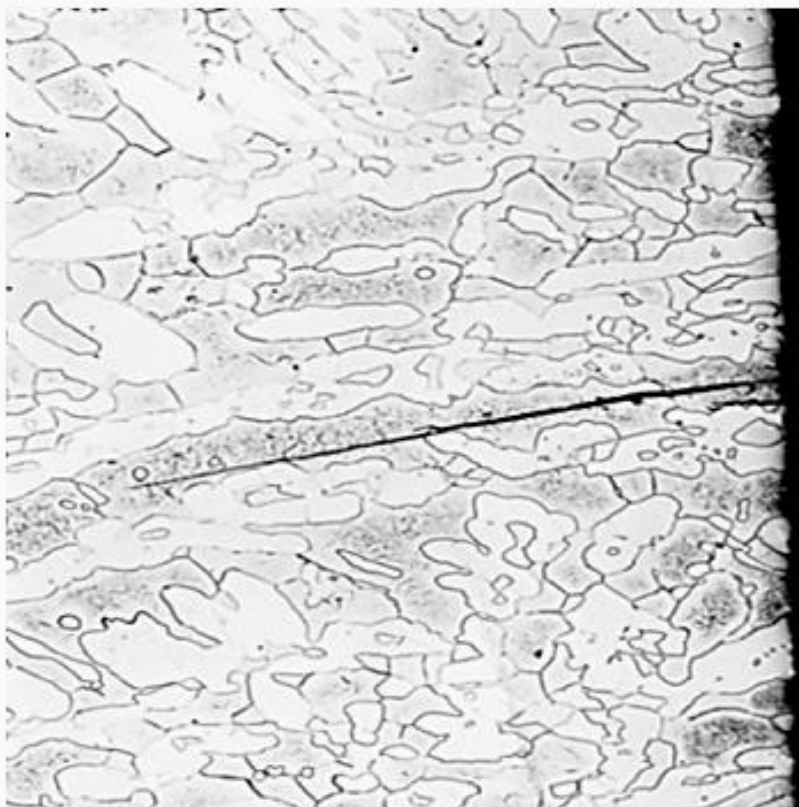
HE of Duplex (22Cr) or SDSS (25Cr)

...CP overprotection ...
< -0.8/-0.85 V OFF Ag/AgCl

... AND Presence of
substantial plastic straining...

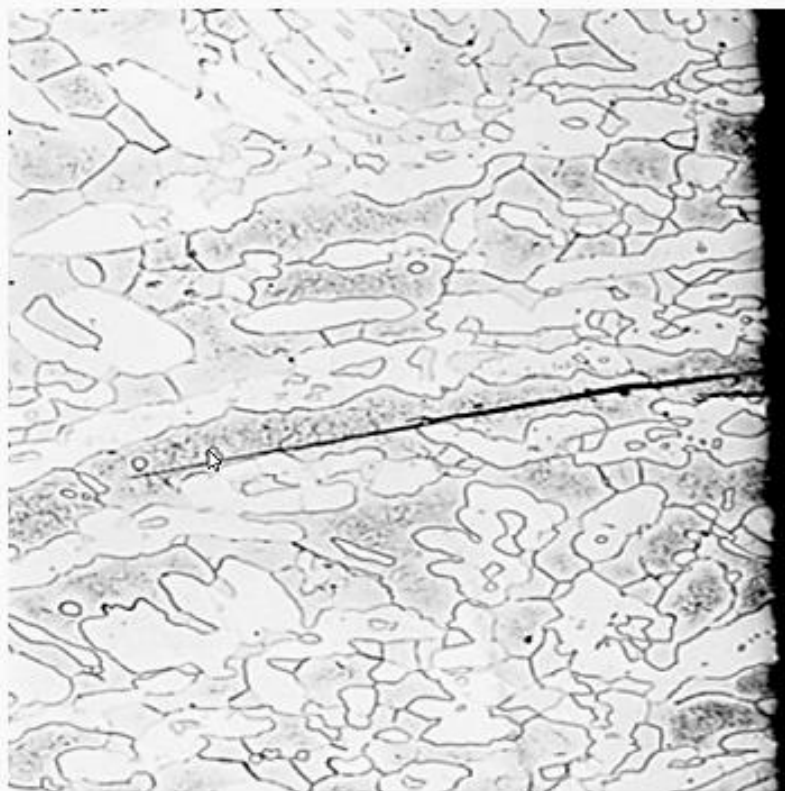
Ferrite content > 50%

...Large grain size...
> 100 – up to 180 μm ...

.... Large austenite spacing....

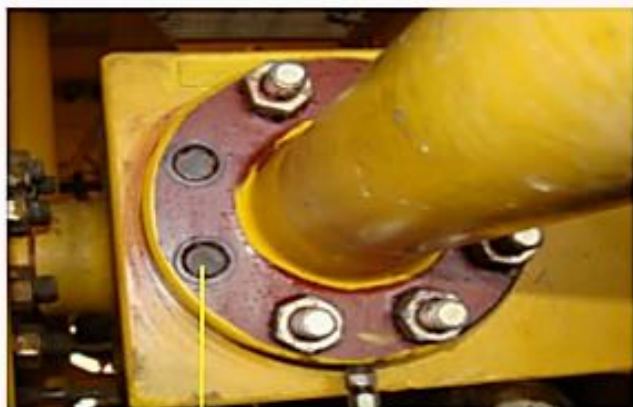
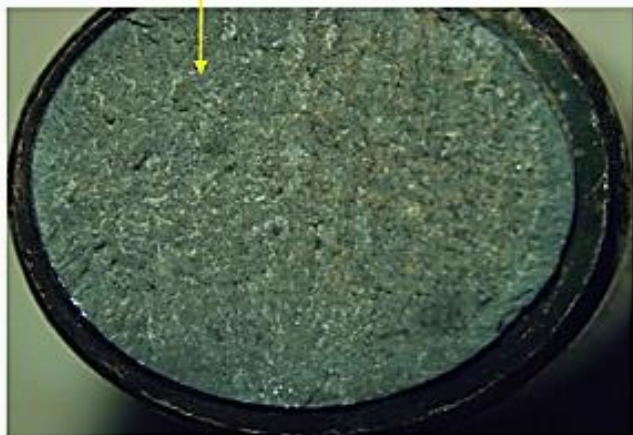
High strength Carbon steel bolts

ASTM A193 B7 - > HRC 35

LAS fasteners

ASTM 320 (bolts)/ASTM194 nuts
