Sonomatic SONAR Robotic Storage Tank Inspection Capability – September 2021

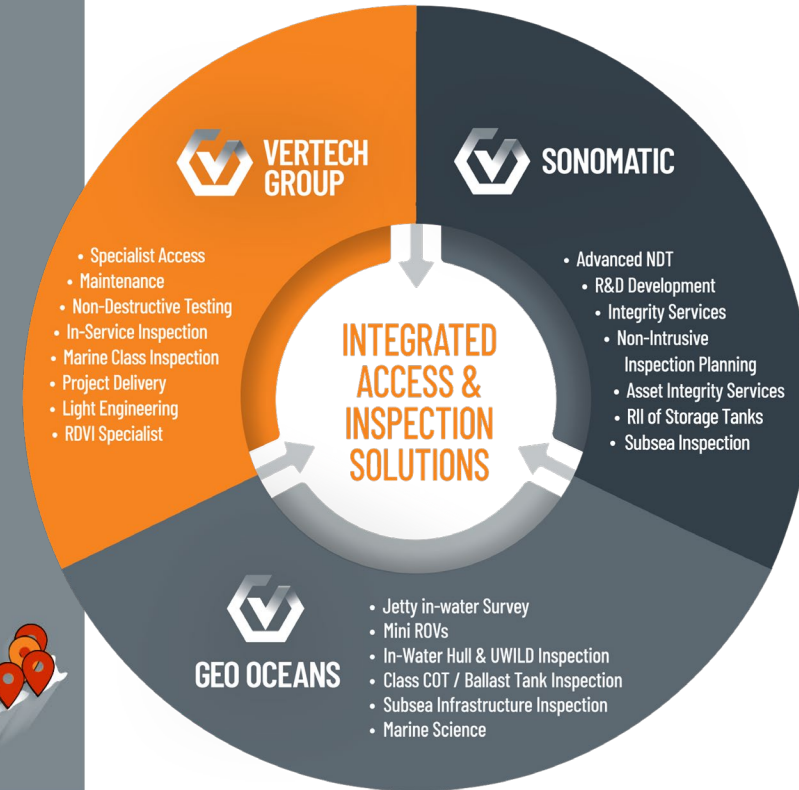
- Objective of an In-Service Robotic Tank Floor Inspection

- Detect floor plate minimum thickness
- Record product side and soil side corrosion
- Assess the tanks condition according to minimum thickness results
- Prepare fitness for service certificate

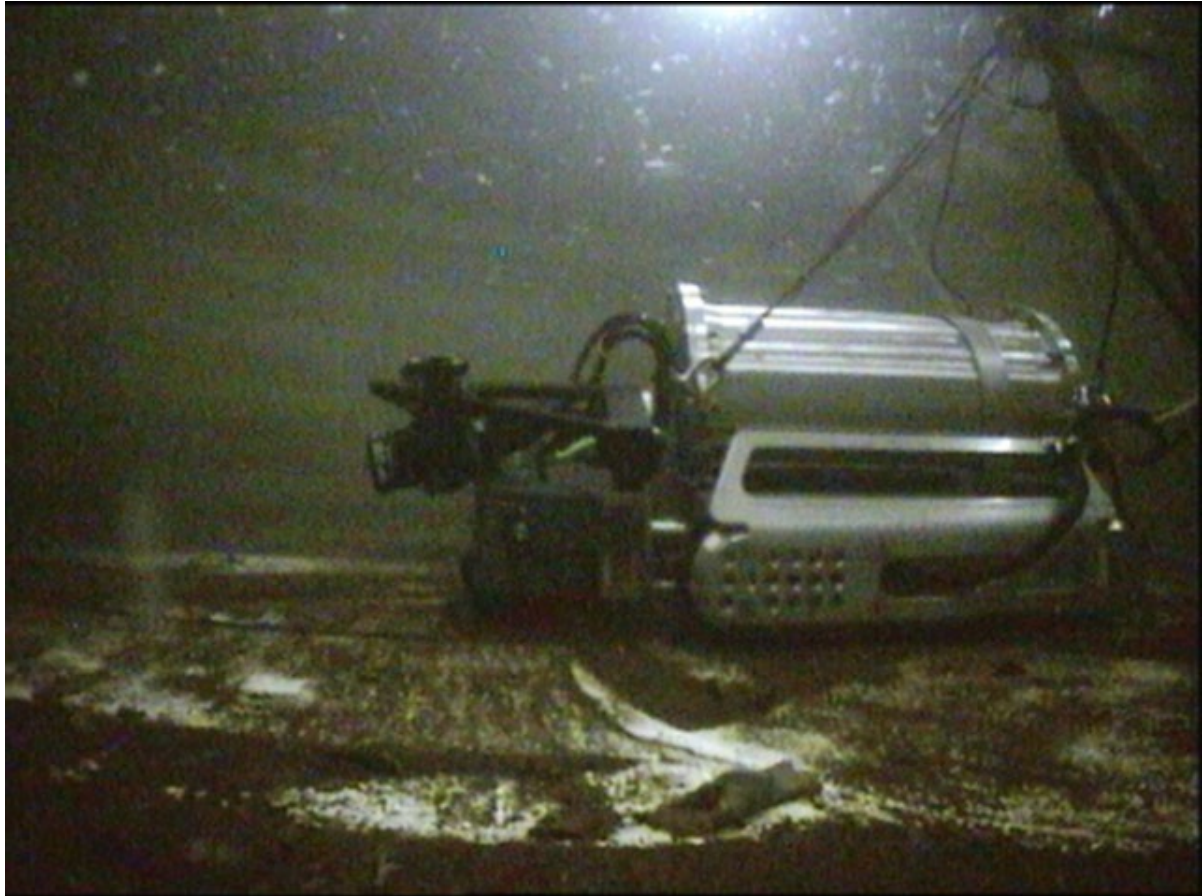
J5 Robotic Inspection Tool

- Different robots according to tank type
 - Hydraulic for heavy hydrocarbons
 - Electric for light hydrocarbons/water
 - Manual Inspection Tool
 - ROV Visual Swimmer
- Ultrasonic inspection
- Suction and discharge for cleaning

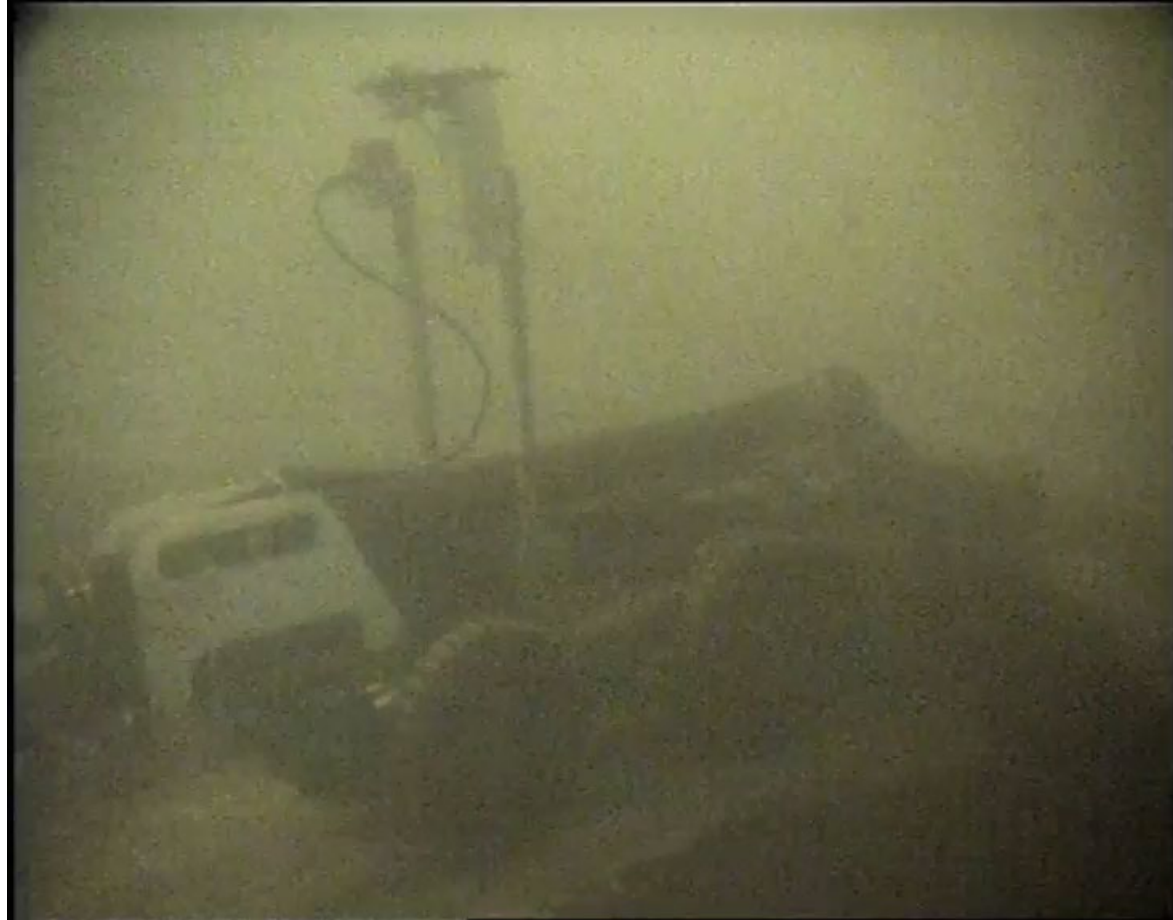
- Emergency Shutdown
- Nitrogen Purge Control
- LEL Monitoring
- O2 Monitoring
- Nitrogen Pressure Monitoring
- Personnel Gas Monitors
- Temporary Manway Pressure Monitor
- Electrical Redundancies
- Grounding and antistatic system

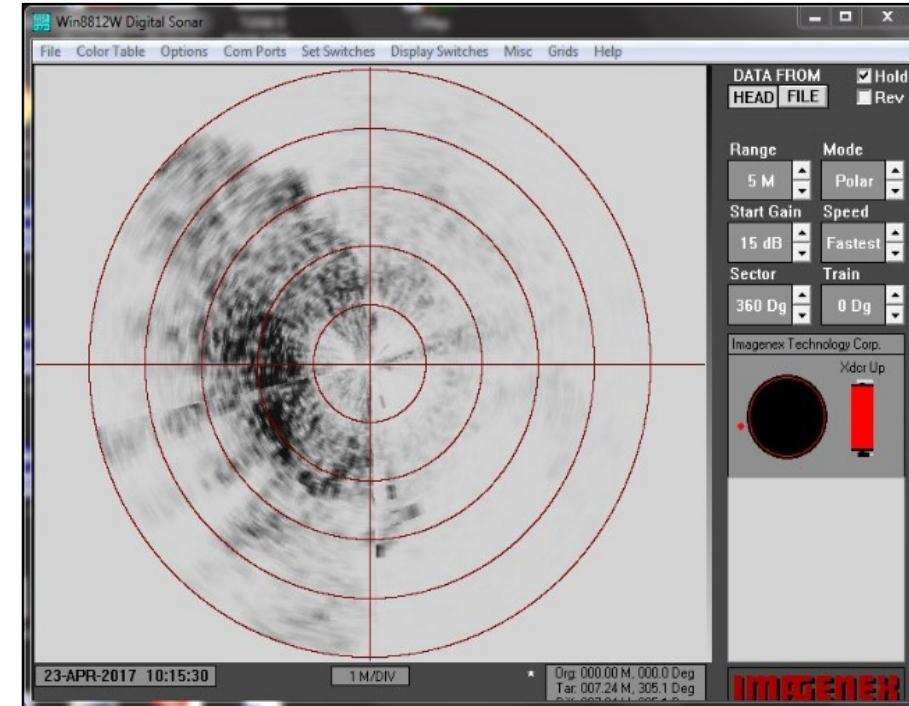
- Ultrasonic inspection used 8 x transducers
- Data collection on Sonomatic Microplus System
- A total of 521 scans were collected, representing approx 5% coverage
- High dynamic range data collected to allow for amplitude variation associated with liquid quality and surface condition
- New module developed in Sonomatic's SIMS software specifically for analysis of tank floor data

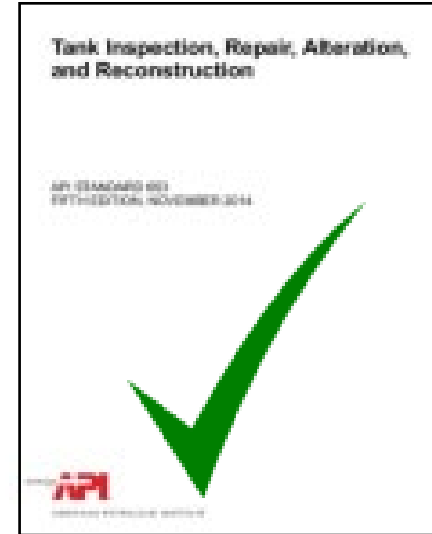
The In-Service Robotic Inspection of the 80m Crude Oil Tank with sludge up to 1m in some locations provided data that when projected forward to the time of the Out of Service Ultrasonic Readings was deemed to be incredibly accurate and comparable. A difference of 0.3mm could be considered to be within the uncertainty of a manual UT reading and the % difference between the two methodologies was less than 5%.
