Effect of Ageing Temperature on Localised Corrosion and Atmospheric Stress Corrosion Cracking of 15-5PH Stainless Steel

ICorr Aberdeen –TWI webinar
26/09/23

Alyshia Keogh*¹, Anthony Cook¹, Emily Aradi¹, Zacharie Obadia², Phil Prangnell¹, Fabio Scenini¹

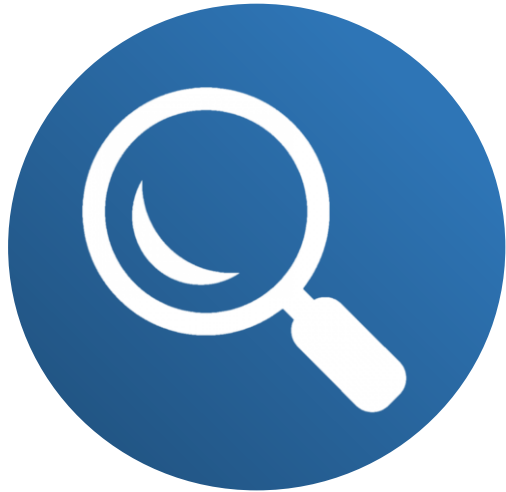
- Mechanical Testing
 - Tensile properties
 - Hardness
- XRD
 - Austenite phase fraction
 - Based on methodology used by Tanaka and Choi (2003)
- Microscopy
 - SEM (Zeiss Sigma VP FEG)
 - TEM (ThermoFisher Talos F200X)

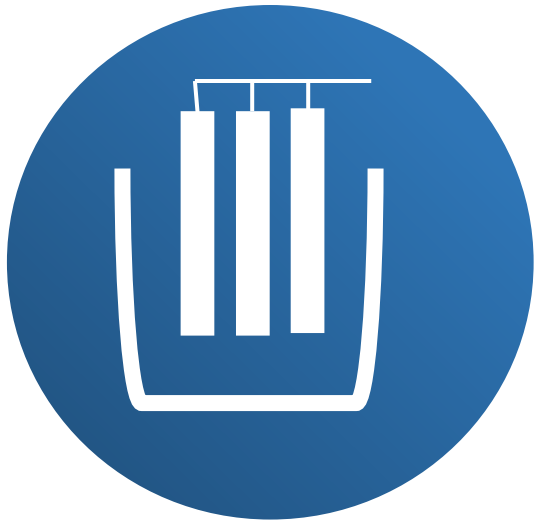
- Potentiodynamic Polarisation
 - Pitting susceptibility
- DL-EPR
 - Assessment of passive film integrity after heat treatment
- Electrochemical noise
 - Directly comparing microstructures

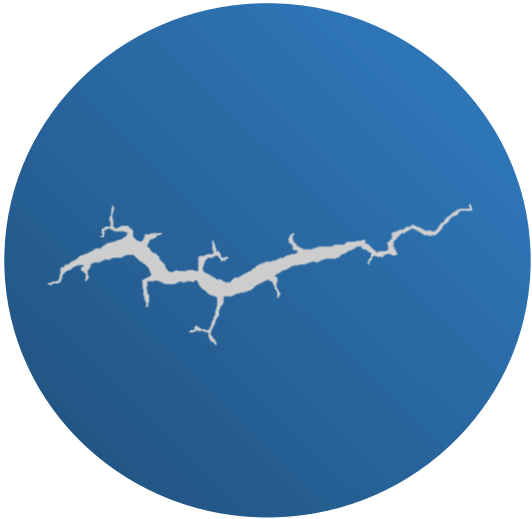
- MgCl_2 salt deposits droplets
- Relative humidity (RH) of 30% or 90% in environmental chamber
- 50 °C
- Test performed over 5 or 10 days
- Surface features of crack and crack cross-section analysed by SEM post test

- Stress applied via 4-point bend to 80% YS of 540 °C sample
- 1 µl MgCl₂ salt deposits with concentrations 1M, 0.1 M or 0.01 M
- Temp = 50 °C, Time = 5 and 10 day
- Pit diameter and crack length measured post test
- Stress-free specimens tested under identical conditions

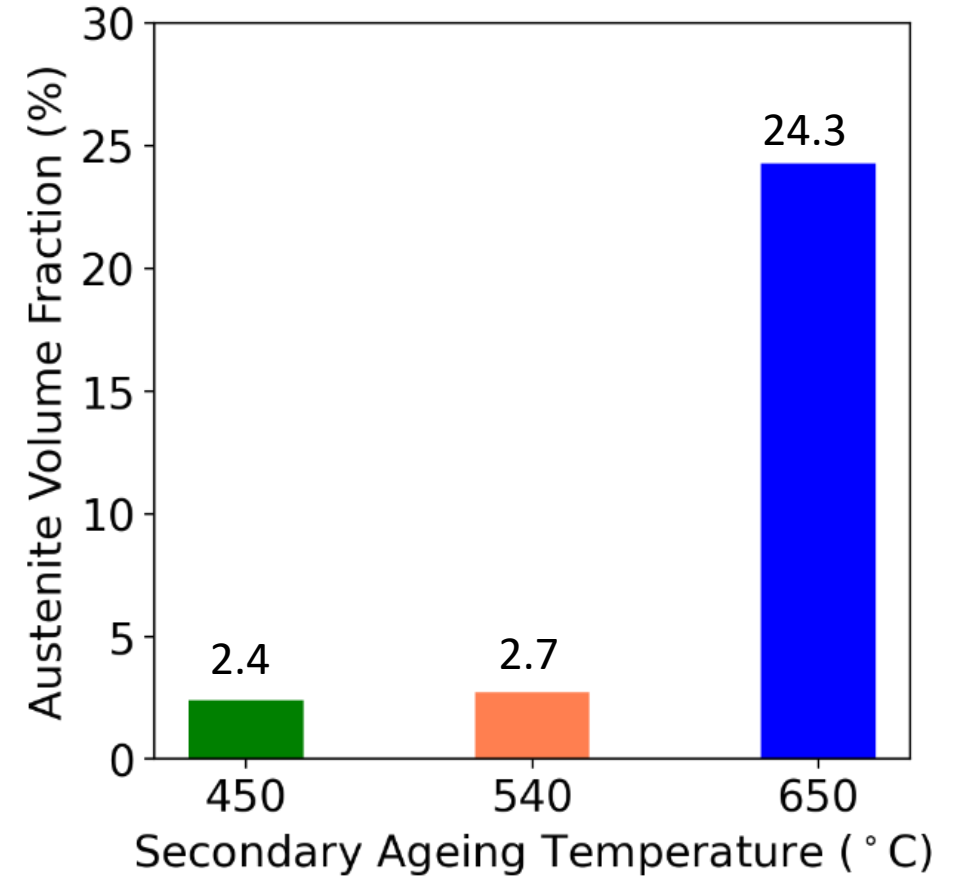
XRD Phase Fraction

- Phase maps - qualitative measure of austenite content
- Austenite nucleates along lath boundaries and PAGBs
- Austenite reversion greatest with 650 °C ageing treatment

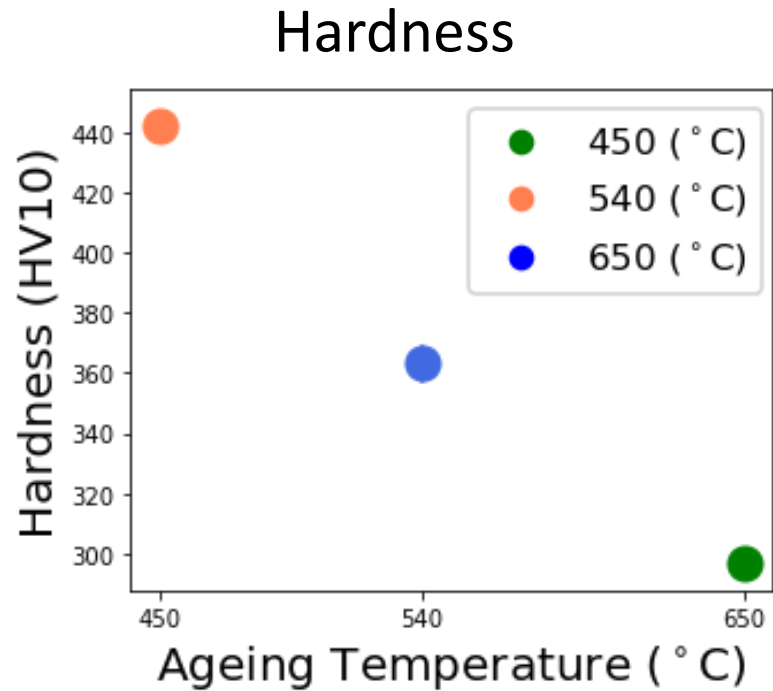
- Increase in ageing temperature results in:
 - Decrease in hardness
 - Decrease in UTS
 - Increase in tensile ductility

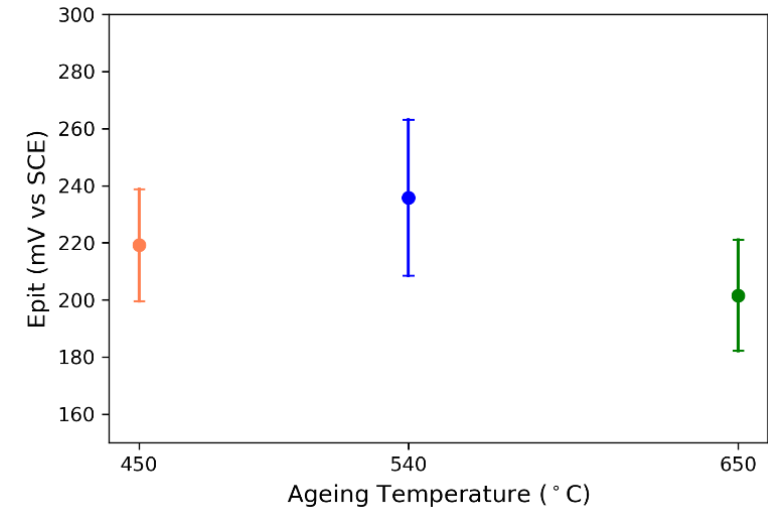
- 0.6 M NaCl
- 0.5 mV/s
- 1 μm diamond polish
- OCP measured for one hour

- On average 650 °C has the lowest E_{pit}
- However scatter is too large for E_{pit} to be considered statistically different
- Pitting is a stochastic process and PDP may not account for slight differences in microstructure

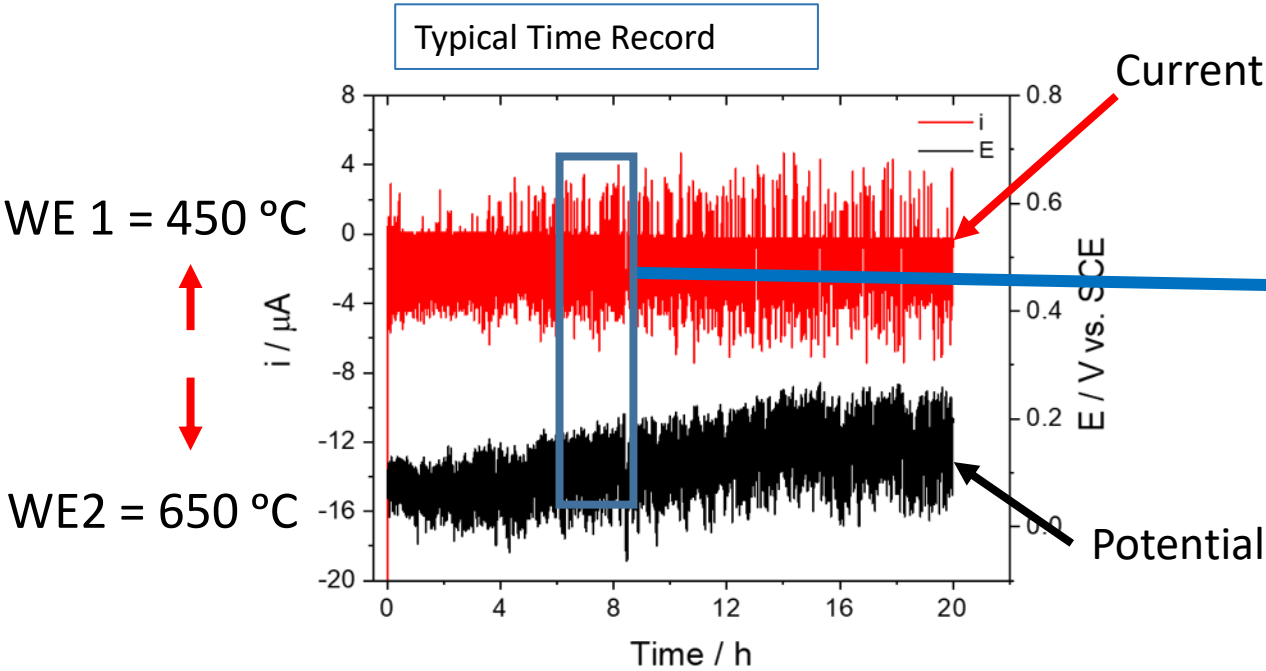
- +ve current indicates WE1 is pitting (450 °C sample)
- -ve current indicates WE2 is pitting (650 °C sample)

A - pit initiation on WE1 (450 °C)

A → B pit growth

B → C pit repassivation

Potential drops when pit initiates and rises when pit repassivates

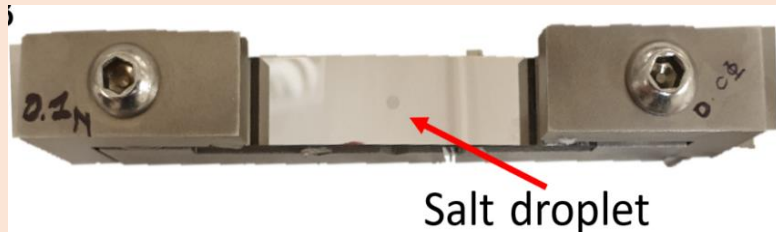
Stressed samples with
MgCl₂ salt droplet

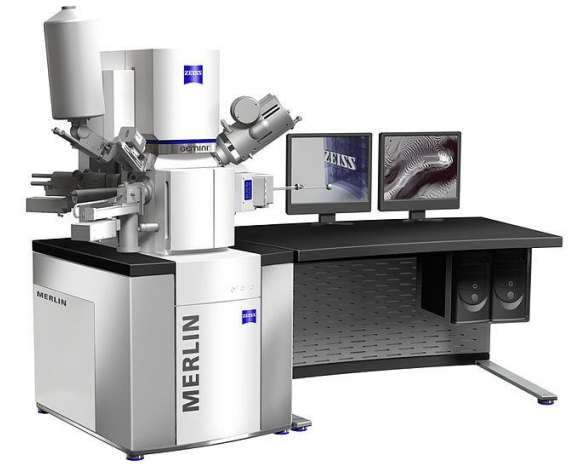
Samples analysed post test with
SEM to understand extent of SCC

- 1 μ l droplet from 1M MgCl₂
- Temperature – 50 °C
- RH – Saturated MgCl₂ - 30%

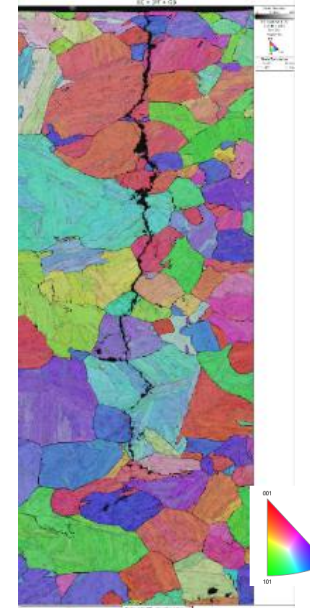
- 540 °C susceptible to cracking but mechanism may be Cl⁻ induced SCC indicated by TG crack pathway

- Crack travels through some grains for 540 °C – mixture of TG and IG cracking
- Possible Cl induced SCC
