# Cathodic Protection for Pipelines - Electrical Isolation / Interference Issues

Stephen Tate – Immediate Past President

This presentation is intended to raise awareness of **some of the issues** that may arise when applying Cathodic Protection to buried pipelines.

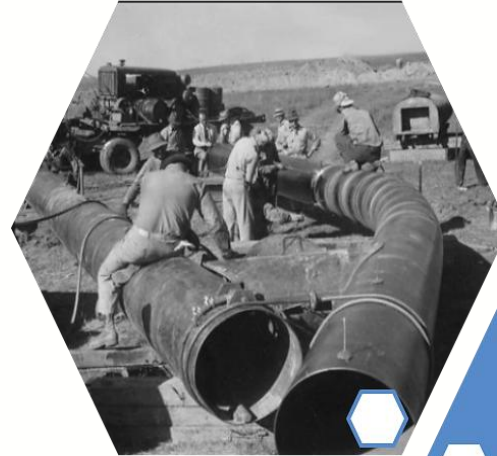
## History and Evolution of Factory Applied and Field Applied Coatings

**1960s** - Saw the birth of mainline coating systems. FBE also provided excellent flexibility properties, this was an answer to the failures of many previous materials due to handling and bending of the pipe spools during pipelay and subsequent cracking of the system

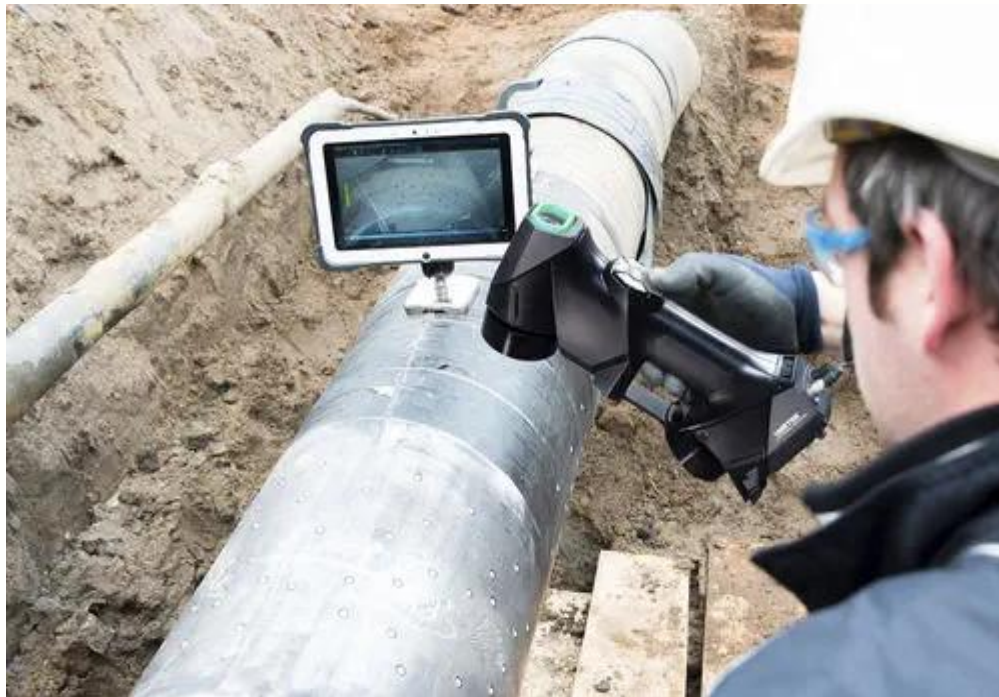
Coating Defects can lead to Localised' Corrosion if applied Cathodic Protection (CP) is inadequate.

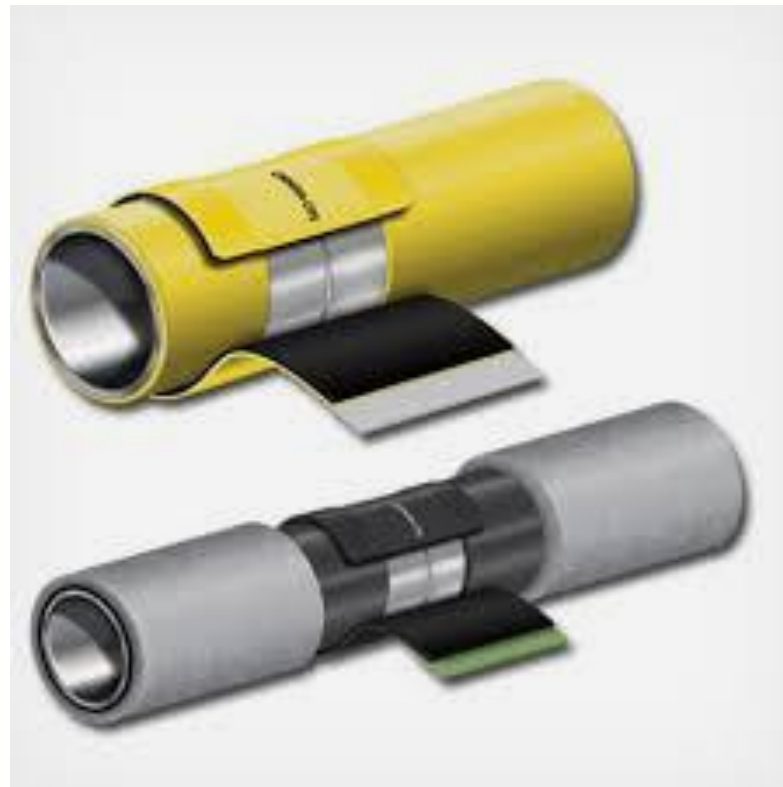
These are often the weakest points of the pipeline coating system.

On rare occasions, pipelines may be buried with some field joints missing.

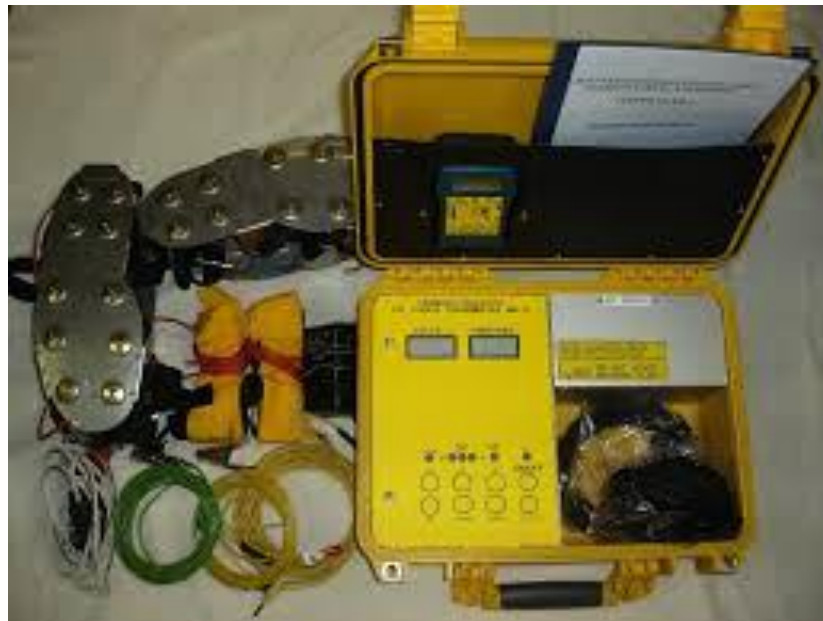
The Pearson system was one of the **earliest** (but manual) methods of coating fault detection.

More efficient recording' methods such as **C-SCAN** and **DCVG** later followed.

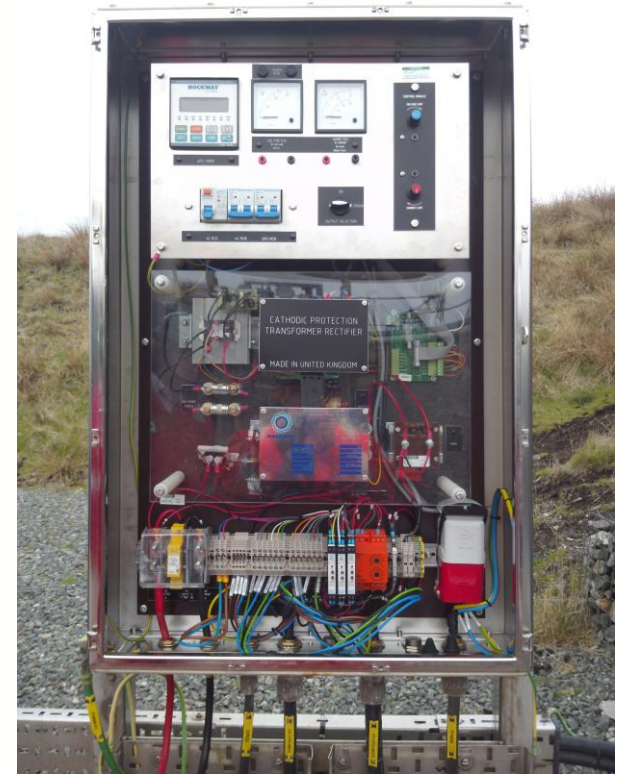
Cathodic Protection  
By IP TRU or Sacrificial Anode

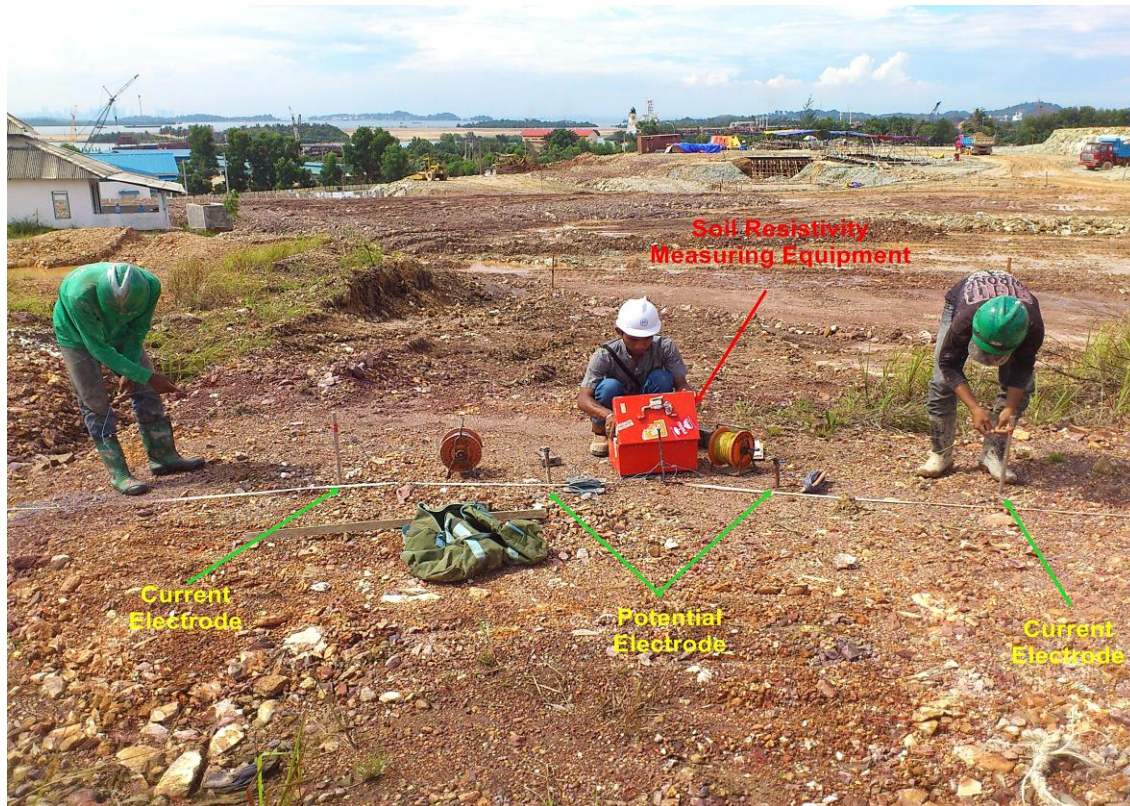
The local ground corrosivity is normally pre-checked early in the **design process** and before a final CP design is produced and the pipeline installed.

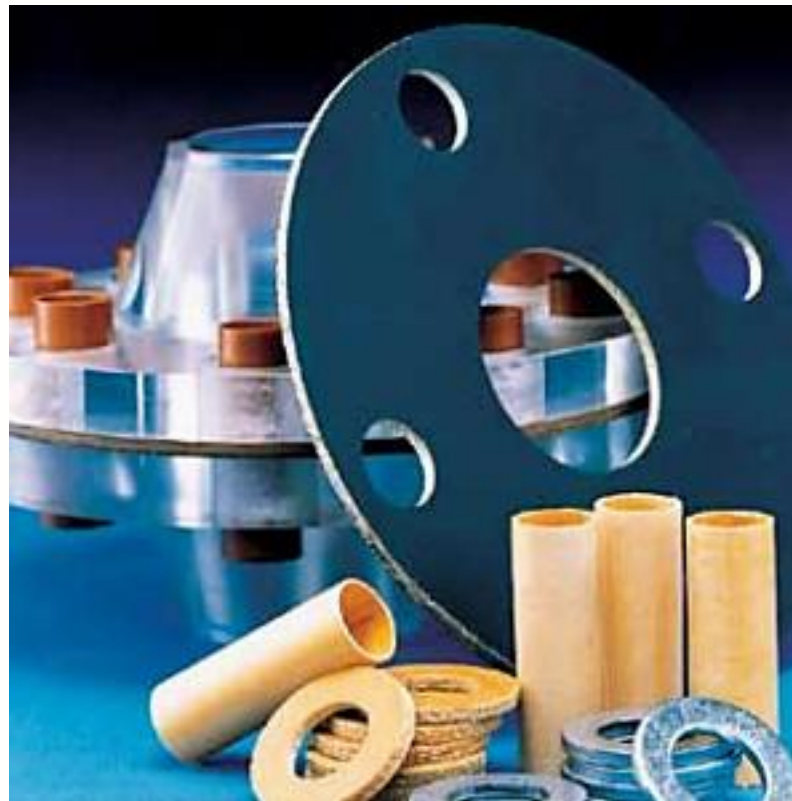
Often used in Plant Pipelines to **separate** Process Areas from buried sections of cathodically protected Pipelines.

Sometimes used to electrically **insulate** between material changes.

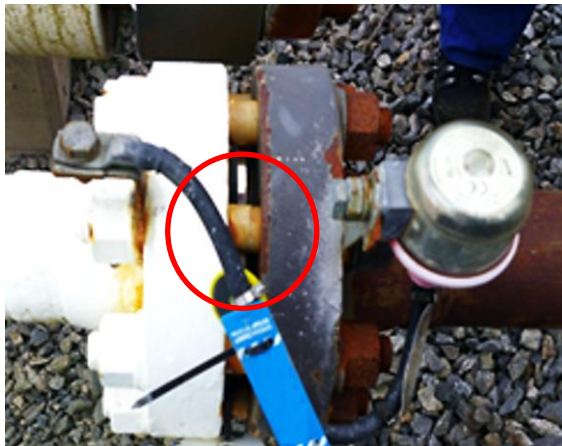
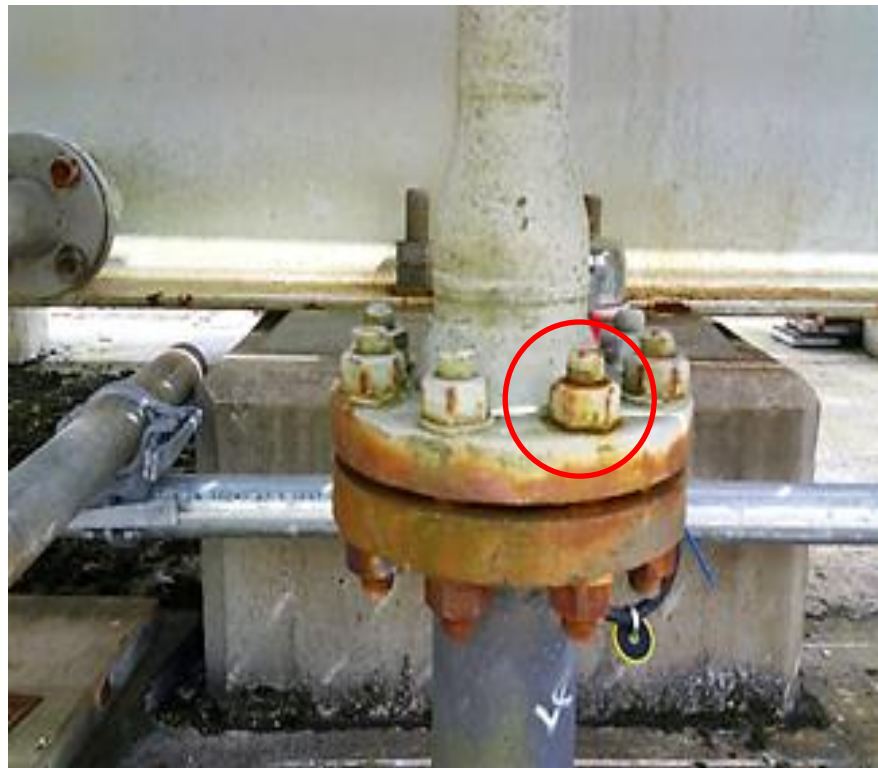
Cracked Sleeves and  
Missing Insulating  
Washers found at site  
survey.

- Under-protected Sections of Pipeline
- Excessive Impressed Current TRU Outputs (attempting to compensate).
- Increased Electrical Interference to other buried services.

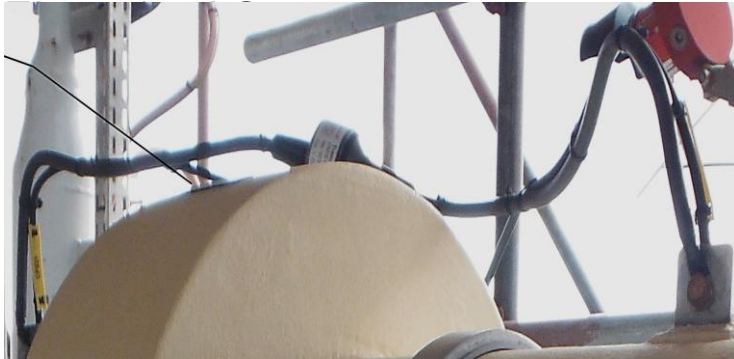
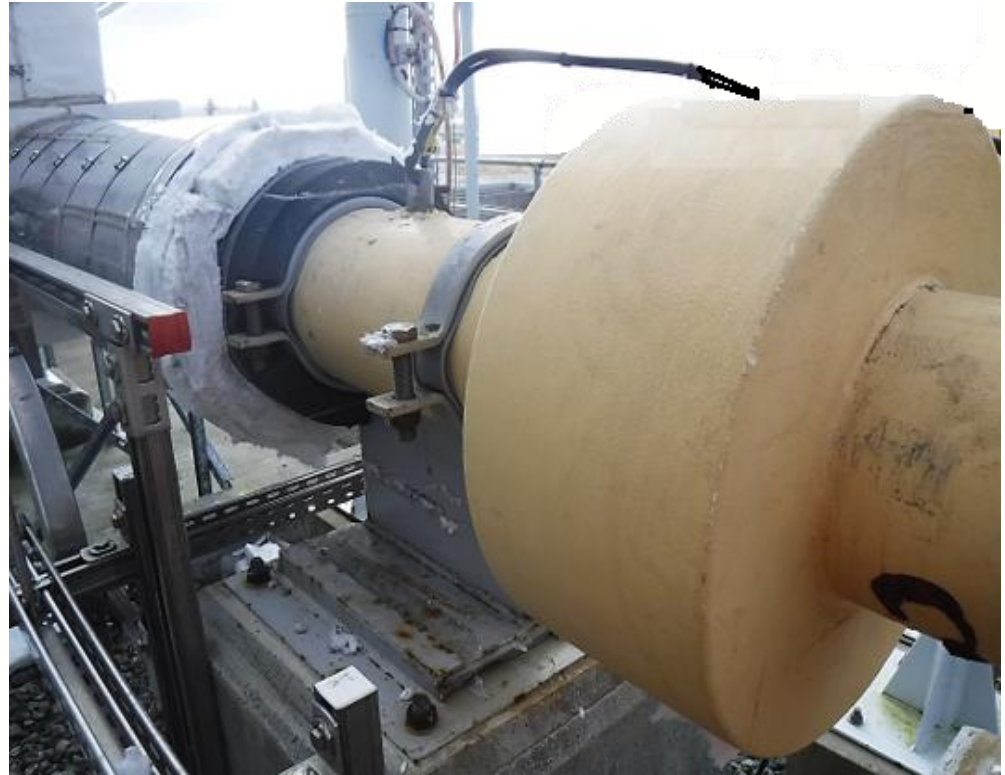
Pipelines of longer length, often deploy Impressed Current type CP systems with 'Monolithic' Isolation Joints at each end, to separate them electrically from Plant.

Live and Dead Side Connections

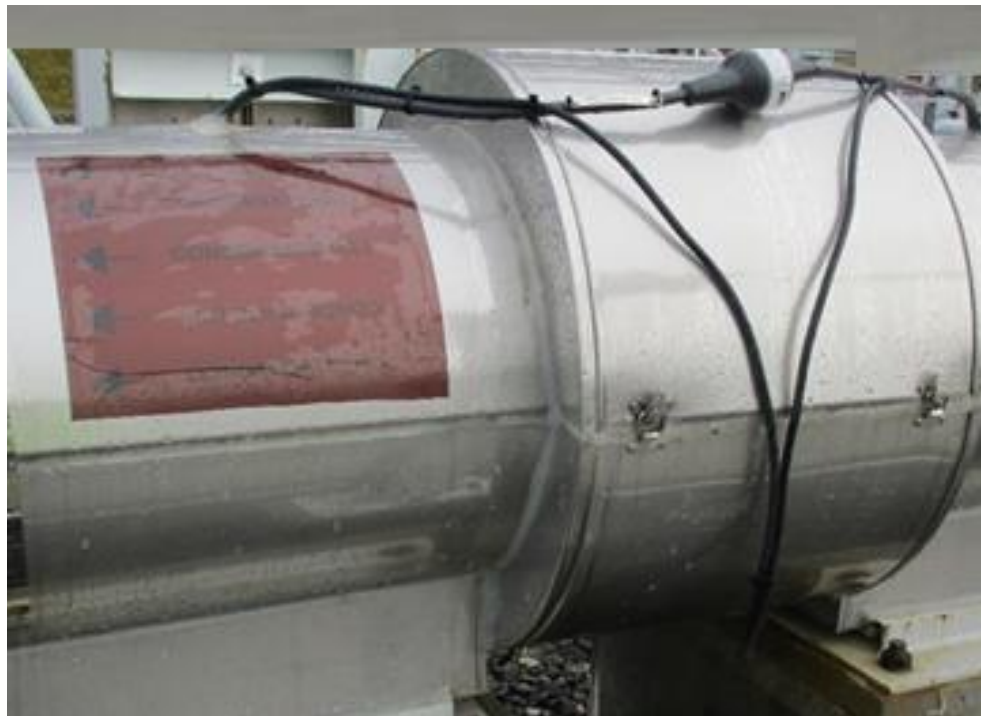
A **cladded** Isolation Joint can result in loss of CP / electrical isolation, if 'metal to metal' contact is allowed to occur.

Image shows joint with protective surge divertor.

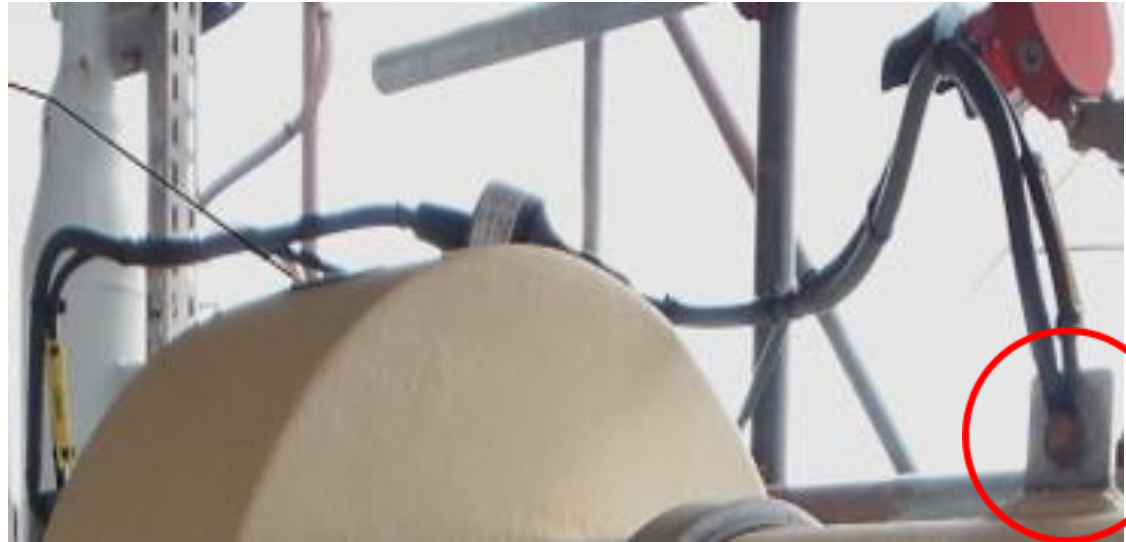
Beneath **cladding** and thermal insulation there are **welded** test cable connection points – ‘tabs’.

**Dead** and **Live** sides of CP scheme.

Under CUI conditions these will **corrode** and the connections can become unreliable.

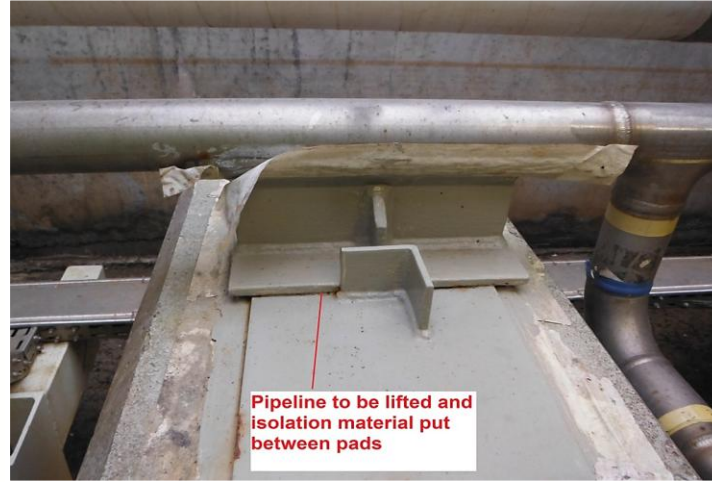
There are **numerous** different possibilities to be aware for loss of CP Isolation via installed plant earths, e.g. Pipe and Valve supports

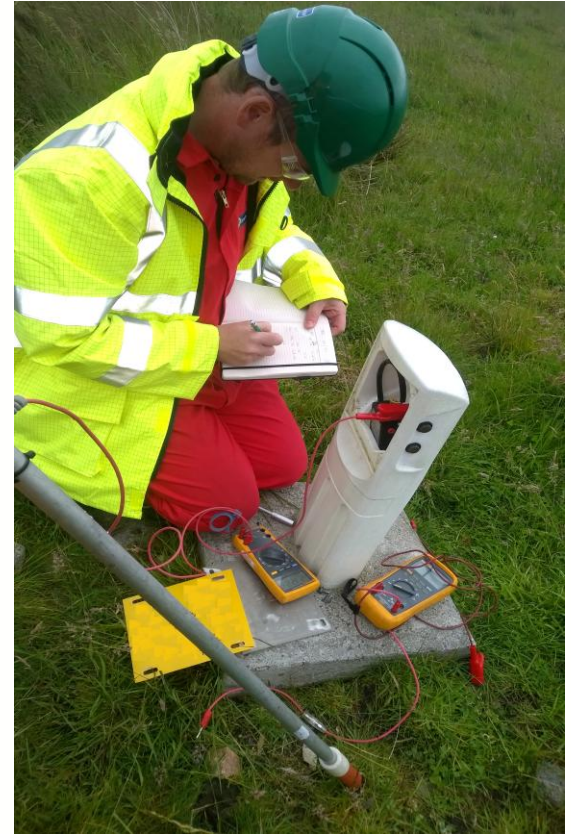
Manual CP System Monitoring (on Land) deploys a **Cu/CuSO<sub>4</sub>** Reference Electrode connected to a High Impedance Multi-meter.

An Anode Connection Box is also shown (Anode Cable Tails in Red).

Other Reference Electrodes may be deployed according to the Pipeline Environment. e.g. **Ag/AgCl** for Marine conditions.

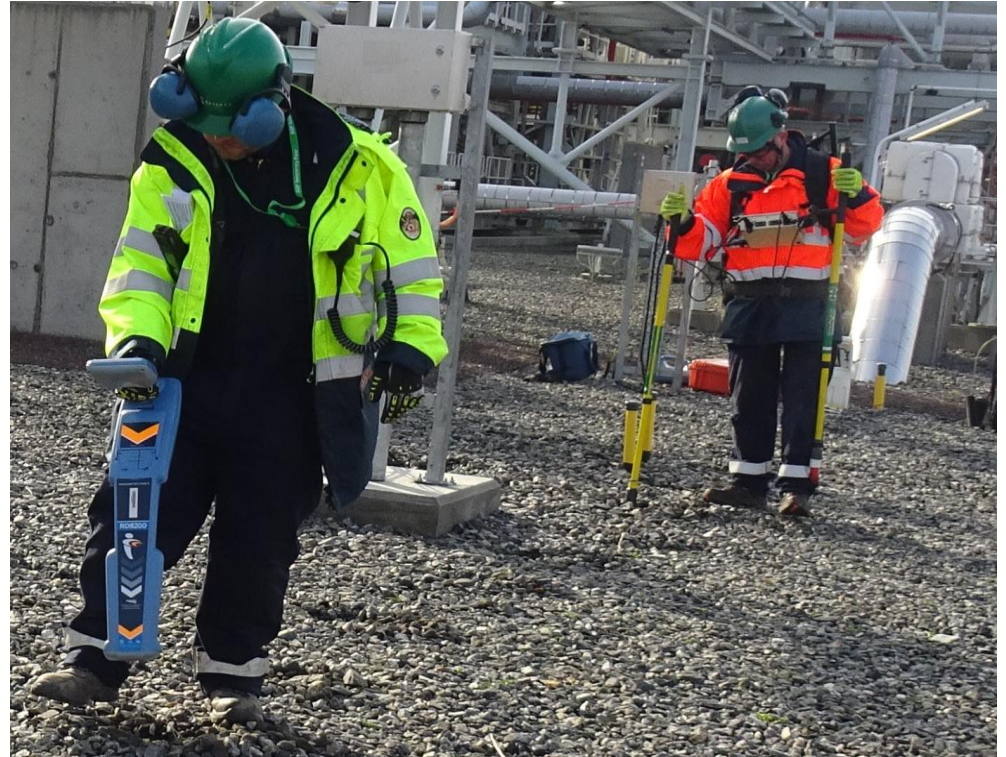
Verification of CP performance is very important and is normally done via **CIPS** with measurements taken ~ 1 metre Intervals.

The leading surveyor is using a Pipeline locator to **stay on course** over Pipe centreline.

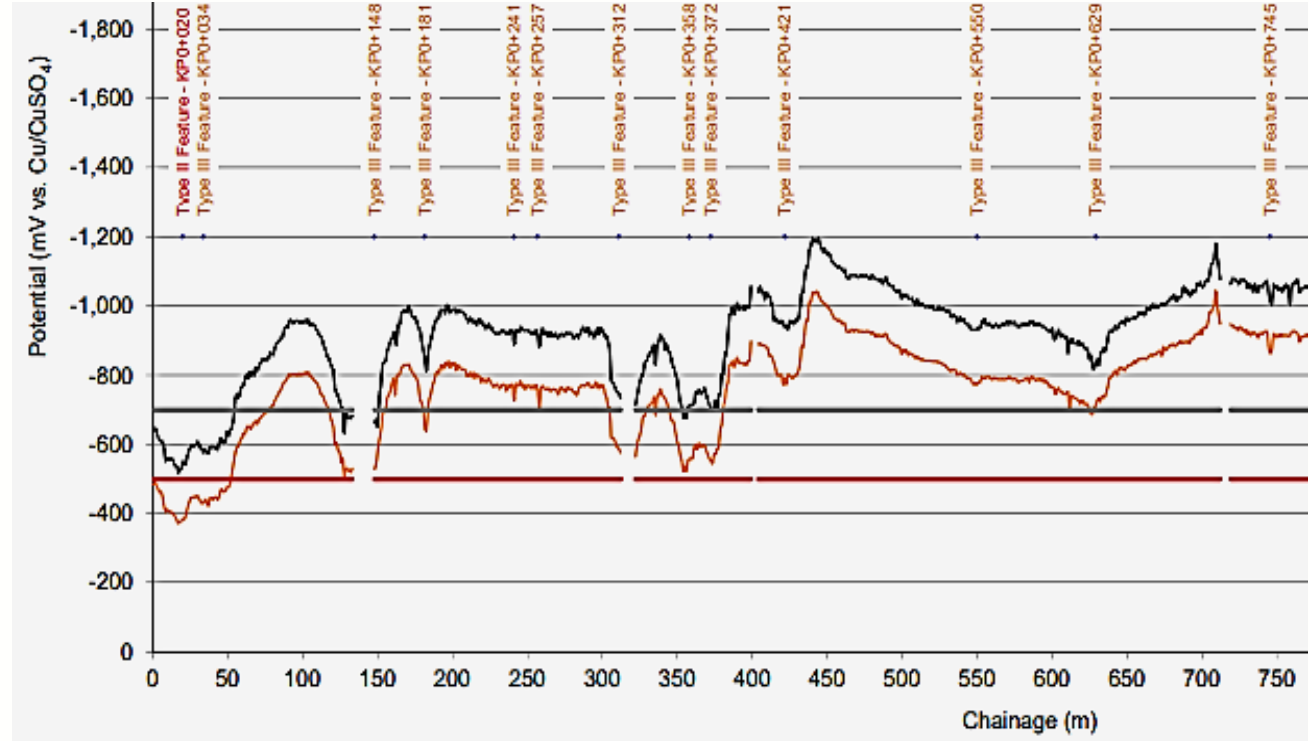
This survey shows an **Impressed current CP** System switching On/Off and the resulting CIPS and DCVG (Direct Current Voltage Gradient) recording (as Slide 10 above).

Areas of **Under/Overprotection** are highlighted from these initial surveys along with Coating Defects.

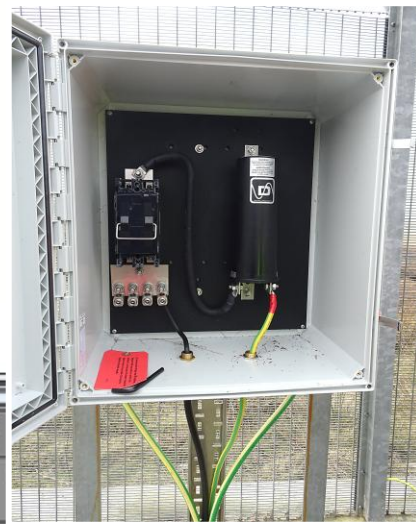
- SWX-100-ENCL
- Any PCR-3.7KA, PCR-5KA or PCR-10KA
- MTL Conductor Kit, Optional
- BCL-2 Shorting Cable

CP solutions by  
Corrpro
