# Development of coatings to last the life of the asset

# Hutton TLP Case History

# In service performance: Hutton TLP 1<sup>st</sup> Assessment

# Nov 2022 – Second Assessment Report Element Independent Test Company

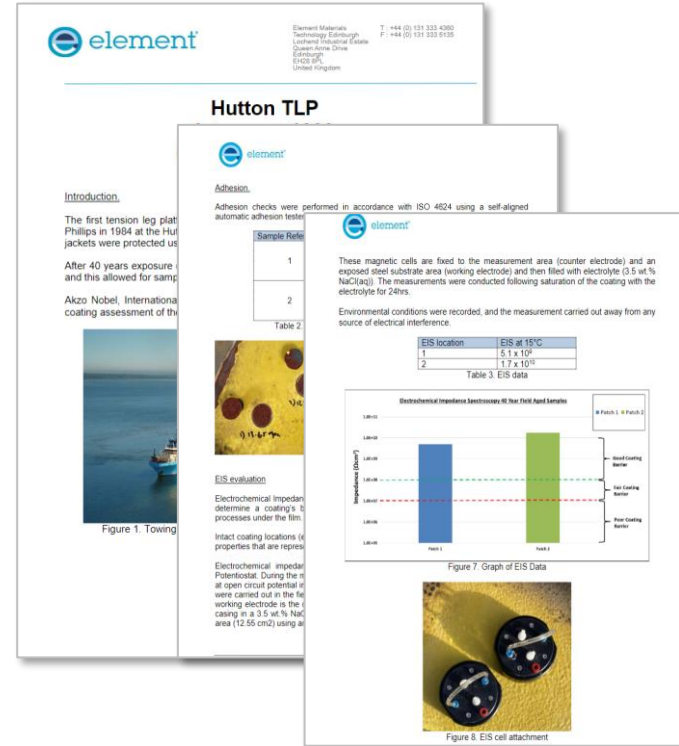
This is a summary of the results of testing undertaken on large samples / sections of the Hutton TLP jacket

AkzoNobel conducted these assessments of the coating system and has worked with world leading materials testing company Element to independently verify and report the results.

Several tests and assessments were undertaken and completed on sections of the TLP to determine the performance of the coating system.
