# Advisory – Corrosion in Pipelines

Corrosion Awareness Day, 2026

Luke Munro Pipeline Specialist –  
LR Offshore Technical Support Offshore

## Corrosion Defect Assessment of Thistle Alpha Export Line

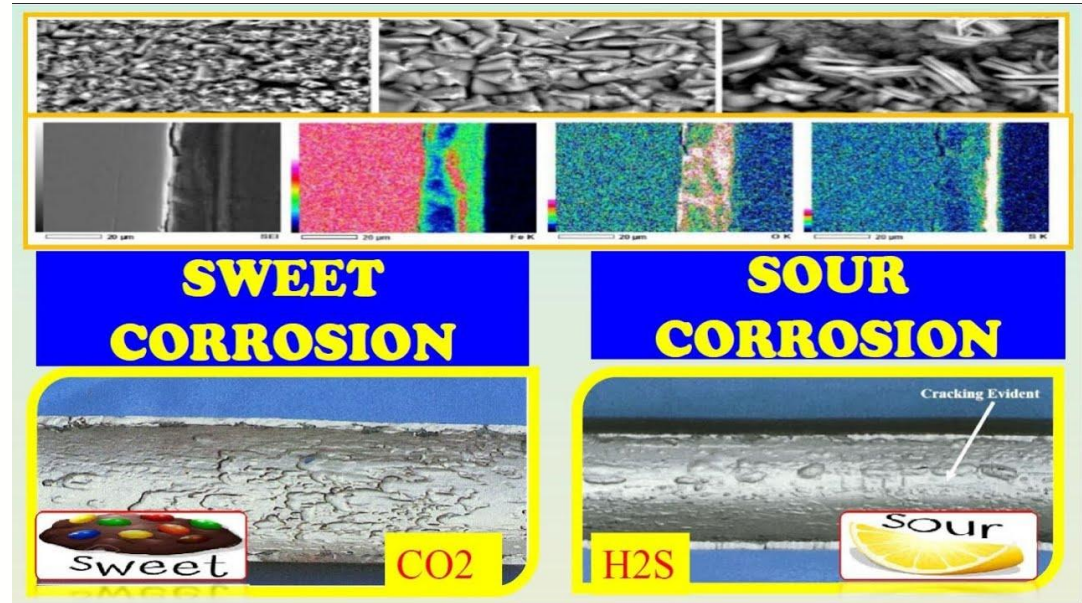
- Key issue = what's in the pipe
- Sweet corrosion
  - Most common internal corrosion mechanism
  - CO<sub>2</sub> dissolved in water
  - Siderite films are formed
  - Below 60°C – General corrosion
  - Above 60°C – Pitting corrosion
- Sour corrosion
  - Less common than sweet corrosion
  - H<sub>2</sub>S dissolved in water
  - Can result in pitting and cracking

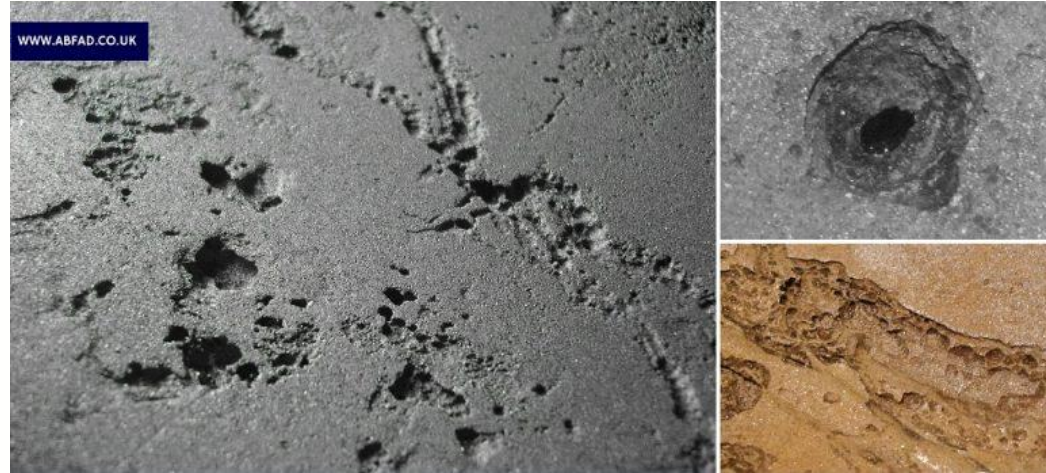
- MIC
  - Caused by bacteria on pipe wall
  - These consume sulphates and produce  $H_2S$
  - Can be introduced via untreated seawater
  - Can form a groove along the 6 o'clock position

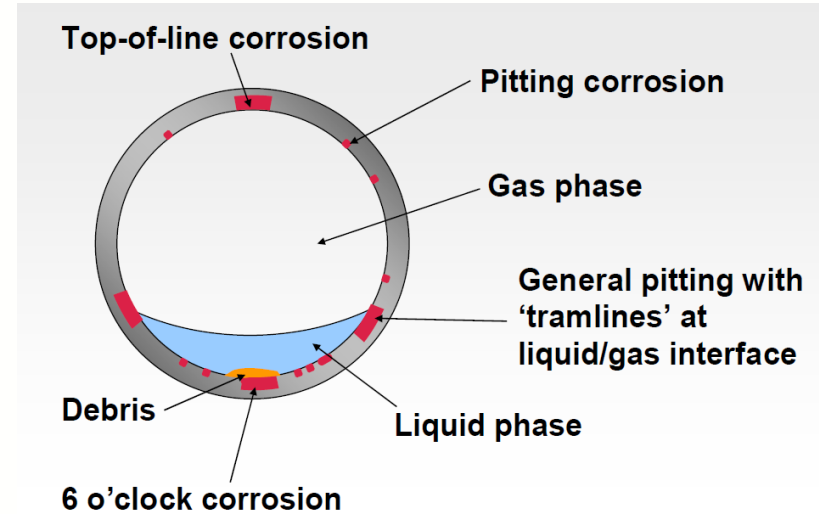
- Top of pipe
  - Issue in high temperature wet gas and multiphase lines
- Bottom of pipe
  - Due to water settling out
  - MIC can result in a groove at 6 o'clock position
- Bends
  - Combined erosion & corrosion

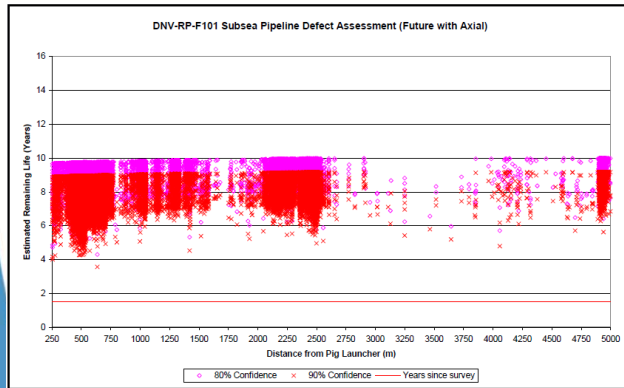
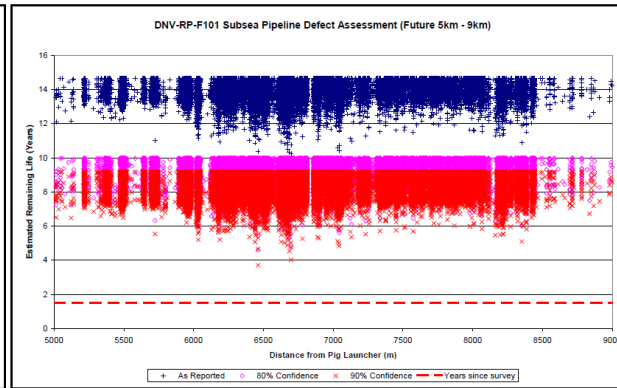
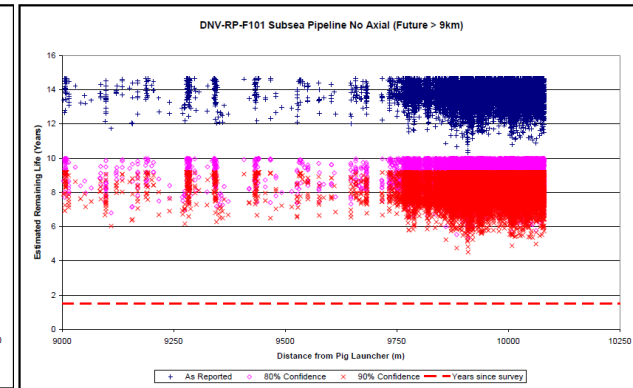
## Results: DNV-RP-F101 subsea pipeline assessment (future)

- Governing external feature was located topsides
  - Defect dimensions at the time of measurement were beyond the allowable code limits
  - LR recommended an immediate repair of all external features
  - This was completed in 2010
- Governing internal feature was located topsides
  - Remnant life of 1.3 years
  - LR recommended that the 10 worst case topside features be inspected further
- LR recommend that ILI is reperformed as soon as possible
  - Missing 1.9 km
  - Possible inaccuracies
