IMG COMPOSITES

October 2017

# WHAT IS A COMPOSOL<sup>®</sup> REPAIR?

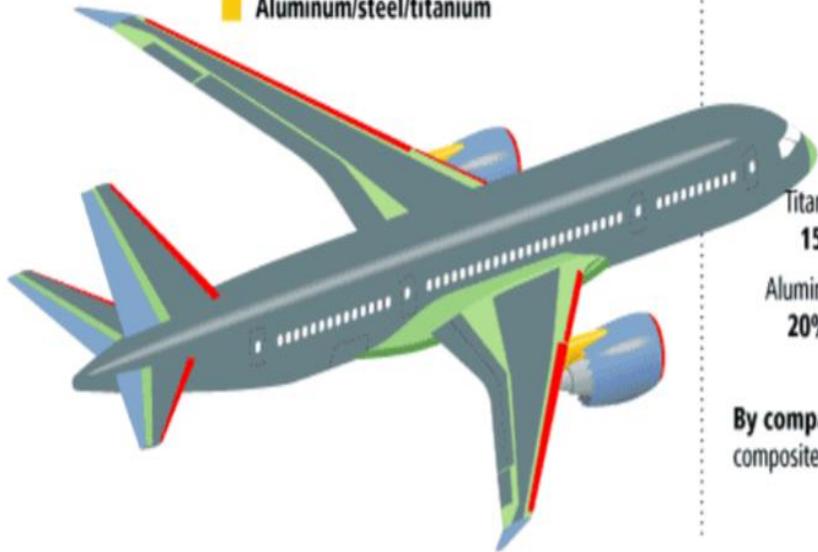
Materials used in 787 body

- Fiberglass
- Aluminum
- Carbon laminate composite
- Carbon sandwich composite
- Aluminum/steel/titanium

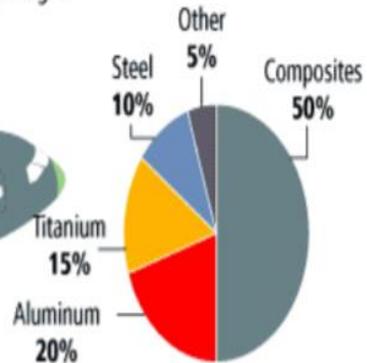
Total materials used  
By weight

By comparison, the 777 uses 12 percent composites and 50 percent aluminum.

The use of composite materials is 50% by weight and 80% by volume

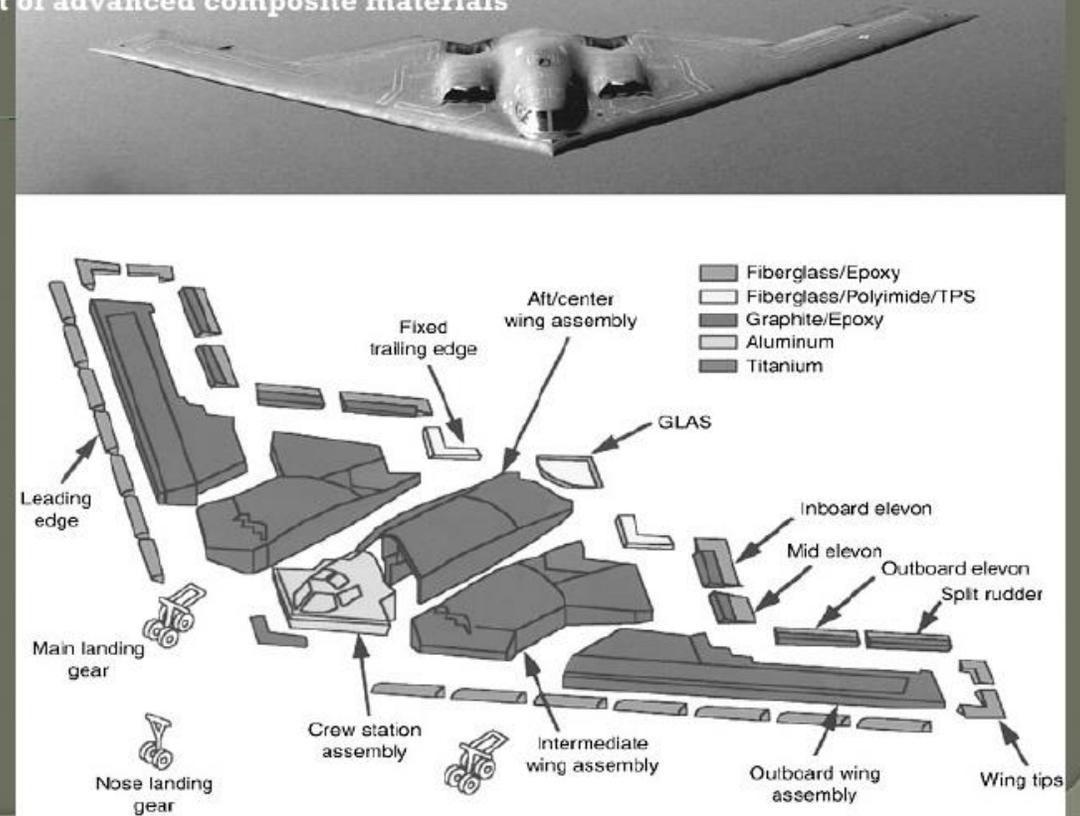
The U. S. Air Force B-2 advanced “stealth” bomber, which is constructed to a large extent of advanced composite materials

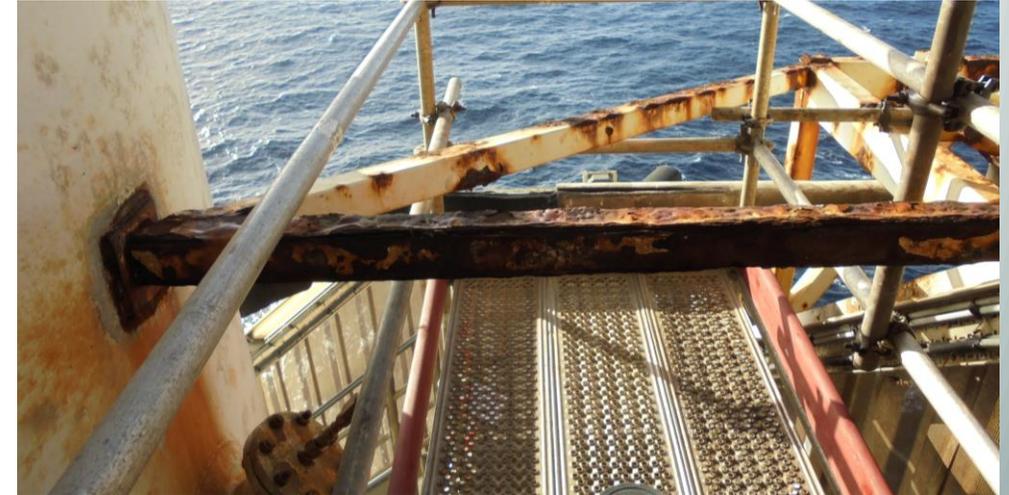
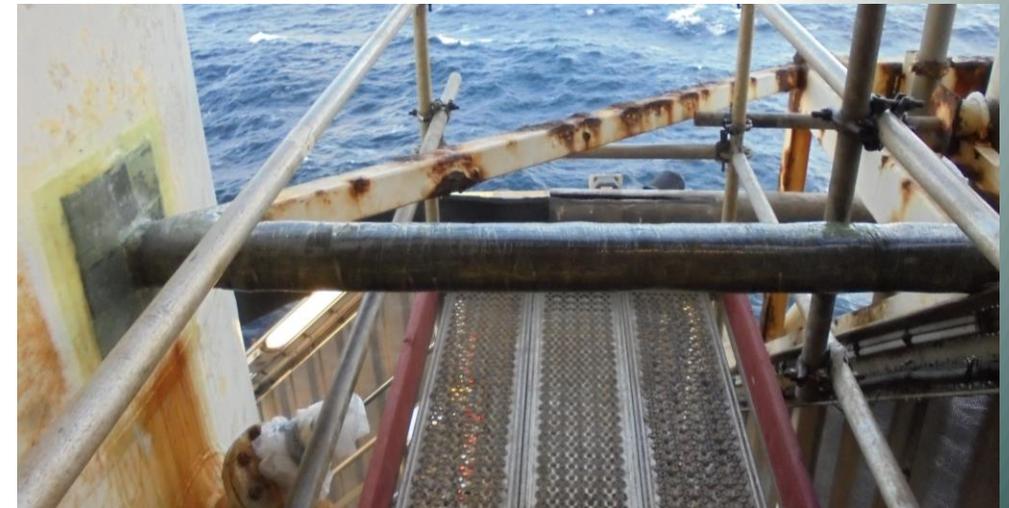
# COMPOSOL<sup>®</sup> STRUCTURE

- Structural repairs have come a long way:
  - Not initially designed or required to take structural loads i.e. incidental strengthening only
- Designed to restore or upgrade capacity
- Applied to a variety of structures
  - Decks
  - Caissons
  - I-beams
  - Hollow sections

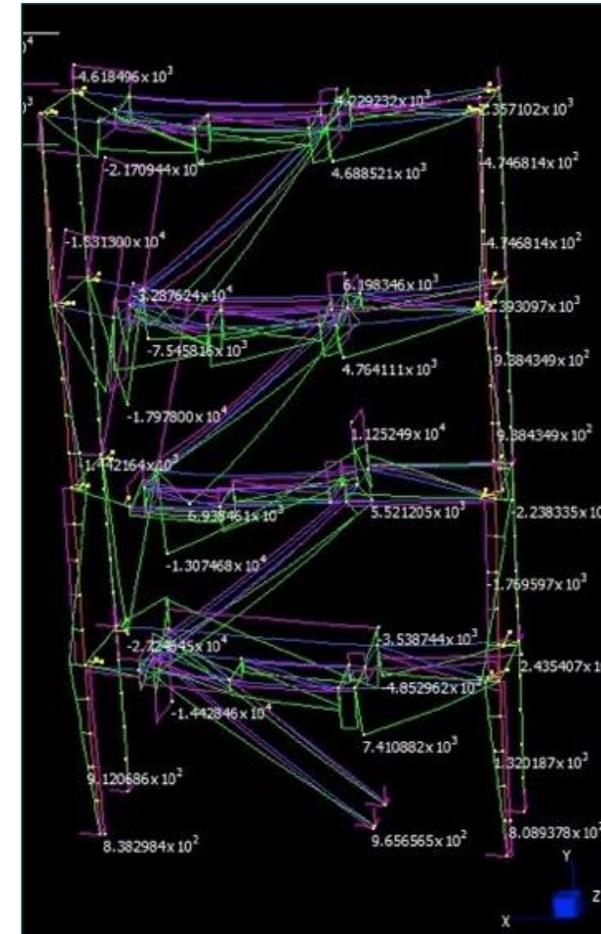
# CASE STUDY – STAIR TOWER COLUMN AND BEAMS

## Solution: CompoSol® Structure

1. Upgraded Loading Capacity to account for:
  - axial compressive loads (live and dead loading)
  - wind loading
  - Lateral loads (moment and shear)

2. Bond Analysis
  - Lap shear
  - Energy Release Rate

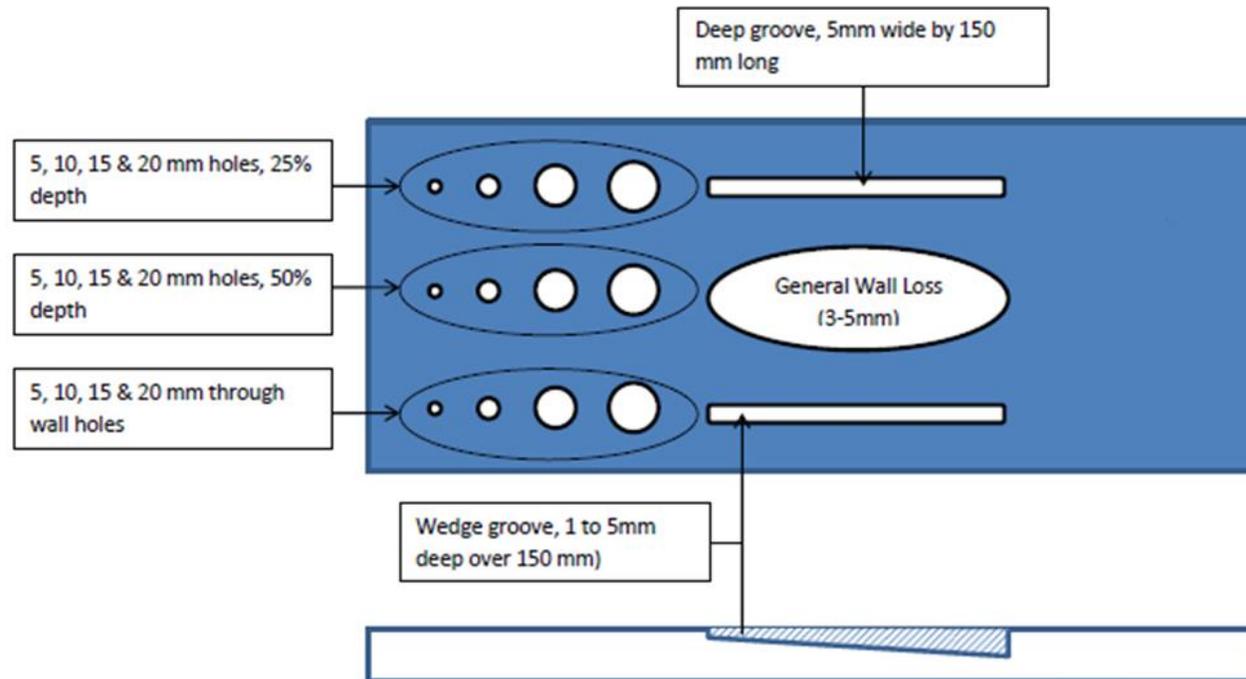
# HUGINN PROJECT

- Project utilized wrapped CompoSol® Spools with different defects, such as the below with machined defects

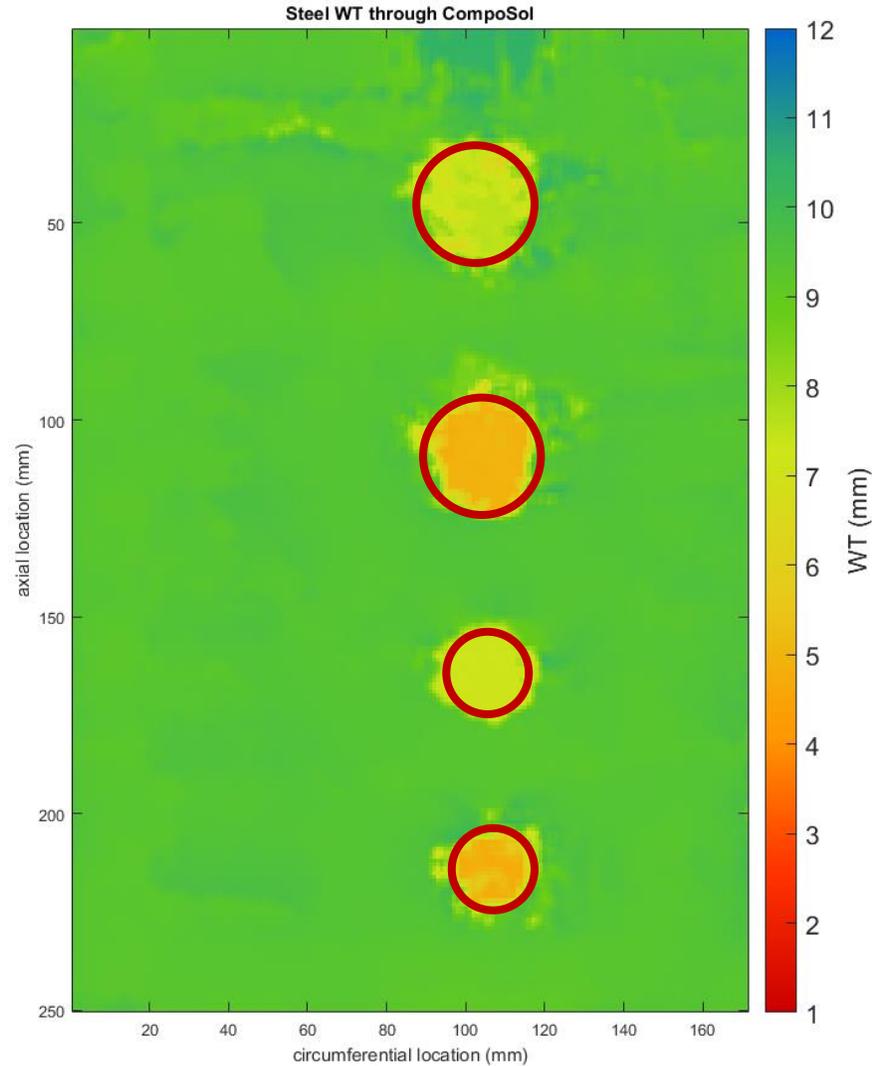
# DYNAMIC RESPONSE SPECTROSCOPY

DRS	Machined (centre point)
7.3 mm	7.0 mm
4.9 mm	4.5 mm
7.2 mm	7.0 mm
4.8 mm	4.5 mm

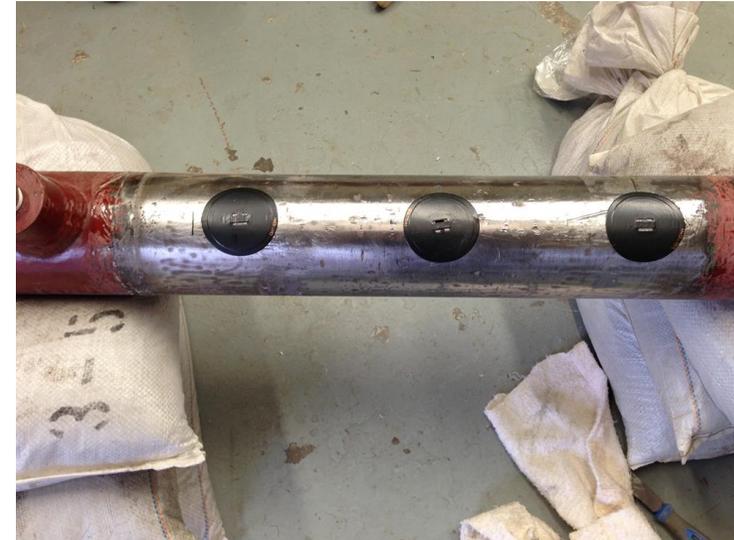
# SPOOL B: RESULTS

- Surface Prep: St.2
- Thickness: 8 Layers
- Test Increments: 20 bar every 5 minutes
- Burst Pressure: No Failure up to 400 bar

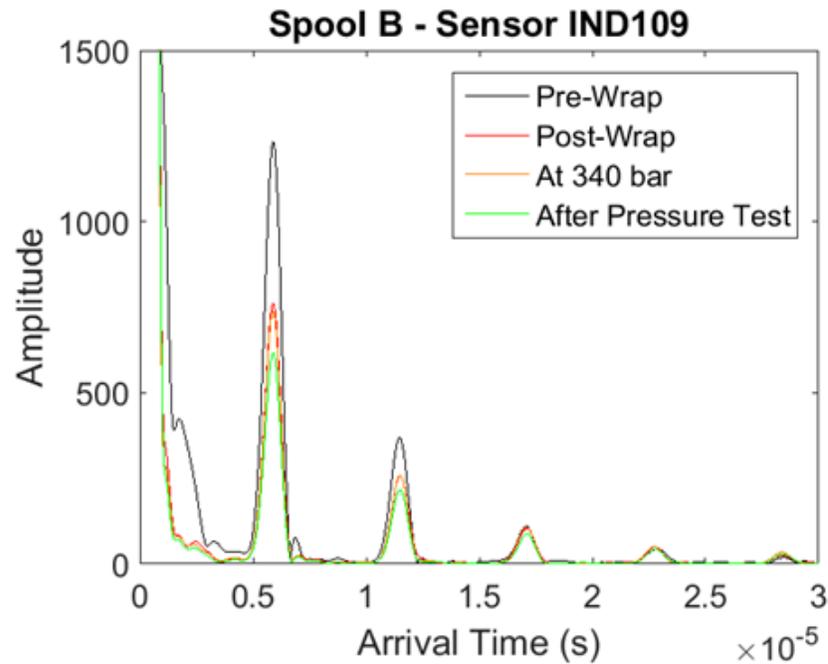
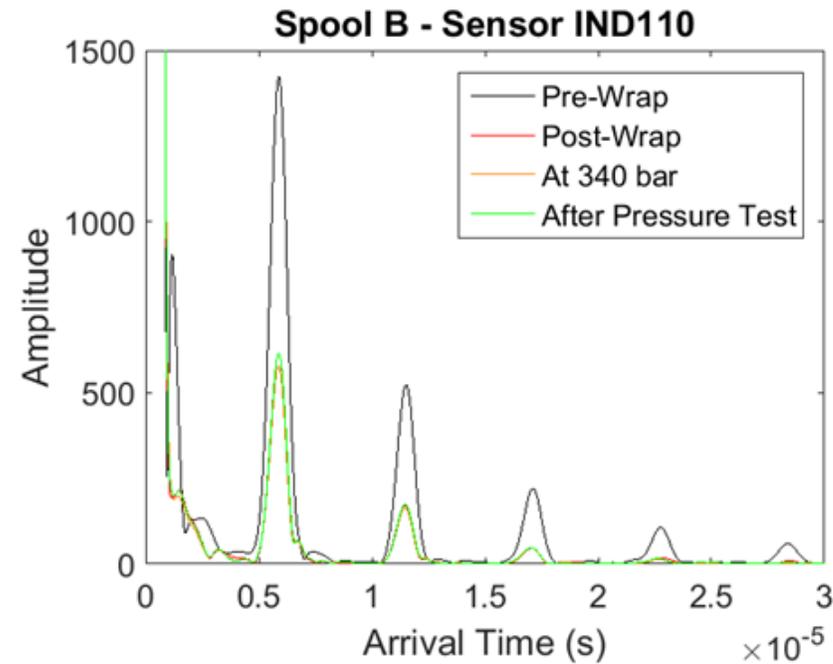
# SENSOR FUNCTION: SPOOL B

- The loss in signal amplitude may be attributed to the increased distance between the sensor and measurement coils caused by the presence of the repair wrap.

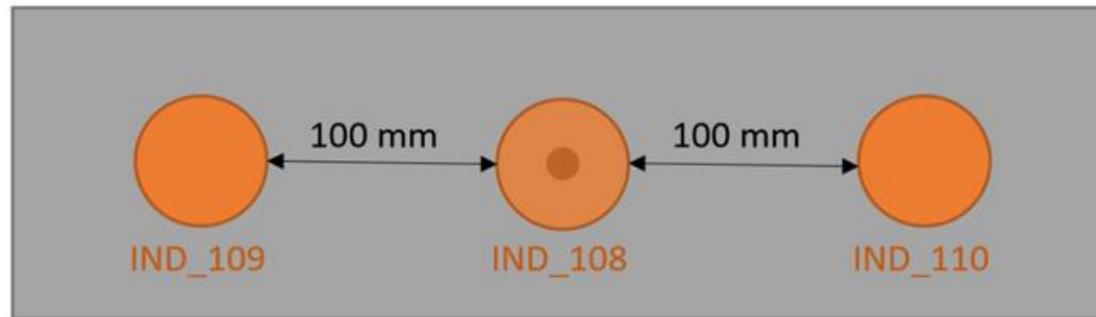
# SENSOR FUNCTION: SPOOL B

- Two sensors either side of defect functioned well after wrap and during the test

Measurement Point	Measured Thickness (mm)	
	IND109	IND110
Before wrap	17.141	17.025
After wrap	17.133	17.013
At 340 bar pressure	17.133	17.037
After pressure released	17.117	17.056
