Conductor Integrity

Hidden Risks and Mitigations

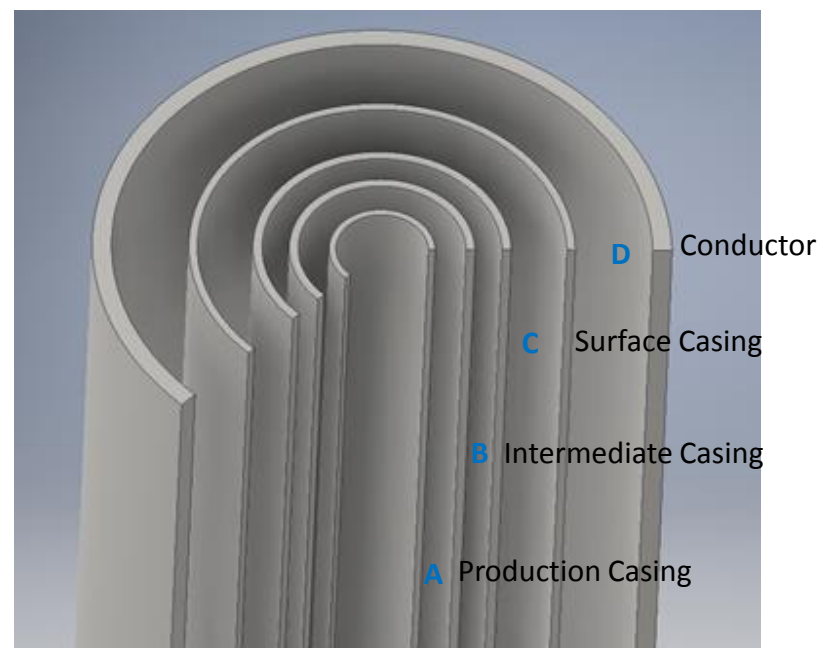
Typical well cross section

Internals

- Annuli contents will vary and may not be known, especially in older wells.
- Surface casing (generally) carries well load across underwater zone.
- Load sharing can be complex and affected by deterioration of conductor.
- Casing integrity – implications for well barriers to maintain safe operations.

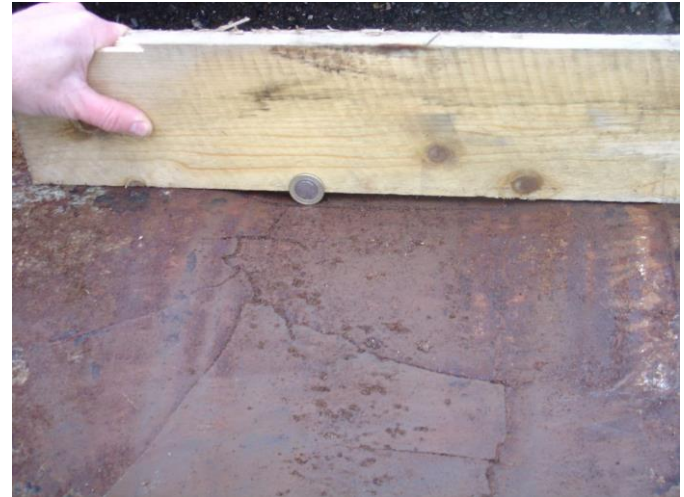
Fretting

Continual relative movement between conductor and guide, even in benign conditions.

Note corrosion behind where guide would have been.

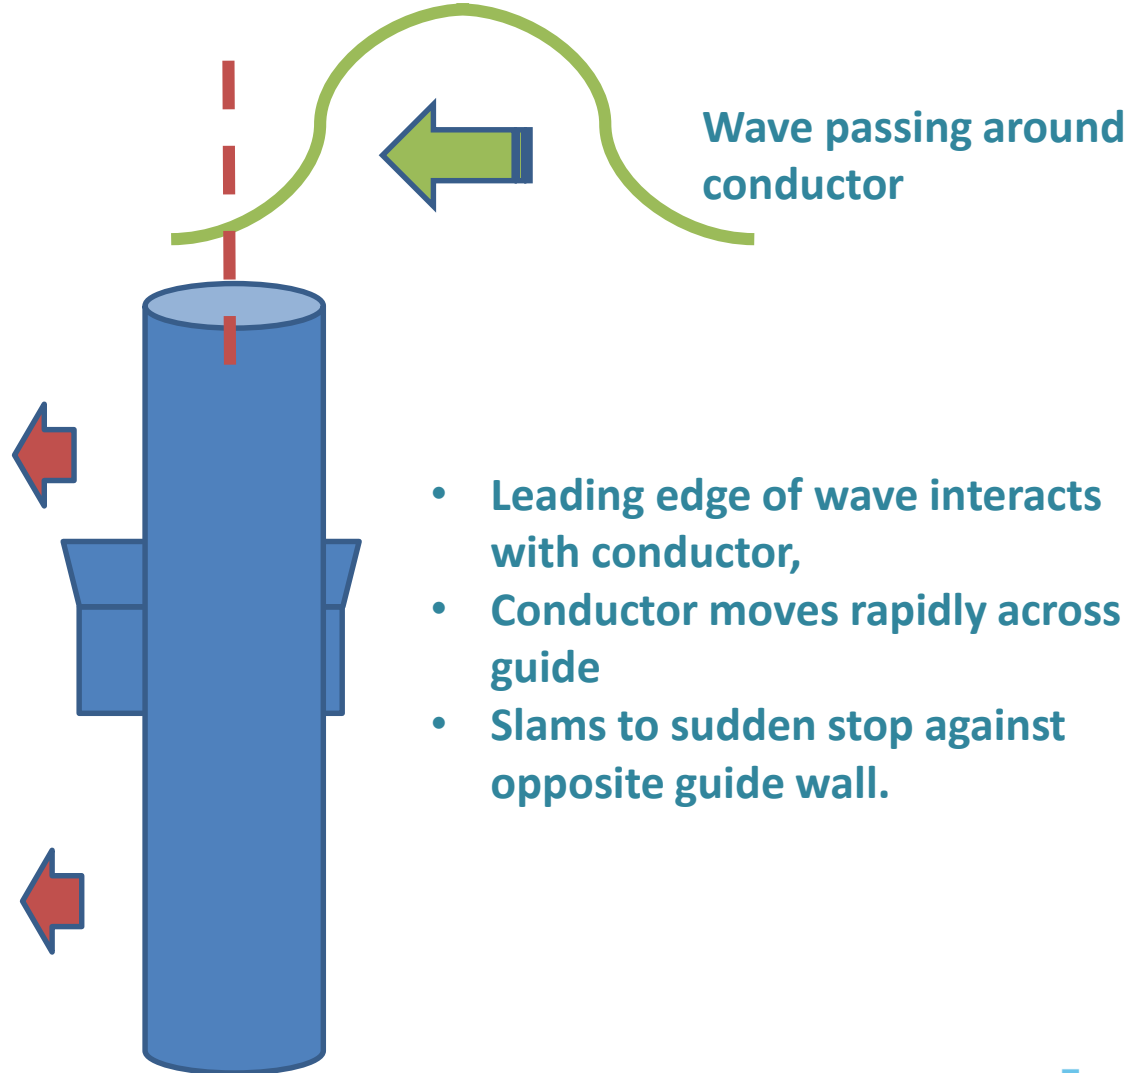
Dynamic loads - environmental

Impact results in a point, or rather vertical line loading.

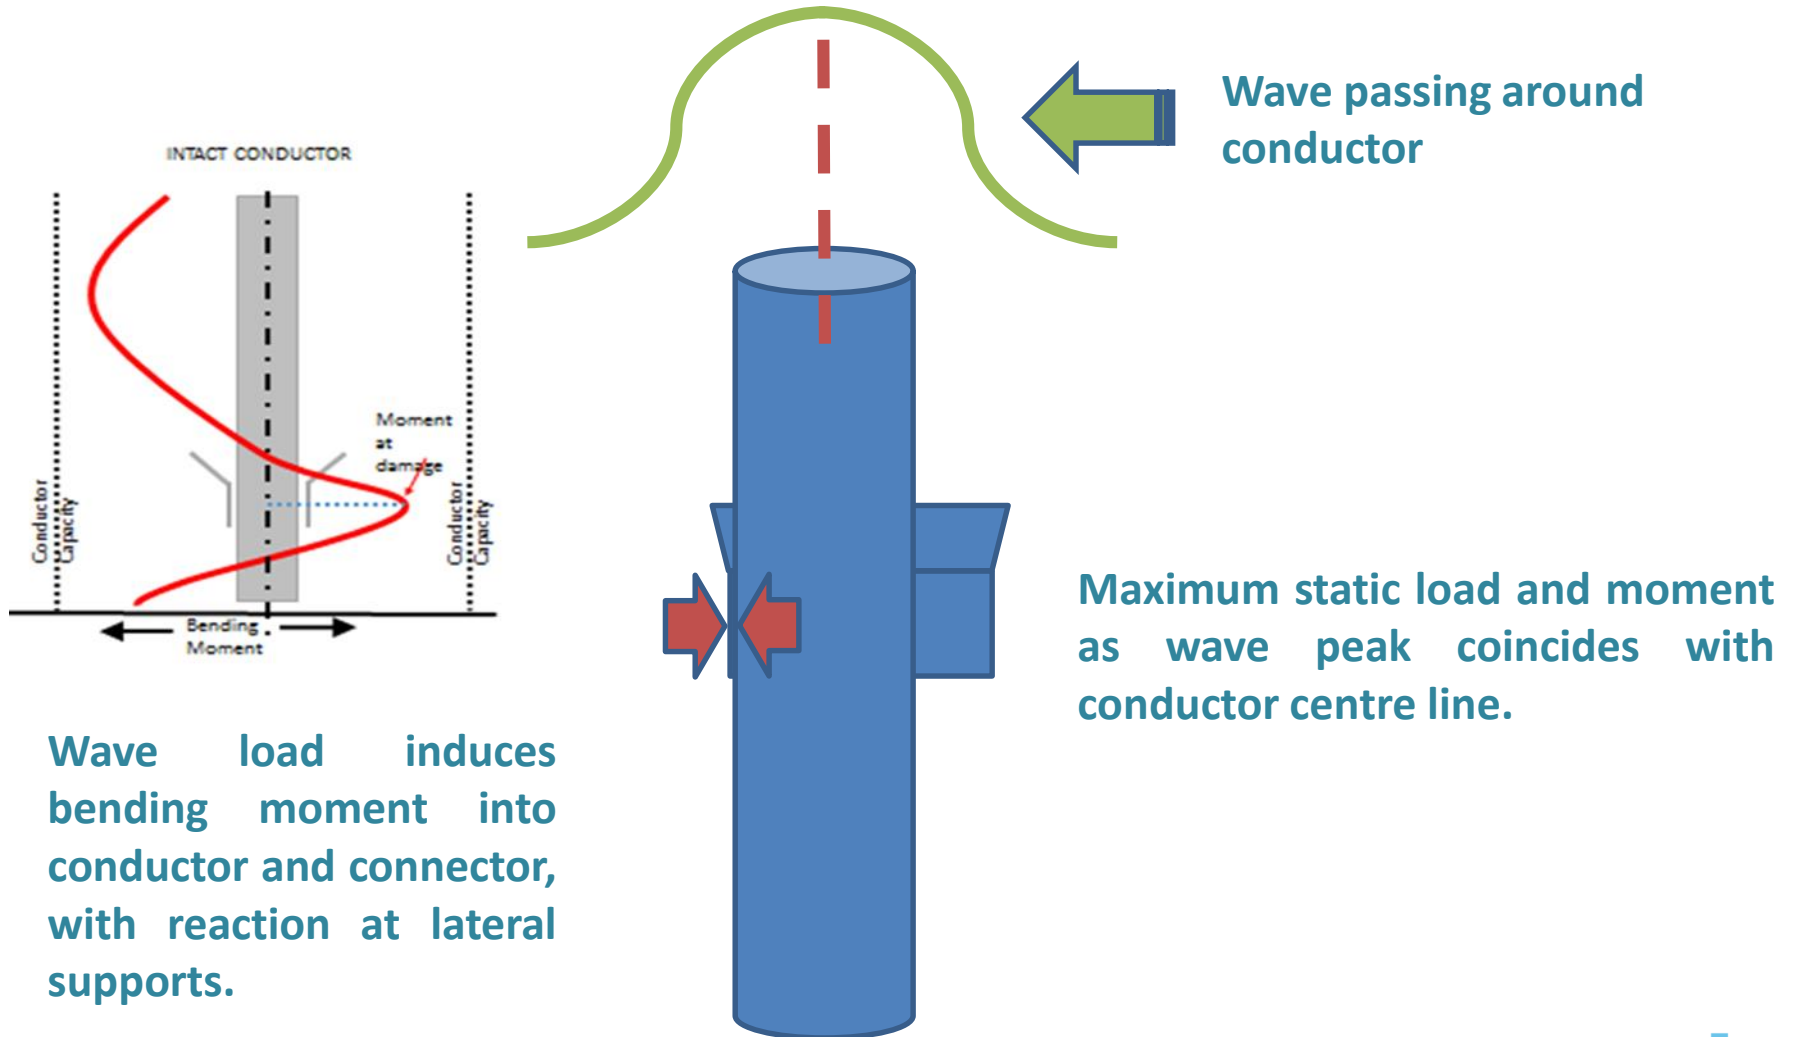
Static loads - environmental

Wave load induces bending moment into conductor and connector, with reaction at lateral supports.

Maximum static load and moment as wave peak coincides with conductor centre line.

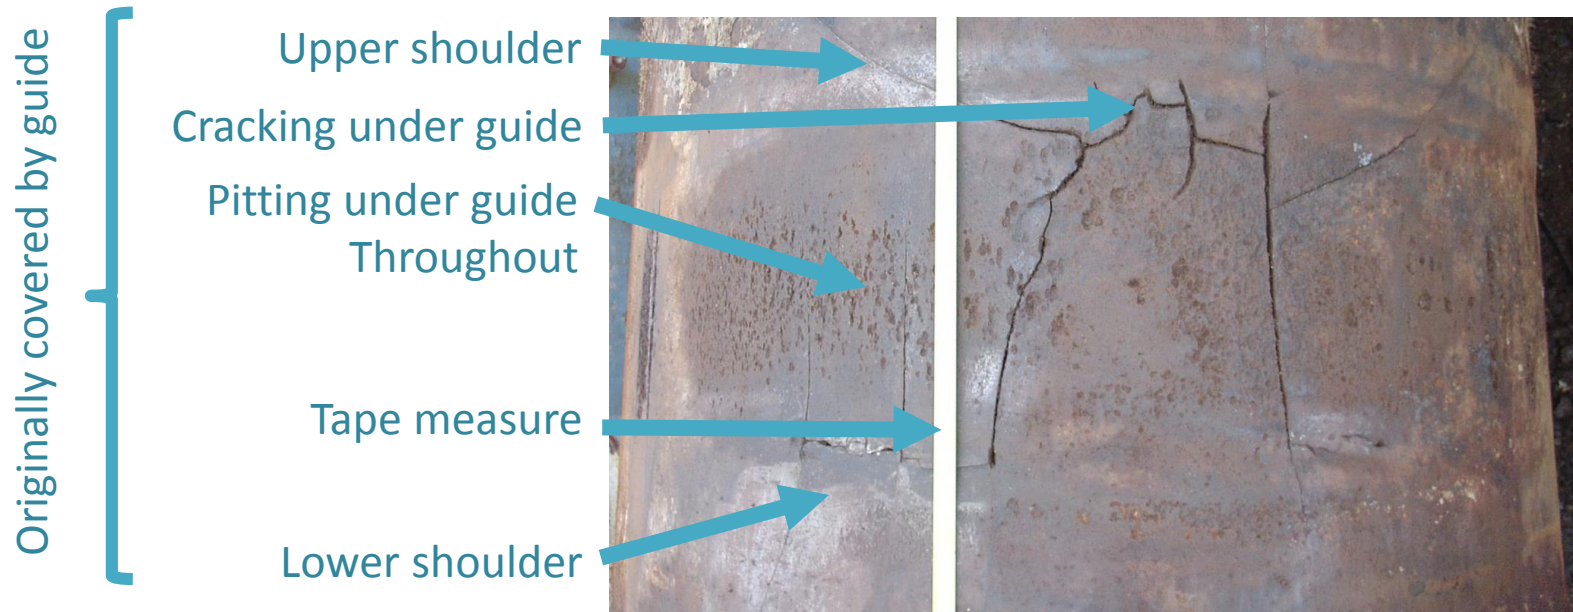
Recovered Conductor showing where guide sat

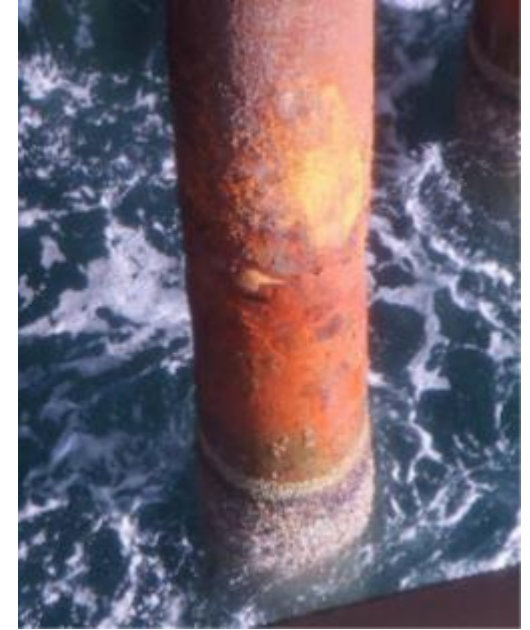
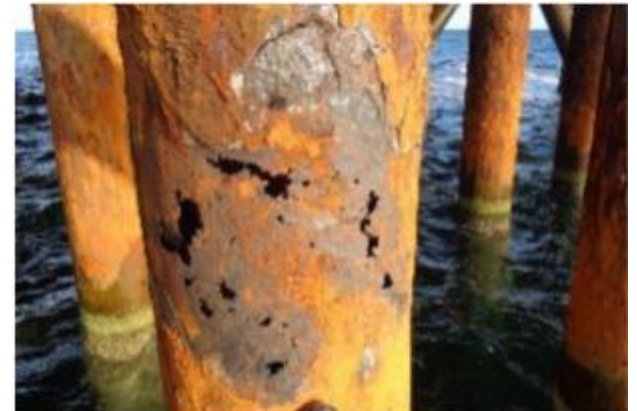
Example of surface corrosion
 El-3 m to +3 m in Caspian:
 through wall corrosion and
 threat to well; this well was
 plugged.

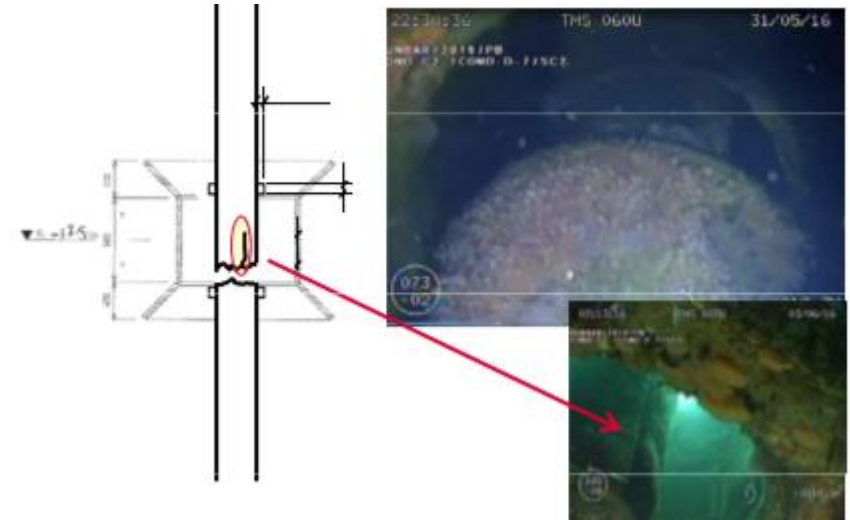
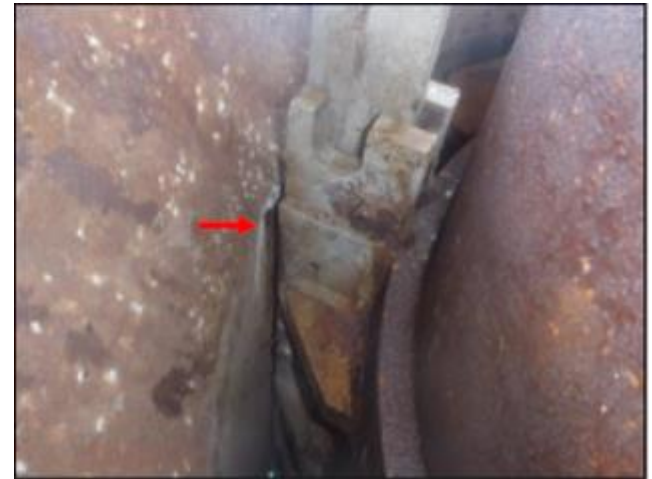
Components

Conductor components can cause issues.

Often through inadequate design or fabrication details or component failure.

- Tie-back conductor centralisers
- Retrofit chocks

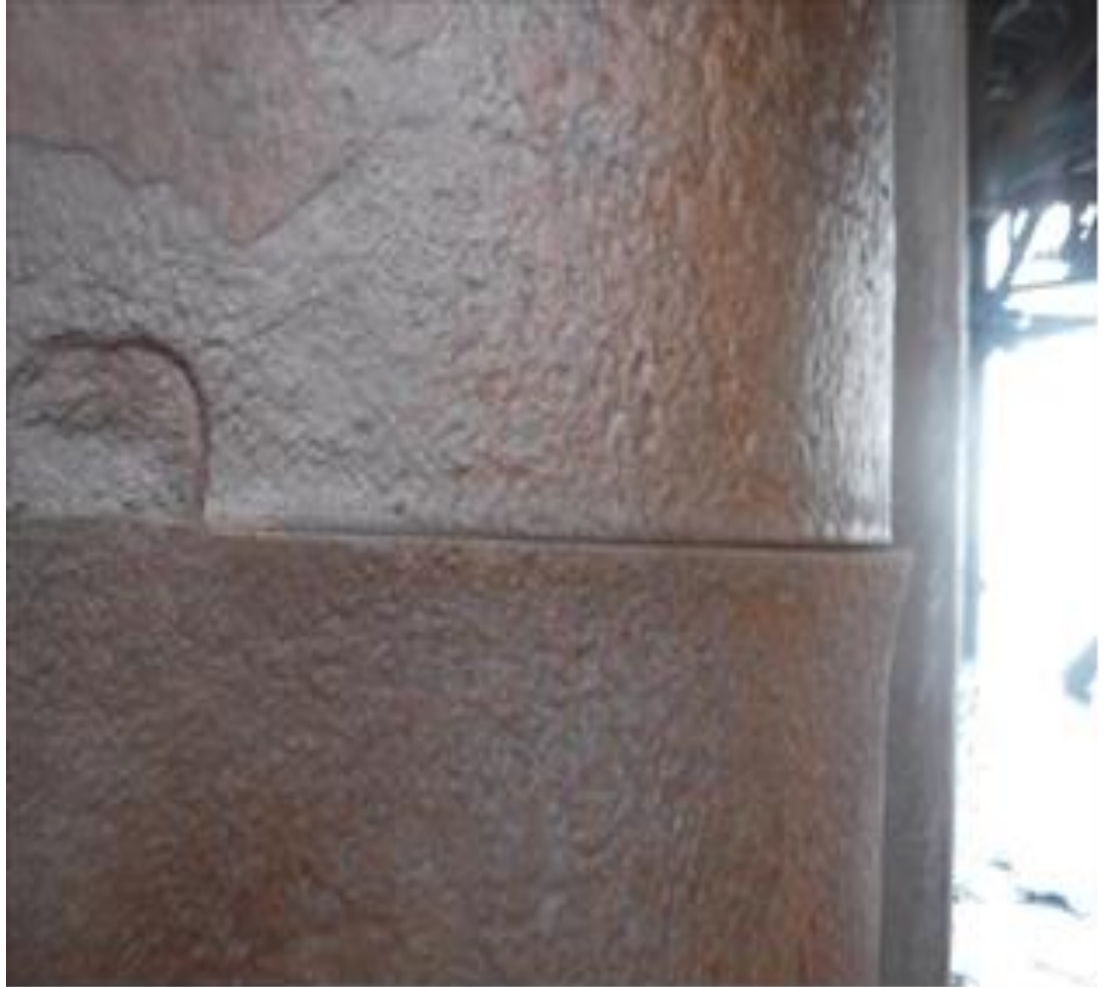
Connector Failure – Air Gap

Early signs can be an opening of the gap between the pin and box and is generally progressive.

Connector in air gap, easily found and assessed.

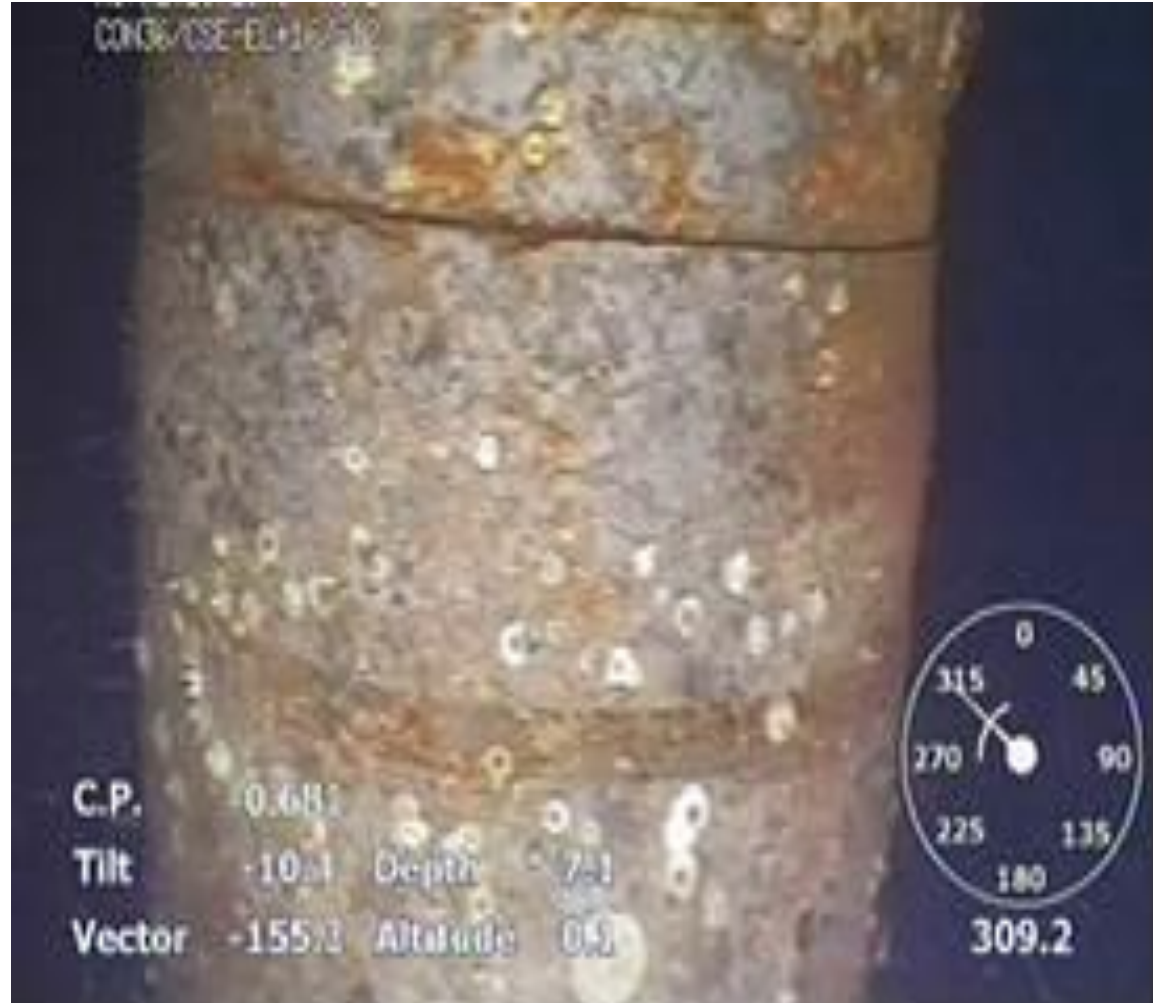
Connector Failure – Subsea

Flush connector's location subsea or degree of separation cannot be ascertained without marine growth removal, unless defect progression is advanced.

Failed connector subsea – after cleaning by ROV.

Difficult to find in marine growth.

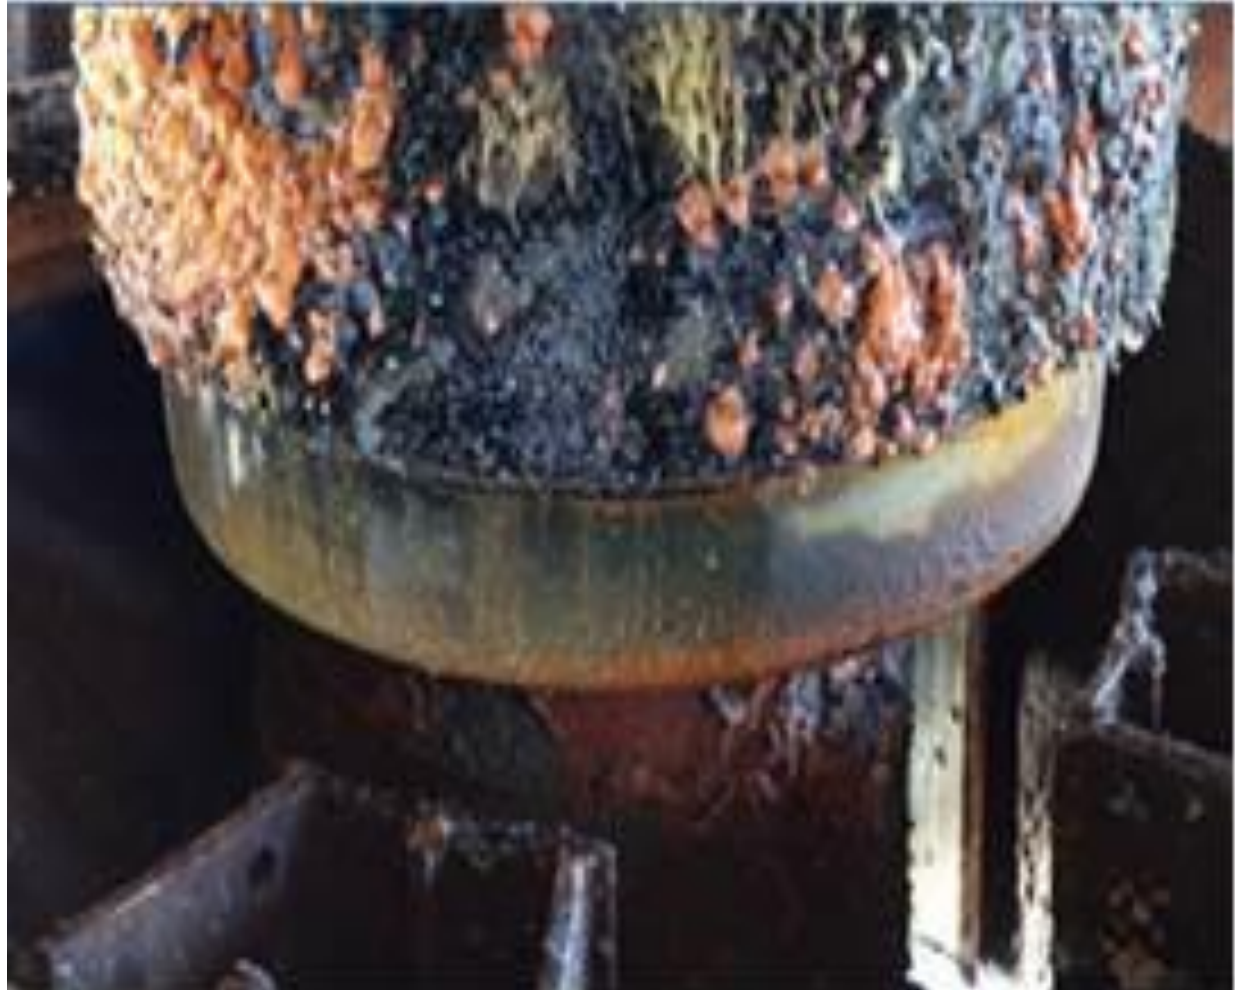
Connector Damage

Grossly failed connector – pin and box square cut threads have been ground smooth.

This well was P&A'd, photo taken during recovery.

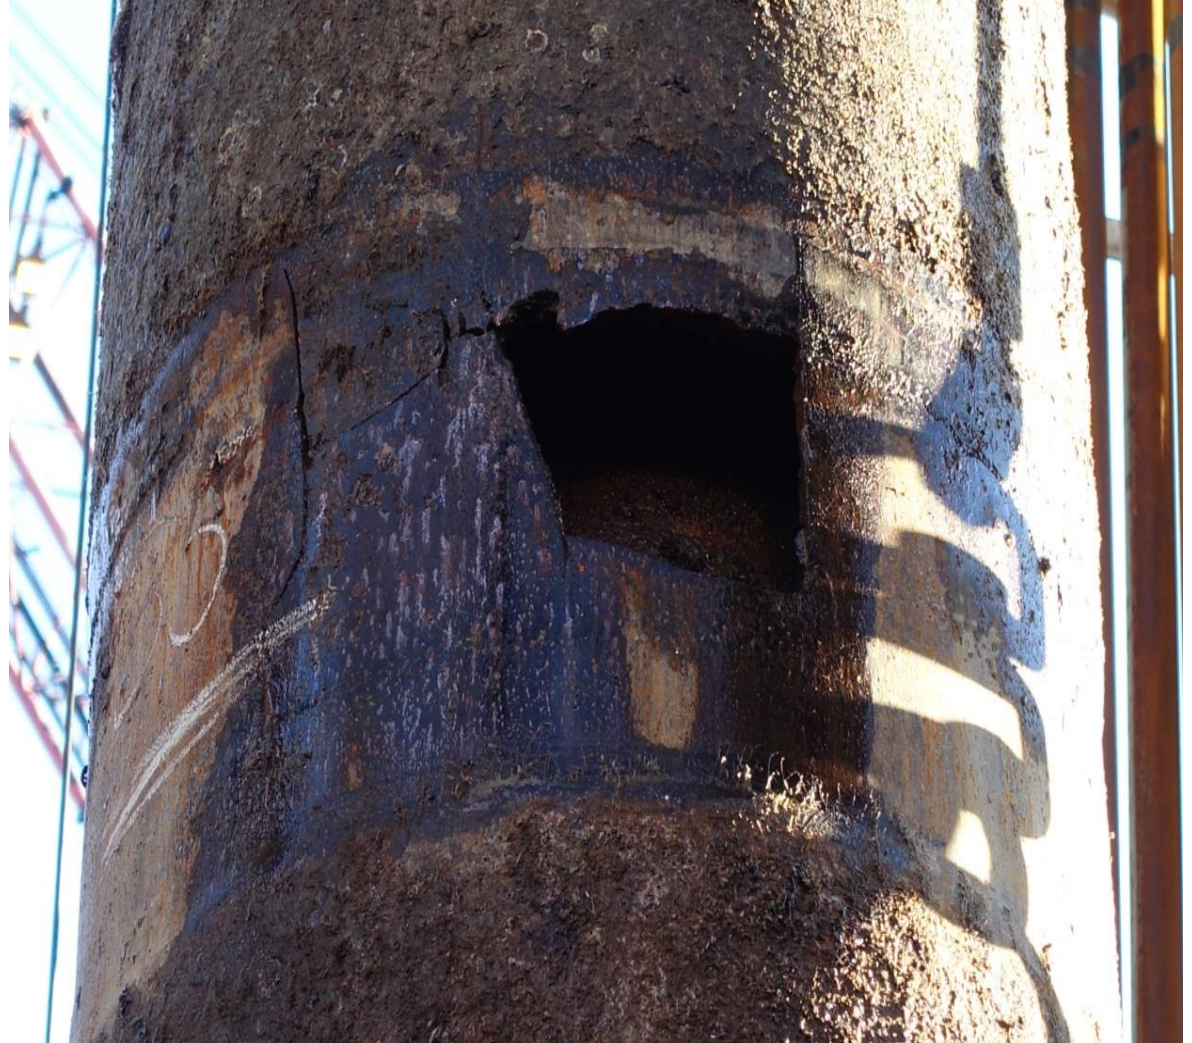
Fretting & Random Cracking

Failed conductor.

TWD and circumferential cracking within guide.

Photo taken whilst conductor and well string being recovered.

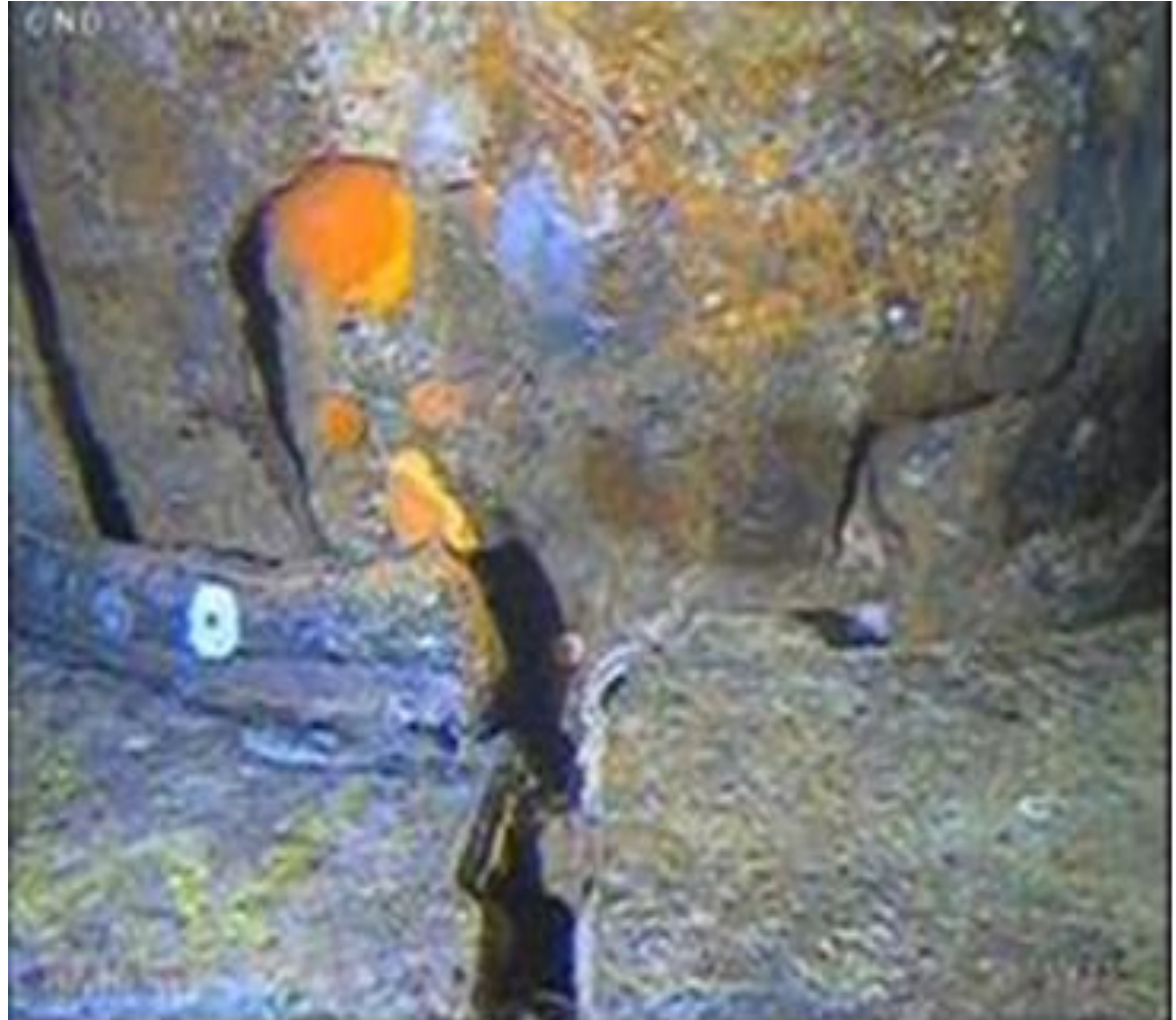
Conductor & Guide Damage

Failed guide – support web missing, section of guide cone missing.

TWD to conductor.

Marine growth removed by diver.

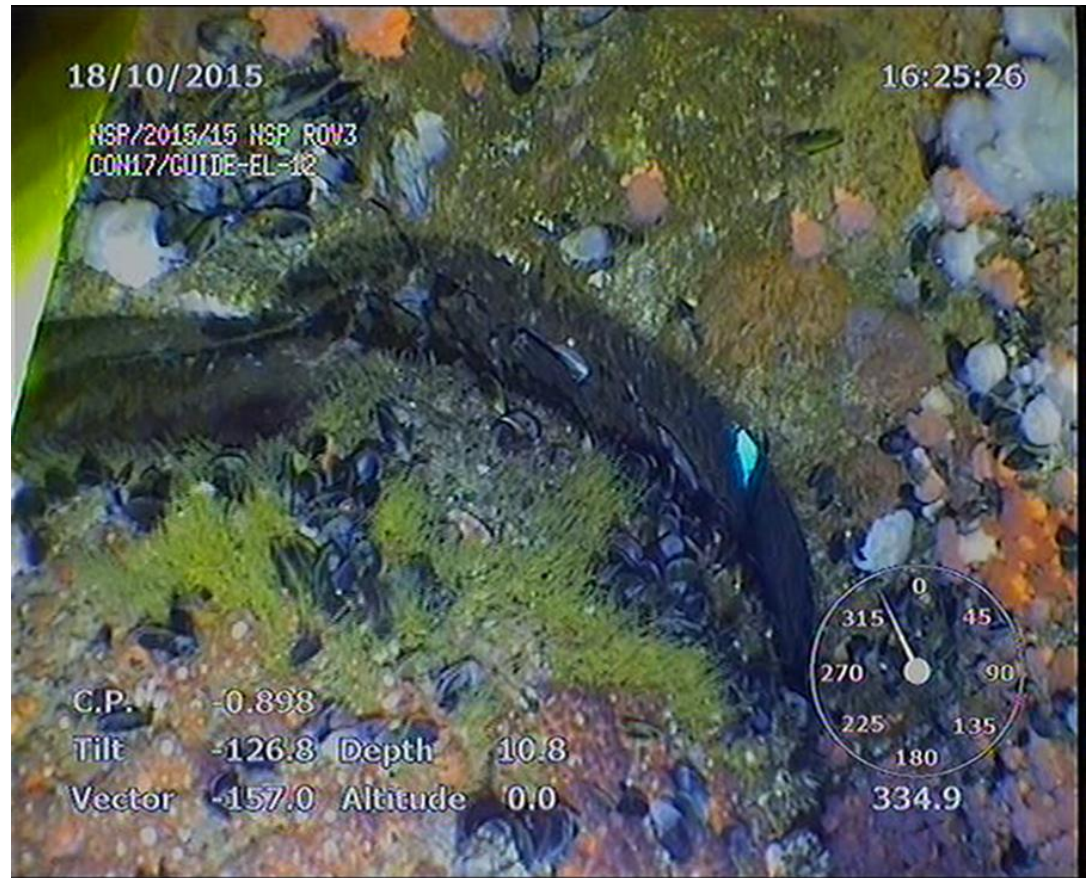
Guide Damage

Broken guide down stand

Through wall defect running circumferentially between the 4o/c to the 6o/c position.

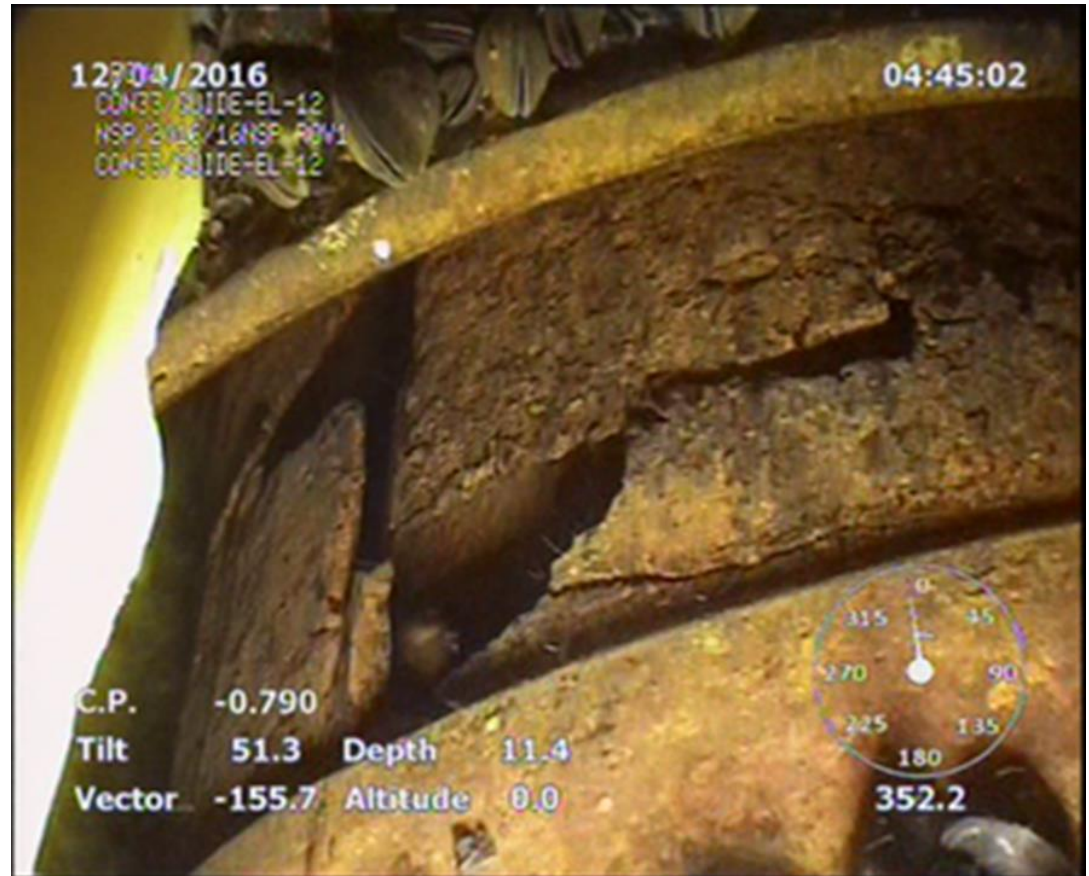
Fretting & Random Cracking

Significant crack positioned on the 11o/c position.

The defect has a Z-shaped appearance with the surface casing clearly visible beneath.

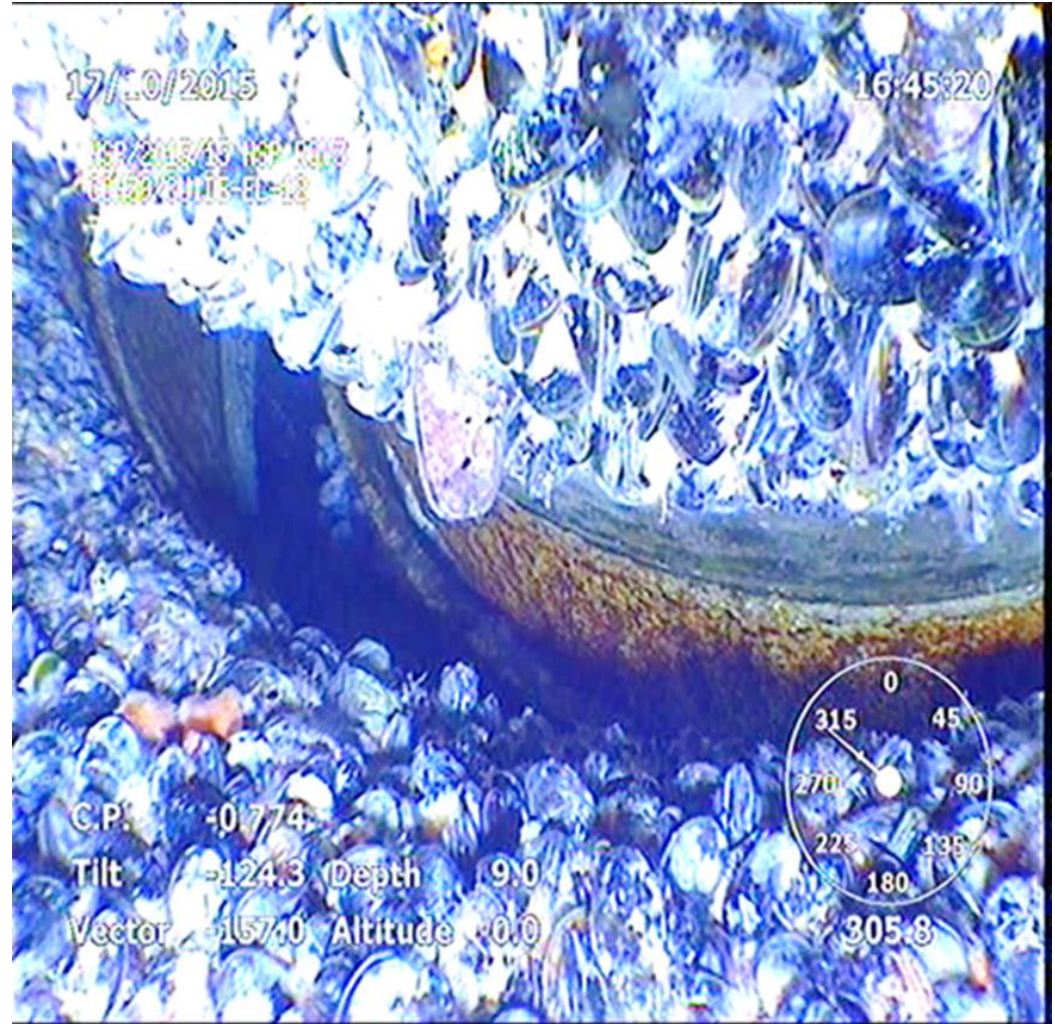
Circumferential Cracking

Circumferential crack on 30" conductor body.

Differential movement between crack halves indicating severance.

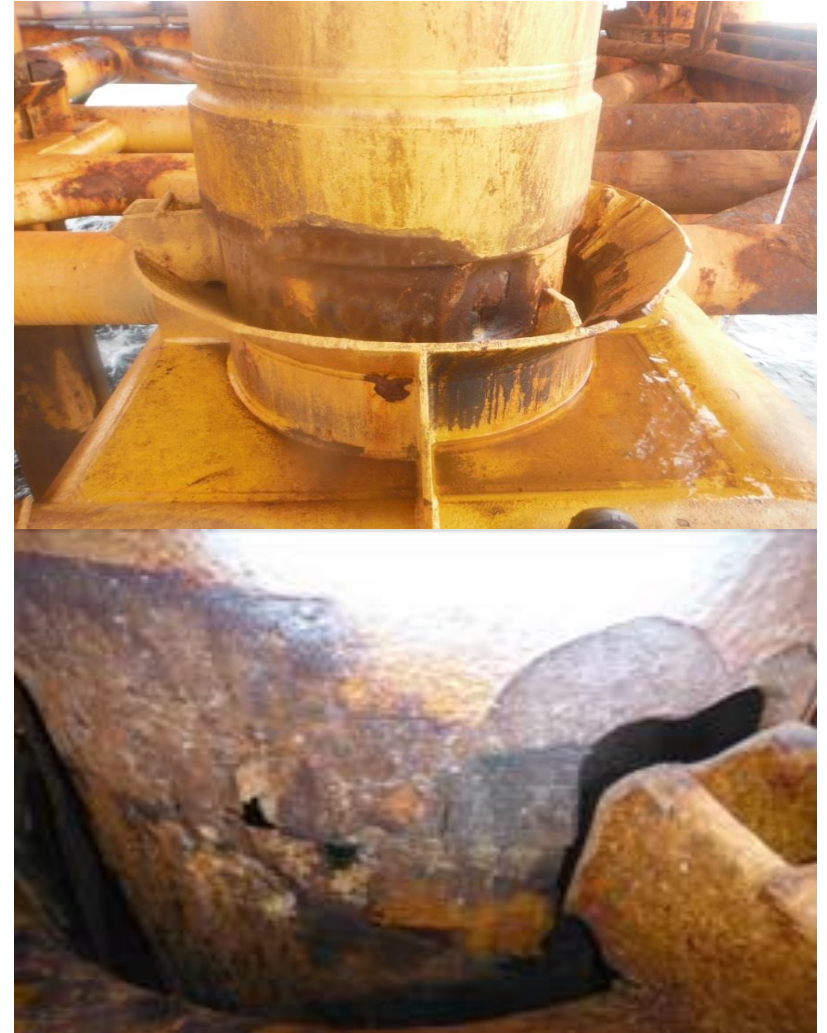
Air Gap Fretting & Puncture

Poor chock design, poor inspection and poor maintenance regime.

Leading to:
Guide damage

Chock damage and subsequent
conductor puncture.

Conductor fretting within guide.

Reduction in movement between
conductor and chock prevented cracking
but engendered punctures.

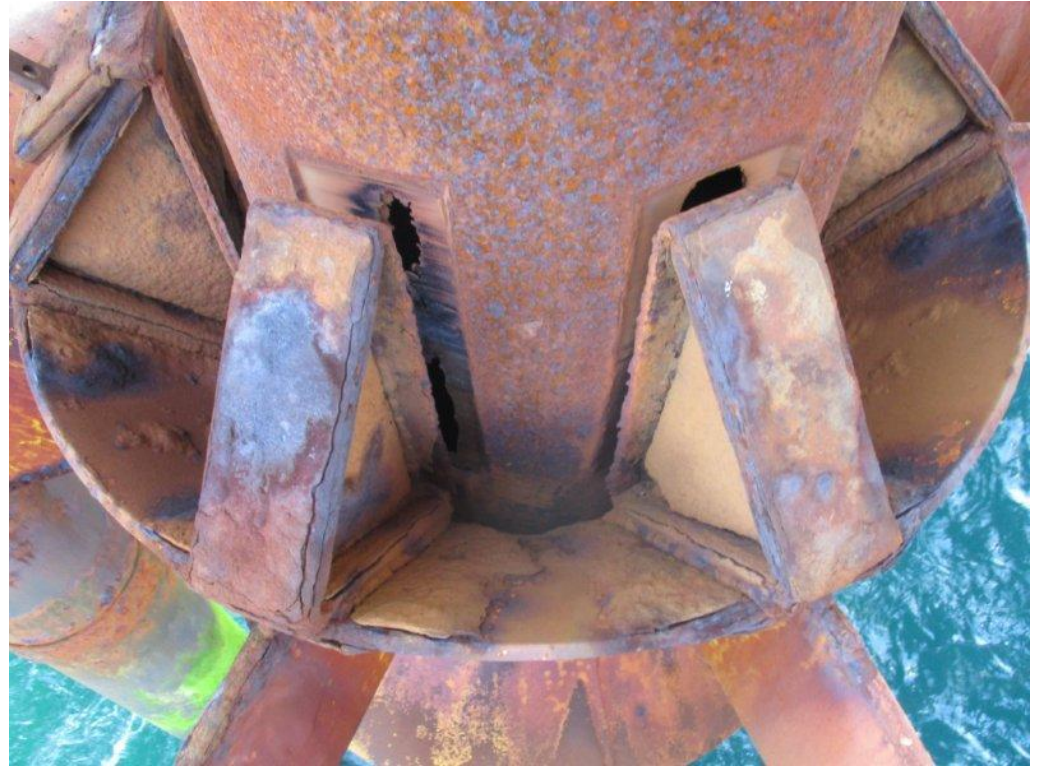
Air Gap Fretting & Puncture

Chock fretting and subsequent conductor TWD

Better choke design but poor inspection and maintenance regime.

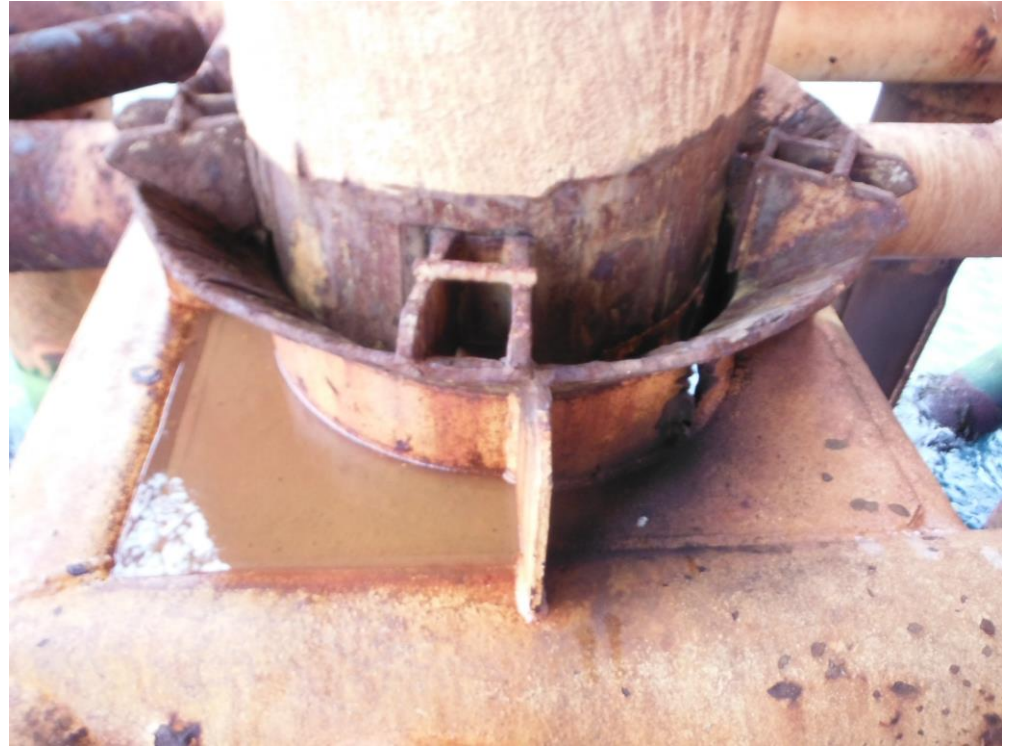
Air Gap Fretting & Puncture

Chock fretting and subsequent conductor TWD.

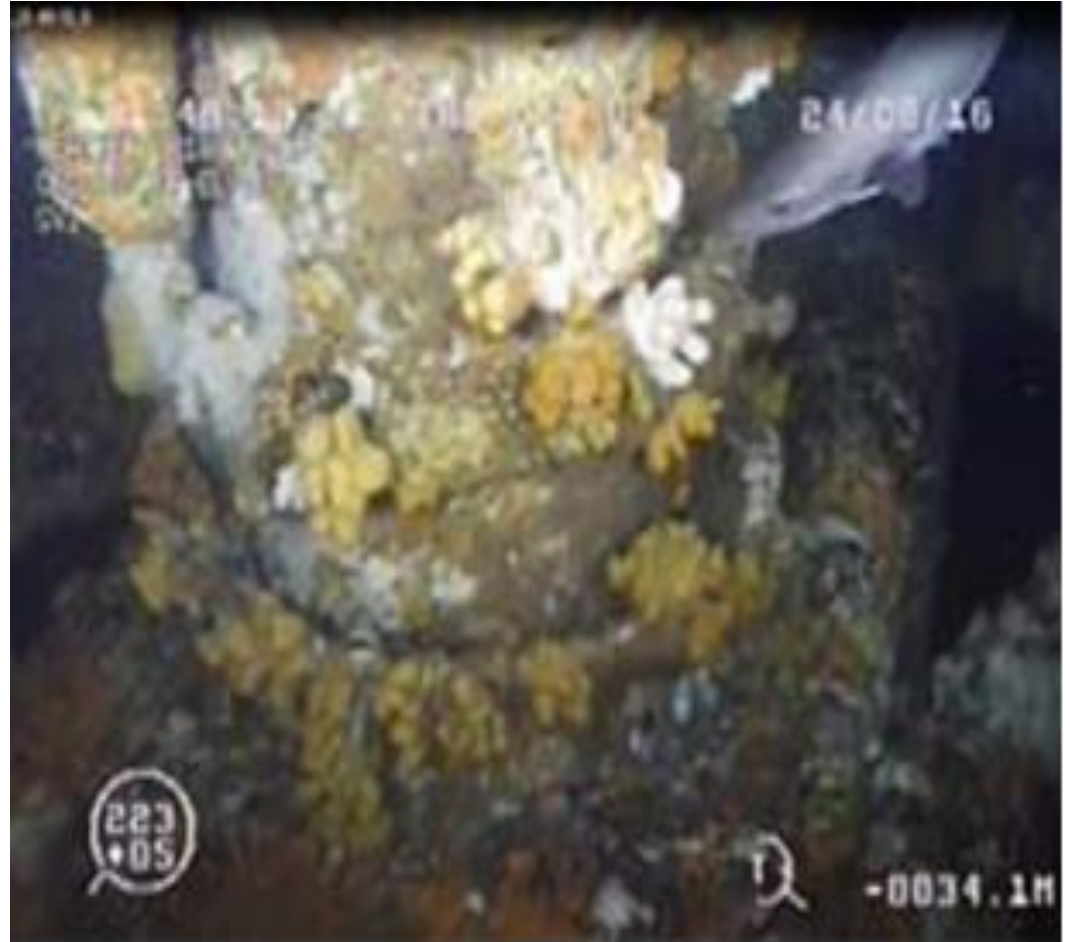
Subsea Inspection - Illustration

Generally conductor inspection is undertaken by ROV.

The upper elevations most susceptible to damage.

Other issues are poor inspection quality, poor anomaly appreciation, no MG cleaning.

Image illustrates typical video quality

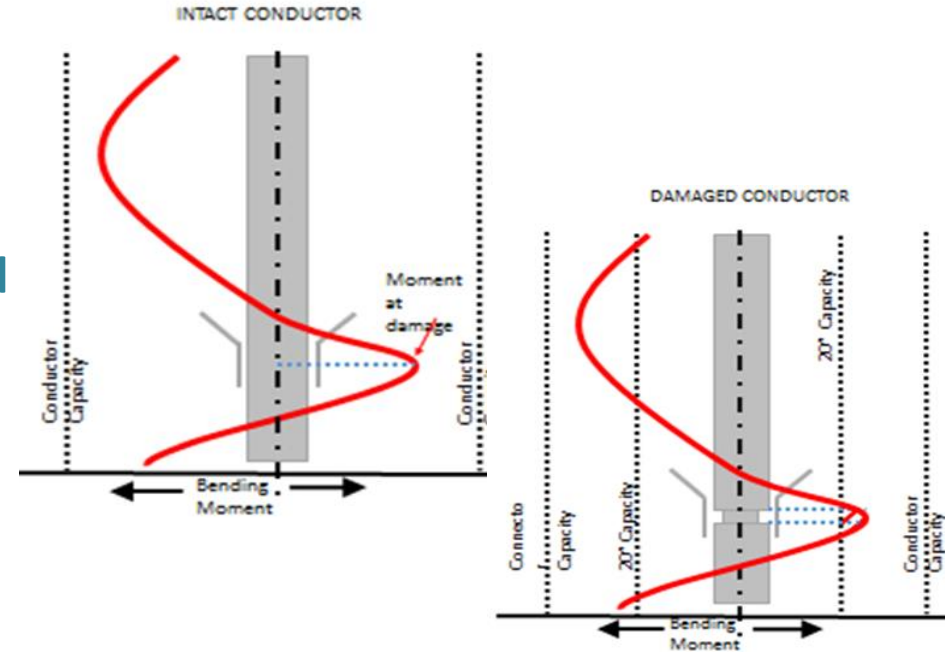
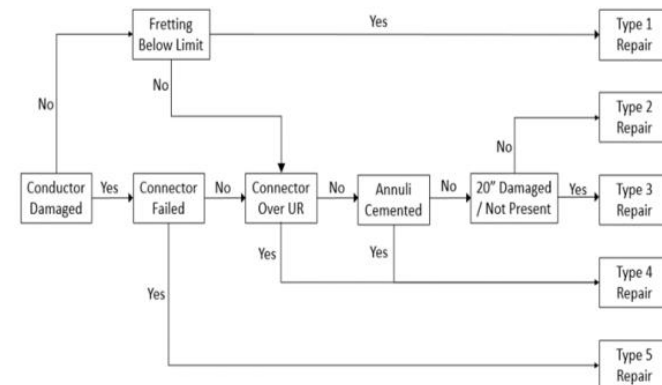
5. REPAIR ANALYSIS

- Understand current condition & determine implications of damage.
- Build model across all conductors based on current condition and loadings.
- Further analysis required for legacy components.
- Analyse for trends and defect mechanisms.
- Consideration of unique defect situations: separation at guide & connector above.

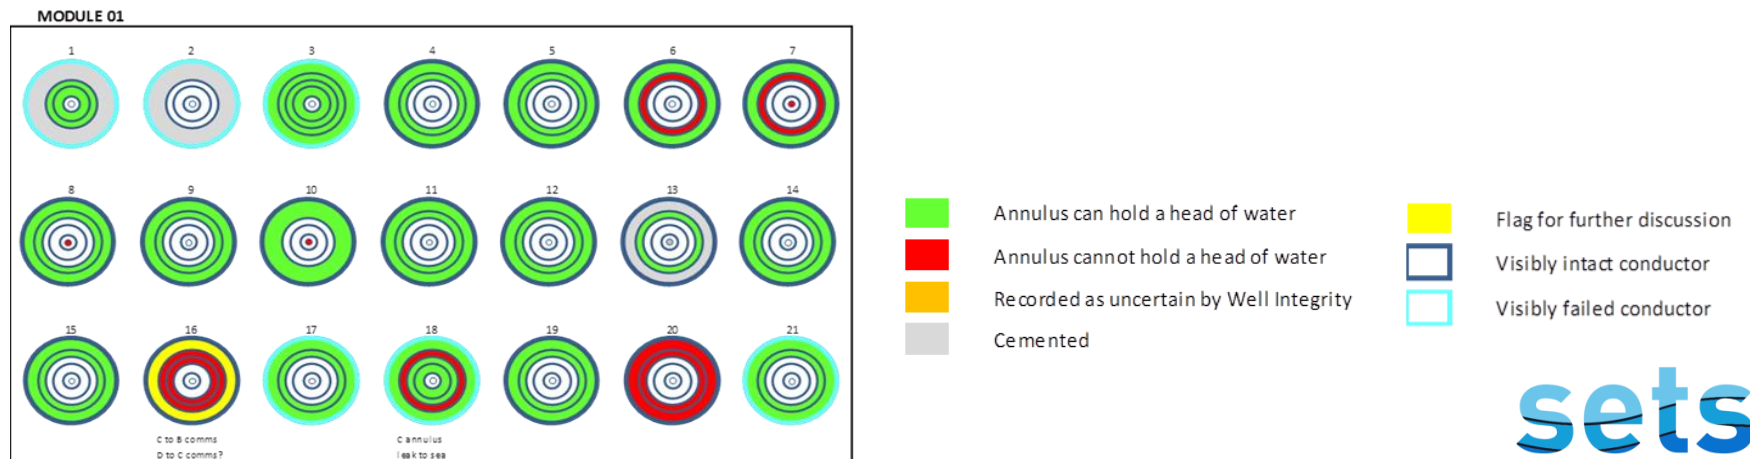
Analysis

- Over laid conductor inspection results with well integrity data with structural analysis to build overview of integrity.
- Line-up integrity overview with well economics to inform repair strategy.
- Conductors can support a single item of damage, either connector or fretting damage.
- Double failure – conductor unstable – mechanism.

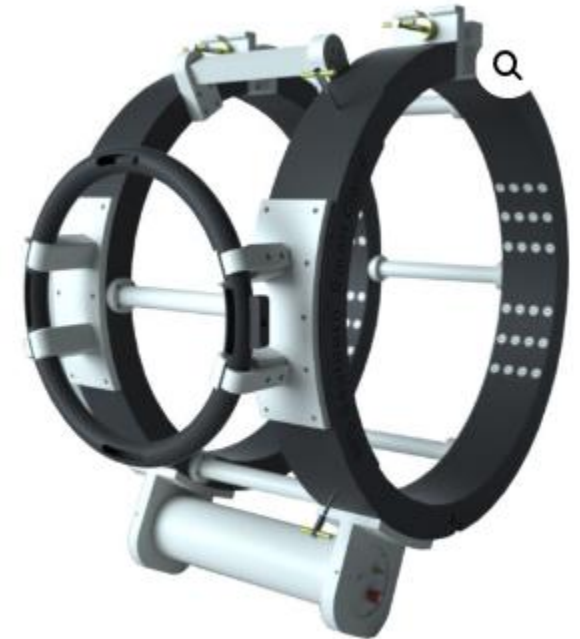
Mitigation - Monitoring

- Integrated strain, acceleration, pressure and temperature monitoring sensors to generate real-time fatigue/load/movement data.
- Structural Monitoring System, providing real-time movement/fatigue analysis of difficult to access assets.
- Installed to create a wireless network, transmitting to the topside receiver.

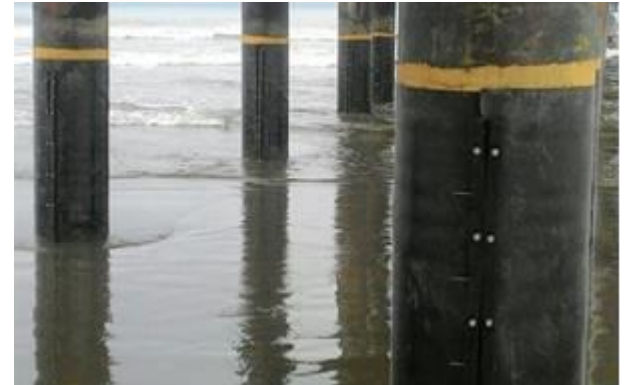
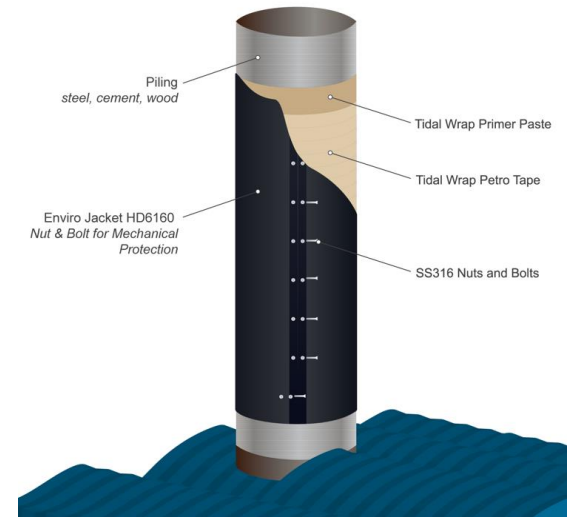
Mitigation – Wrapping/Cladding

- A means of excluding seawater from conductor surface to mitigate corrosion.
- Monel – not retro fit but effective.
- Painting – underwater paints.
- Wrapping – well understood topside more challenging across splash zone.
- All options present challenging application across splash zone and subsea.
