Conductor Integrity

Hidden Risks and Mitigations

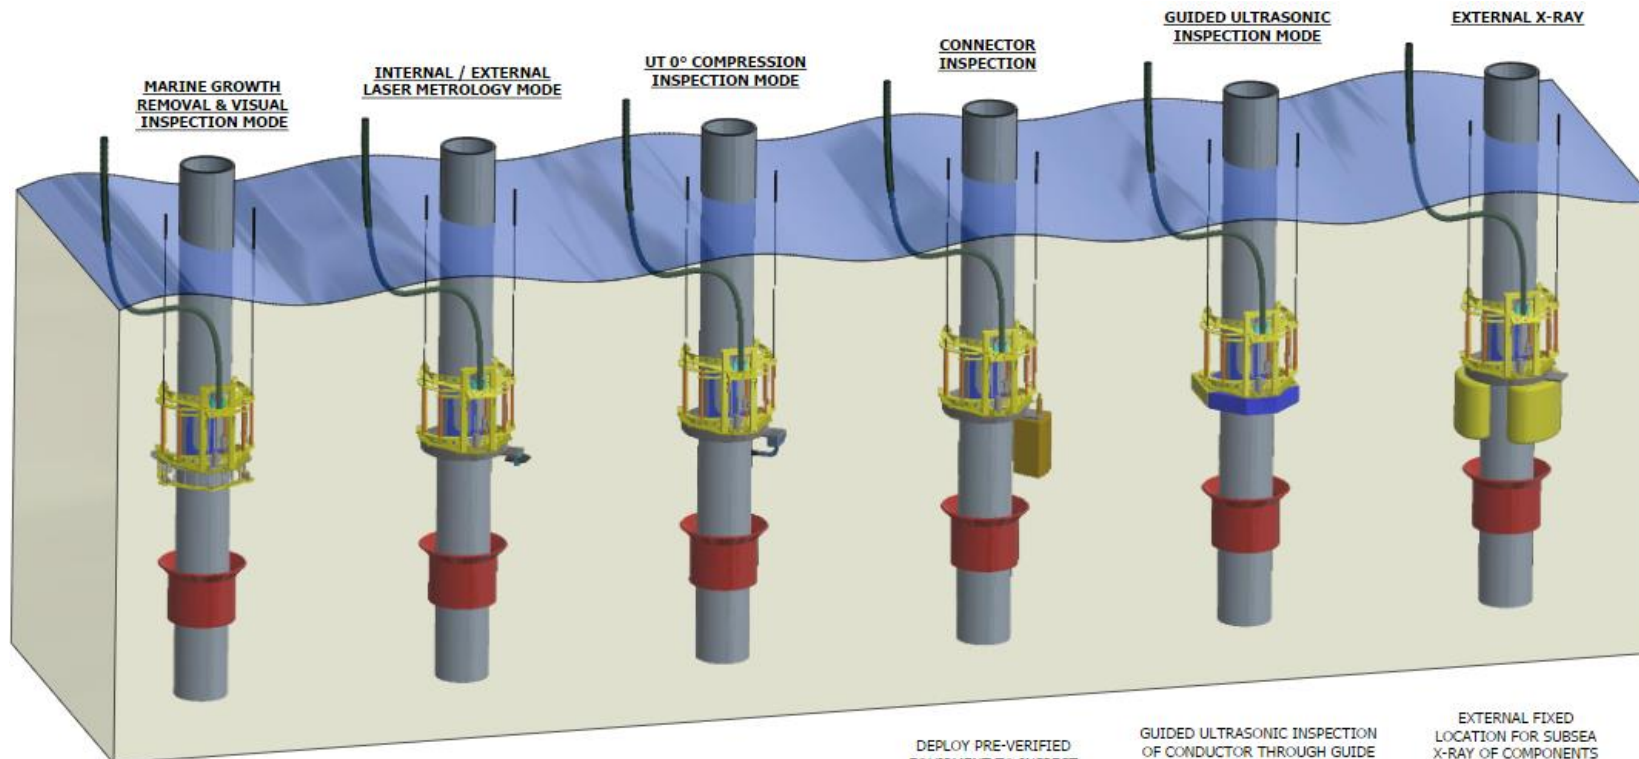
Mitigation - Inspection

MARINE GROWTH REMOVAL & VISUAL INSPECTION OF CONDUCTOR SURFACE DOWN TO GUIDE, VIEW INTO ANNULAR GAP

DEPLOY PRE-VERIFIED EQUIPMENT TO INSPECT CONNECTORS EXTERNALLY FOR EARLY SIGN OF DEFECTS
