# Maintenance and Repair Solutions for Damaged or Aged PFP

Chris Fyfe & Dave Wickham, AkzoNobel  
Institute of Corrosion, Aberdeen, 30/05/2023

# Passive Fire Protection Maintenance & Repair Manual

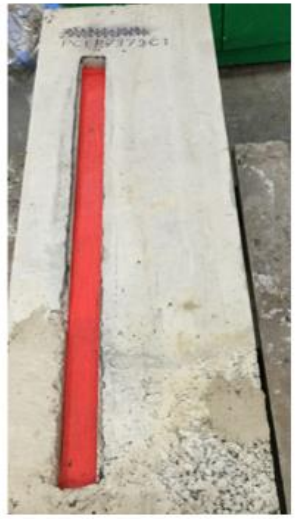
<p>Finished Interkote MP crack repair</p>	<p>Repair does not cover prevention of dropped object hazard. Refer to Item F</p> <p>Where mechanical surface preparation is not possible corrosion protection can be provided by inserting a vapour deposition corrosion inhibitor pellet before installation of Interkote MP.</p>

Repair System	Installation	Photos / Drawings	Limitations / Notes
Interkote MP	<p>a) Remove any adjacent loose or disbonded material back to sound fully adhered material.</p> <p>b) Prepare surface to receive Interkote MP according to section 3.2 above. The edges of the concrete/cementitious to which Interkote MP will bond to should be checked for any surface contamination - wire brushing may be required to remove more stubborn contaminants.</p> <p>c) Prime surface with approved surface tolerant primer per section 4 above. Interseal 670HS is the preferred primer</p> <p>d) Once the primer has cured apply Interkote MP in accordance with technical data sheet. Application by hand wearing suitable gloves should ensure the material is firmly pressed onto the surface and onto the concrete/cementitious edges. The required depth is achieved in 1 application only.</p>

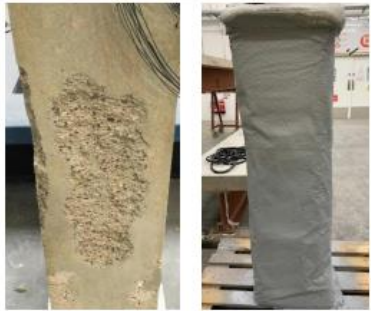
<p>Damaged &amp; loose concrete @ L, wrapped section, GRP &amp; Chartek 7E @ R</p>	Refer to the GRP manufacturers manual for application instructions

Item F	EXISTING PFP / SUBSTRATE	DEFECT / ANOMALY TYPE	
	Dense concrete or cementitious PFP / carbon steel	Dropped Object Hazard	
Repair System	Installation	Photos / Drawings	Limitations / Notes
Chartek 7E & GRP Overwrap	<p>a) Damaged/loose concrete/cementitious should be left in place.</p> <p>b) Cut the GRP material so that there is a minimum 50mm overlap around the perimeter of the section being wrapped</p> <p>c) The GRP should be pulled tight around the damaged PFP and then left to cure. Cure time is dependent on good light levels which should be between 1-2 hours. Any top protective layer should be removed to leave a matt surface finish</p> <p>d) Once the GRP is fully cured, apply Chartek 7E at minimum 2mm directly to the matt surface of the GRP. No primer is required</p>

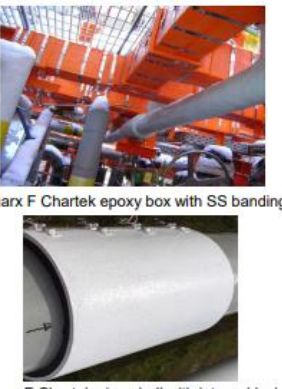
<p>Benarx F Chartek epoxy box with SS banding</p> <p>Benarx F Chartek pipe shell with integral locks</p>	Installation of Benarx solutions will require accurate measurements to ensure correct fit

Benarx Boxes & Pipe Shells	<p>a) Damaged/loose concrete/cementitious should be left in place.</p> <p>b) The Benarx box/pipe shell can be fitted around the loose PFP and held in place using integral toggle &amp; latch fasteners or stainless steel bands</p>

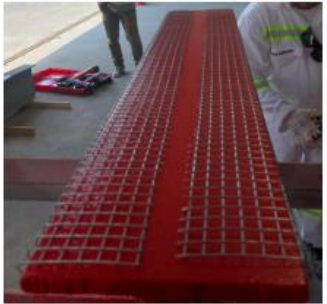
<p>Application of Charloks over flange outstands</p>	See TN/F/CT/357_Rev0 & TN/F/CT/547_Rev0
Chartek 7	<p>a) Visual inspection of system topcoat should reveal no breakdown of existing topcoat</p> <p>b) The topcoat surface should be lightly manually abraded</p> <p>c) Full 100% pinned metal mesh coverage is required for I sections, for hollow sections wire mesh should be wrapped around and tied with lacing wire</p> <p>d) Apply Chartek 7 with HK1 mesh (as required by certification) to the required dft</p> <p>e) Any coating breakdown exposing the substrate that exceeds 0.5% (Ri2) will require surface preparation &amp; priming in accordance with sections 3.2 &amp; 4.1 above</p>

Item H	EXISTING PFP / SUBSTRATE	DEFECT / ANOMALY TYPE	
	None / carbon steel	Omission/Upgrading of PFP	
Repair System	Installation	Photos / Drawings	Limitations / Notes
Chartek 2218	<p>a) Visual inspection of system topcoat should reveal no breakdown of existing topcoat</p> <p>b) The topcoat surface should be lightly manually abraded</p> <p>c) For application over I sections, Charloks should be placed over the flanges, for hollow sections wire mesh should be wrapped around and tied with lacing wire</p> <p>d) Apply Chartek 2218 with HK1 or HK2 mesh (as required by certification) to the required dft</p> <p>e) Any coating breakdown exposing the substrate that exceeds 0.5% (Ri2) will require surface preparation &amp; priming in accordance with sections 3.2 &amp; 4.1 above</p>

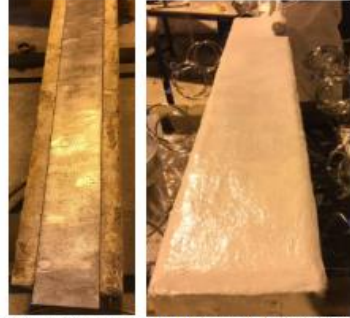
<p>Surface before priming (SP11) @ L, with Charetk 2218 at 8mm</p>	<p>Dft and use of HK2 mesh will depend on the required fire resistance duration.</p> <p>See TN/F/CT/524_Rev1 &amp; TN/F/CT/556_Rev0</p>
Interkote SFR	<p>a) Steel surface to be prepared to minimum SP11.</p> <p>b) Prime the exposed steel surface with approved Interkote primer. Intercrete 4840 is the preferred primer</p> <p>c) Apply Interkote SFR to a thickness 30mm minimum. No reinforcing mesh is required</p> <p>d) A suitable topcoat is required to protect the Interkote from environmental conditions exceeding C3</p>

Item G	EXISTING PFP / SUBSTRATE	DEFECT / ANOMALY TYPE	
	Dense concrete, cementitious or EPFP / carbon steel	Beams with no PFP on top flange	
Repair System	Installation	Photos / Drawings	Limitations / Notes
Chartek 2218	<p>a) Steel surface to be prepared to minimum SP11.</p> <p>b) Prime the exposed steel surface with approved surface tolerant primer. Interseal 670HS is the preferred primer</p> <p>c) Apply Chartek 2218 at minimum 6mm. The Chartek should overlap the exposed concrete edges either side of the beam. Apply topcoat if required</p>

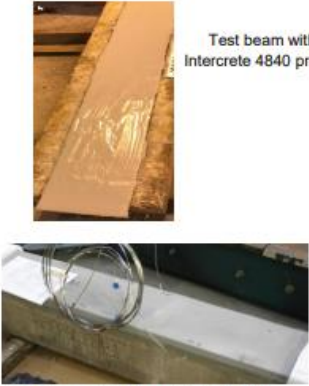
<p>Test beam with Intercrete 4840 primer</p> <p>Test beam with 30mm Interkote SFR</p>	<p>Not suitable for exposures greater than C3 without an approved topcoat</p> <p>See TN/F/CT/524_Rev1</p>

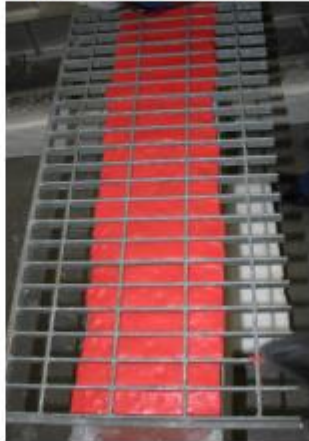
<p>Grated beam with Interkote MP</p>	<p>Interkote MP is supplied in a 30mm thick roll and to suit the flange width.</p> <p>Interkote MP applied to the top flange of beams is not suitable for foot traffic unless a walkway grating is applied over the putty or used in areas like pipe racks</p>

Item G	EXISTING PFP / SUBSTRATE	DEFECT / ANOMALY TYPE	
	Dense concrete, cementitious or EPFP / carbon steel	Beams with no PFP on top flange	
Repair System	Installation	Photos / Drawings	Limitations / Notes
Interkote MP	<p>a) Steel surface to be prepared to minimum SP11.</p> <p>b) Prime the exposed steel surface with surface tolerant primer. Interseal 670HS is the preferred primer</p> <p>c) Roll the Interkote MP over the exposed flange. End lengths should be butted tightly together (the material will adhere tightly when ends are pushed together).</p>

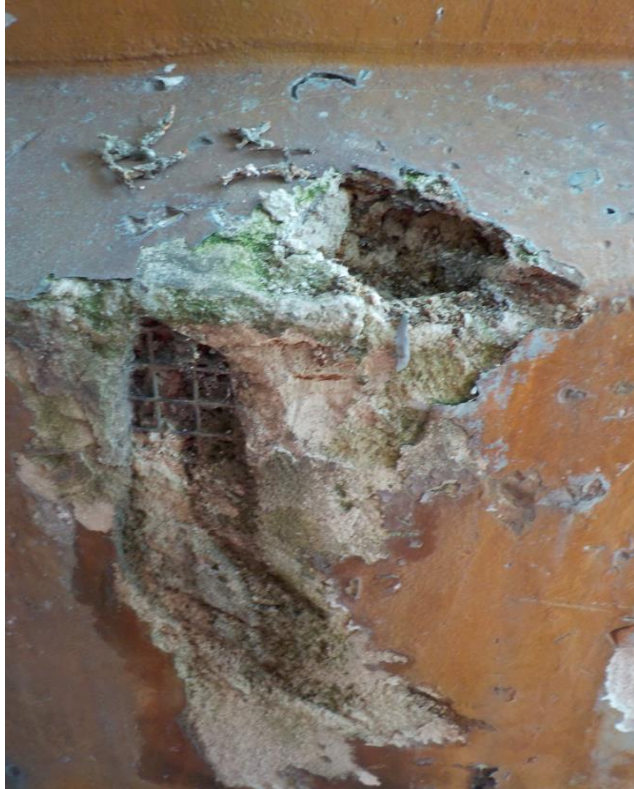
Failed LWC on vessel skirt

Interkote SFR repairs to failed LWC – Site in Belgium

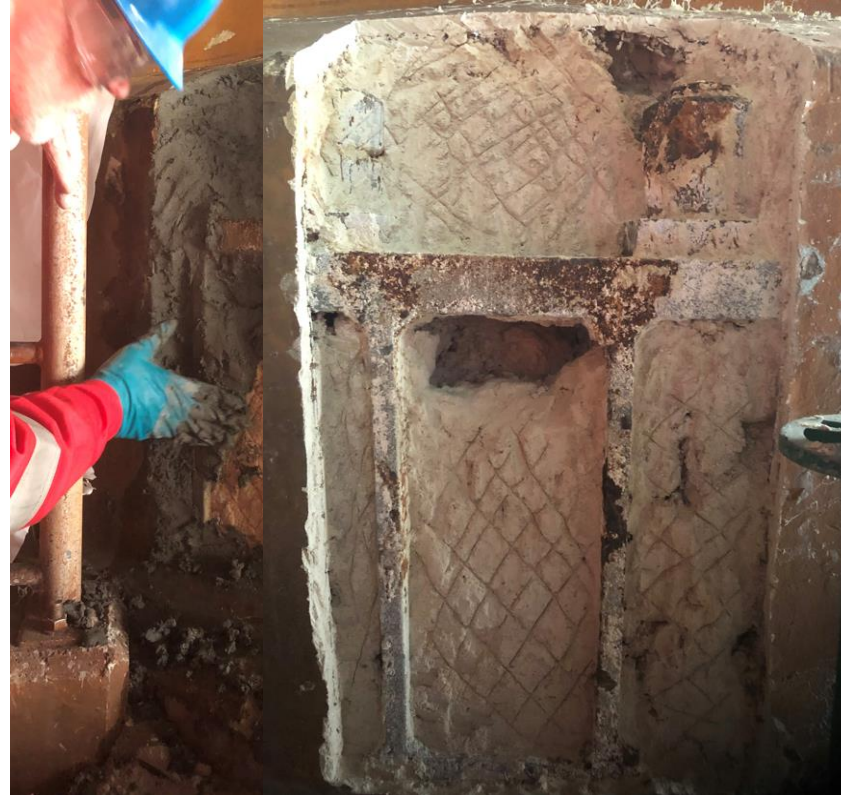
Simple hand application of Interkote SFR

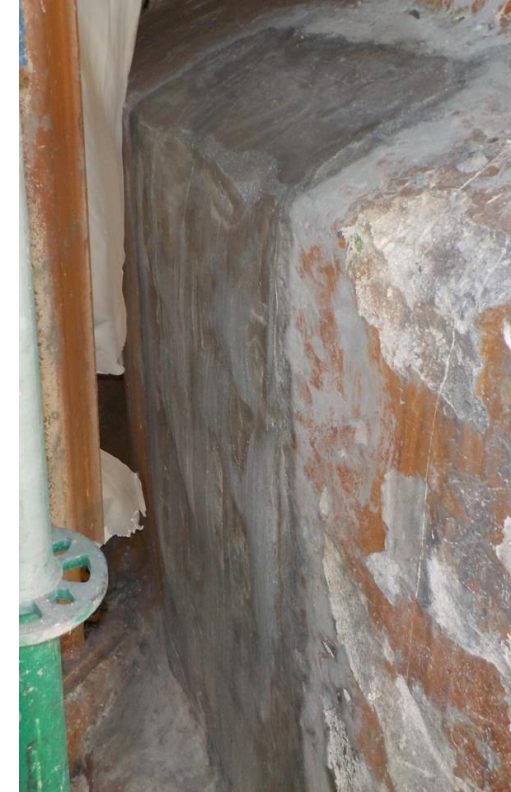
Interkote SFR finished repair

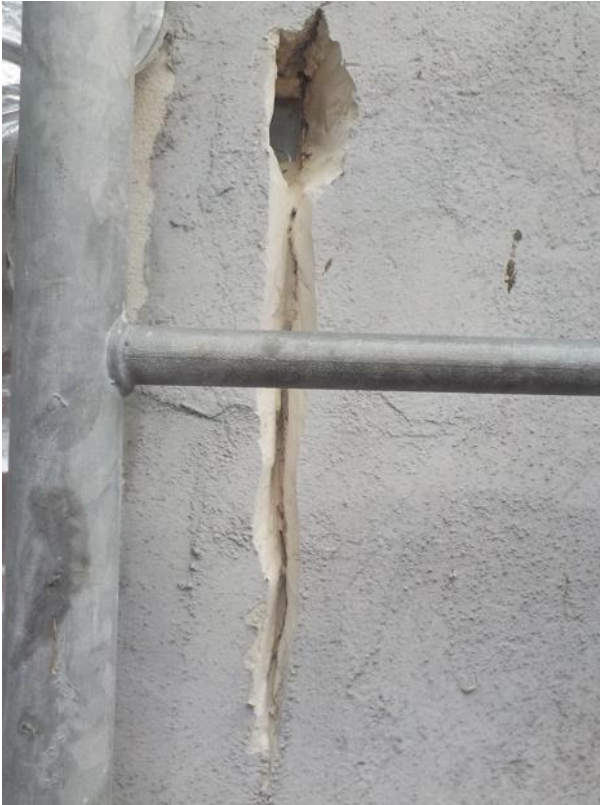
Prepared crack in LWC on vessel skirt

Interkote MP repairs to cracked LWC – site in Belgium

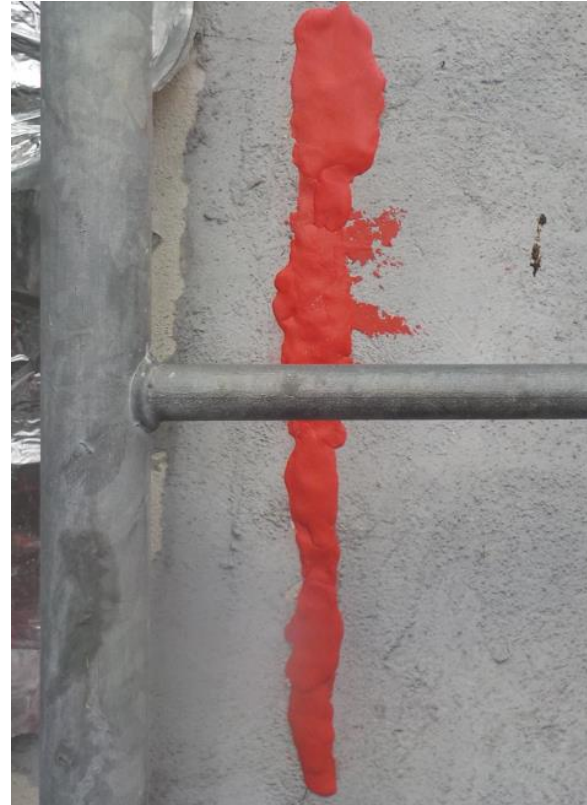
Finished IK MP repair

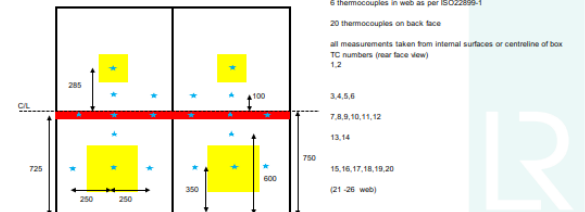
The following is in relation to a jetfire test conducted on a structural steel jet fire box, one half of which was coated in nominally 50mm concrete, the other half (including the central web) in nominally 28mm of Pyrocrete 241. Three uncoated areas on each side of the rear face of the box were filled with Interkote MP repair material, to simulate repairs to damaged/missing fire protection. The three defect areas on each side measured 170x170mm, 740x50mm and 300x300mm. The repair material was filled to the same thickness as the surrounding PFP material. The specimen was prepared by International Paint Ltd to assess the jetfire resistance of the repair material. The test was conducted by DNV GL personnel at Spadeadam test site, with the jetfire test generally conforming to the requirements of ISO 22899-1. The thermocouple arrangement on the rear face was modified to accommodate extra data from the defect areas, as per attached diagram. A total of 20 type K thermocouples were fitted to the rear face of the box. The six thermocouples fitted into the web were as per ISO22899-1.

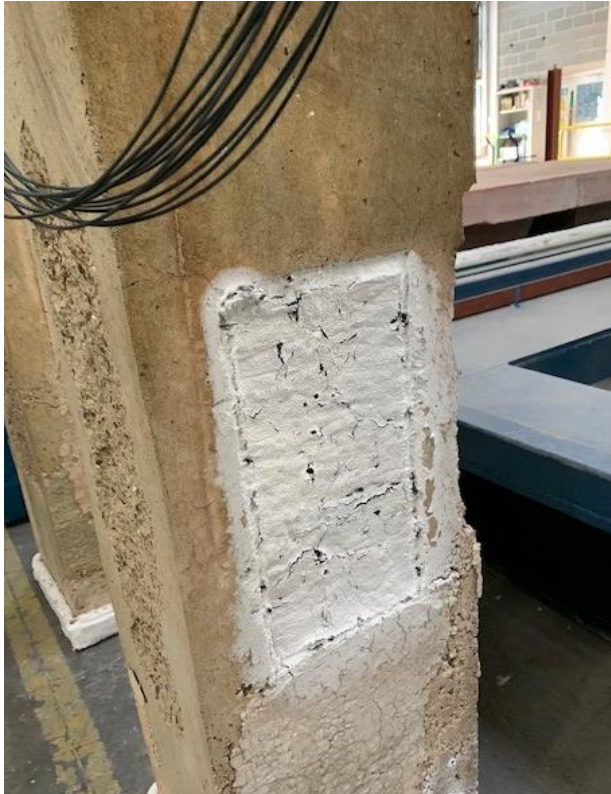
Interkote MP@25mm  
Concrete repair

Concrete / LWC repair solutions – Interkote SFR & Interkote MP

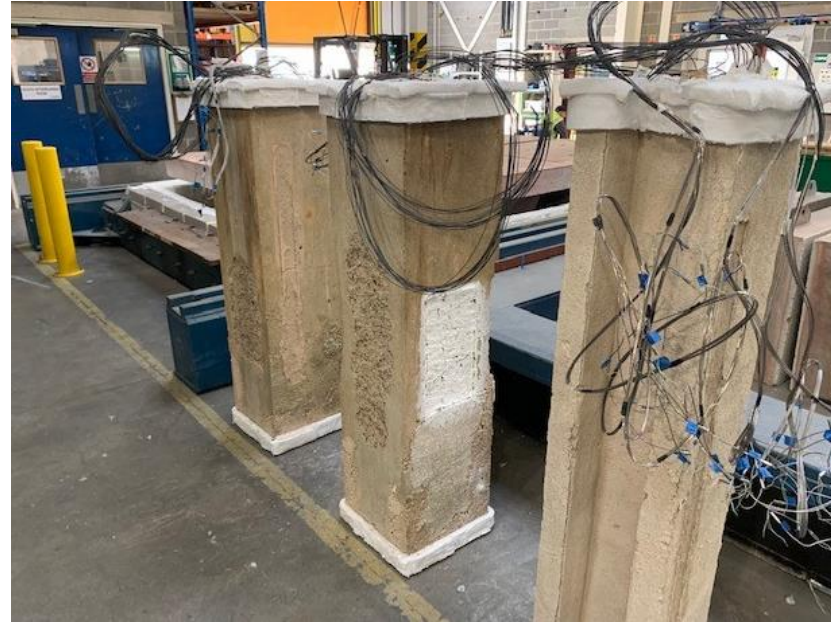
Concrete / LWC Columns  
post test

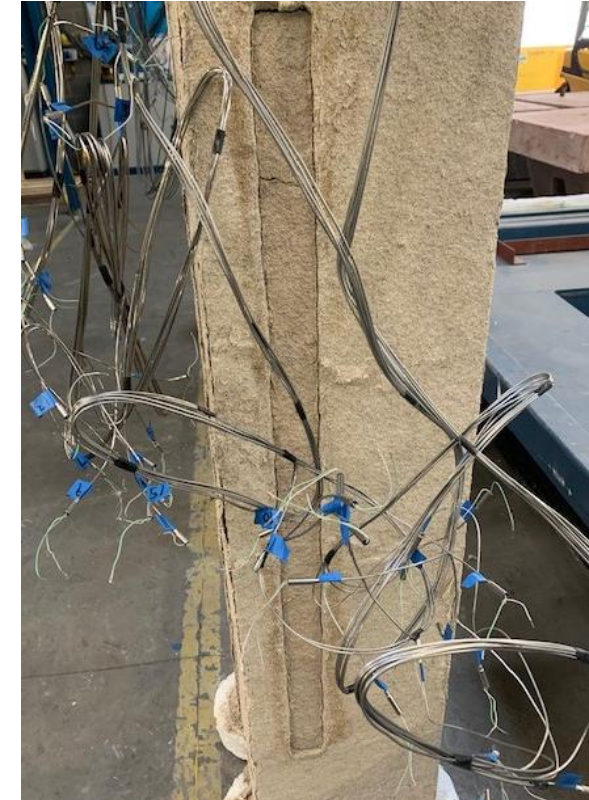
Interkote SFR@28mm  
LWC repair

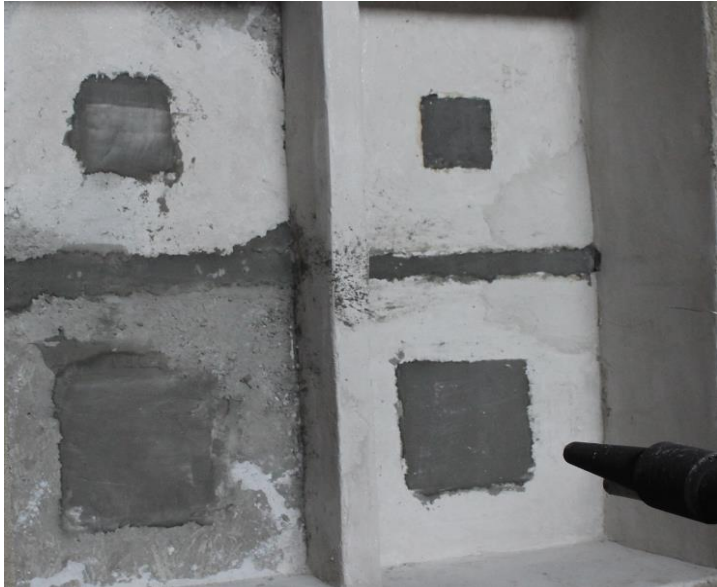
Interkote SFR @50/28mm  
Concrete/LWC repair – jet fire  
box

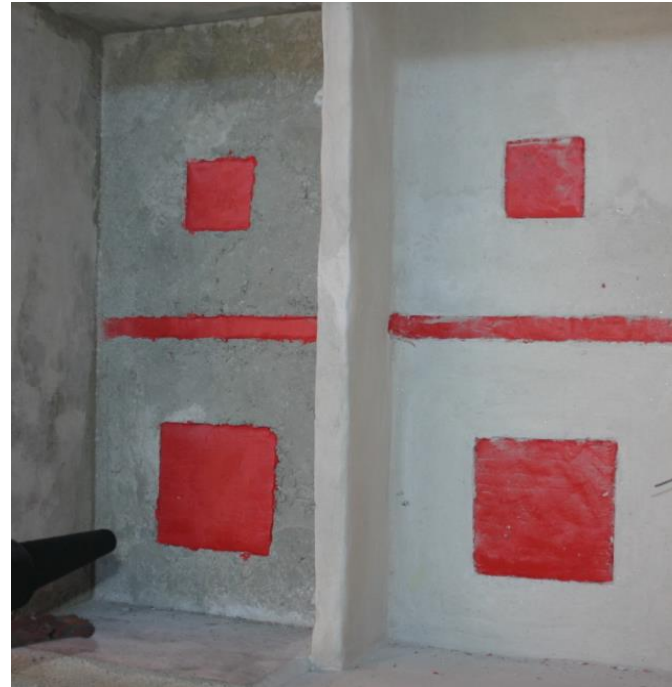
Interkote MP @50/28mm  
Concrete/LWC repair – jet  
fire box

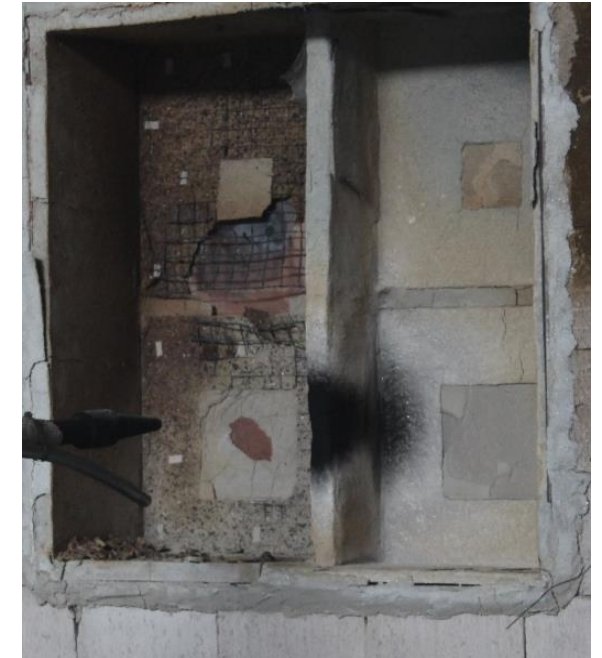
Interkote SFR – post jet fire

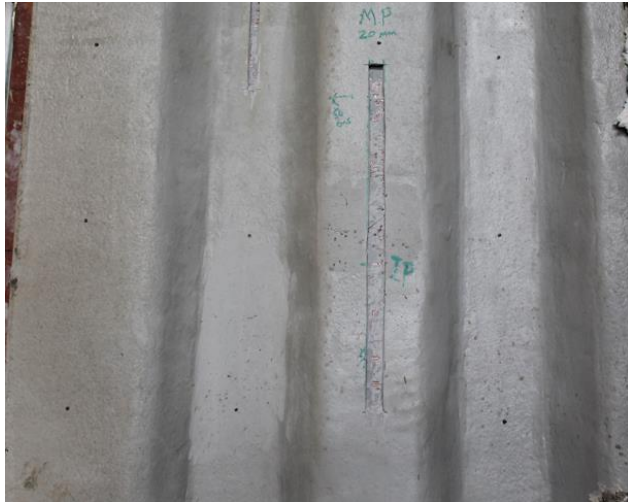
20mm wide 'crack' to steel surface

3x3m corrugated blastwall

Interkote MP@10mm, EPFP repair – 10 and 20mm cracks (steel temp @ 3hrs: no defects = 196C at 3hrs, under IK MP 204C & 220C)

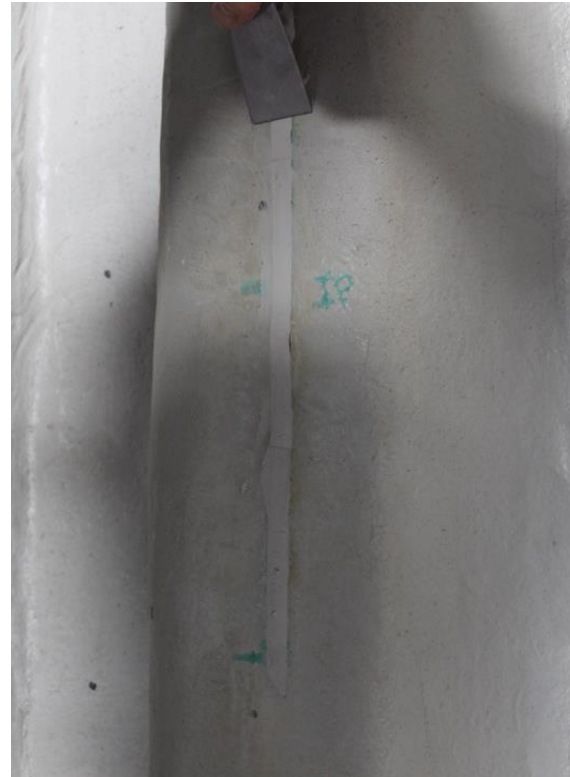
10mm IK MP flush with Chartek

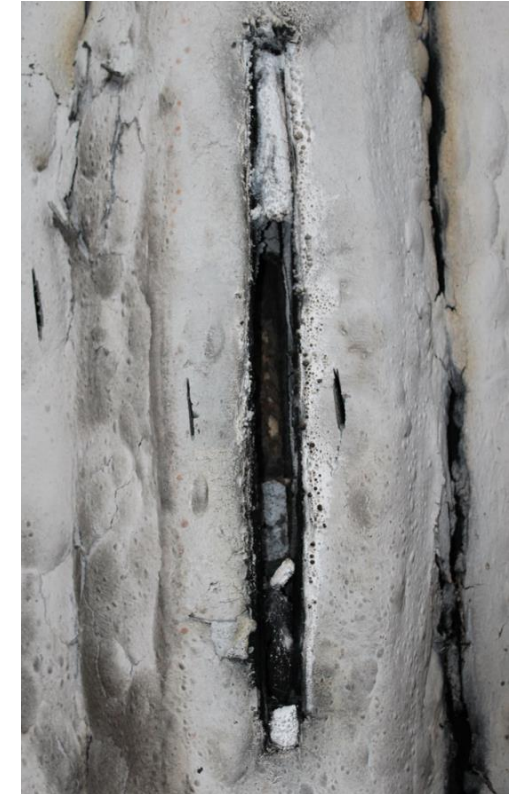
Post-burn examination

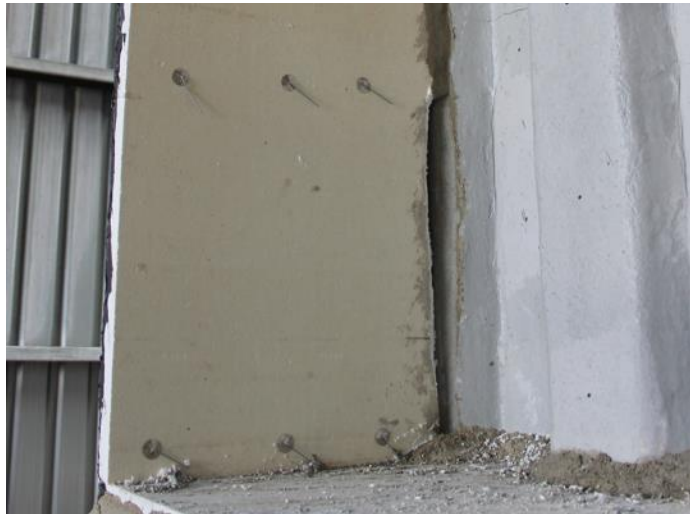
60mm perimeter gap

3x3m corrugated blastwall

Interkote MP @ 25-50mm, Sealer – gap widths up to 60mm (no temp measurements, integrity evaluation only)

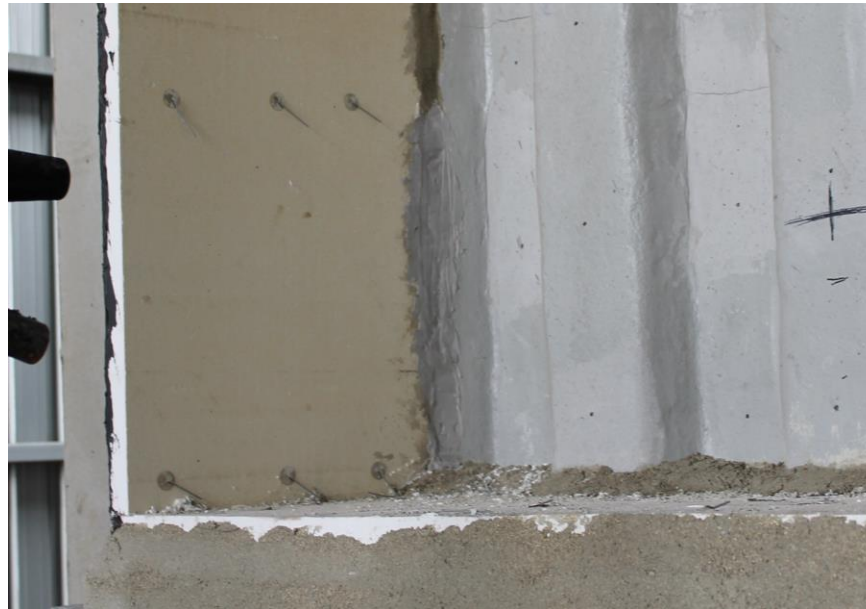
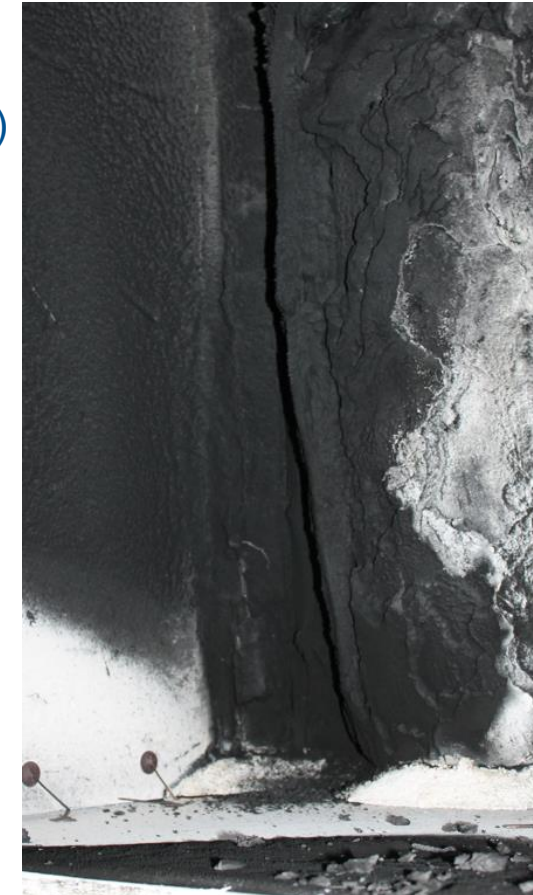
Post test – no integrity failure

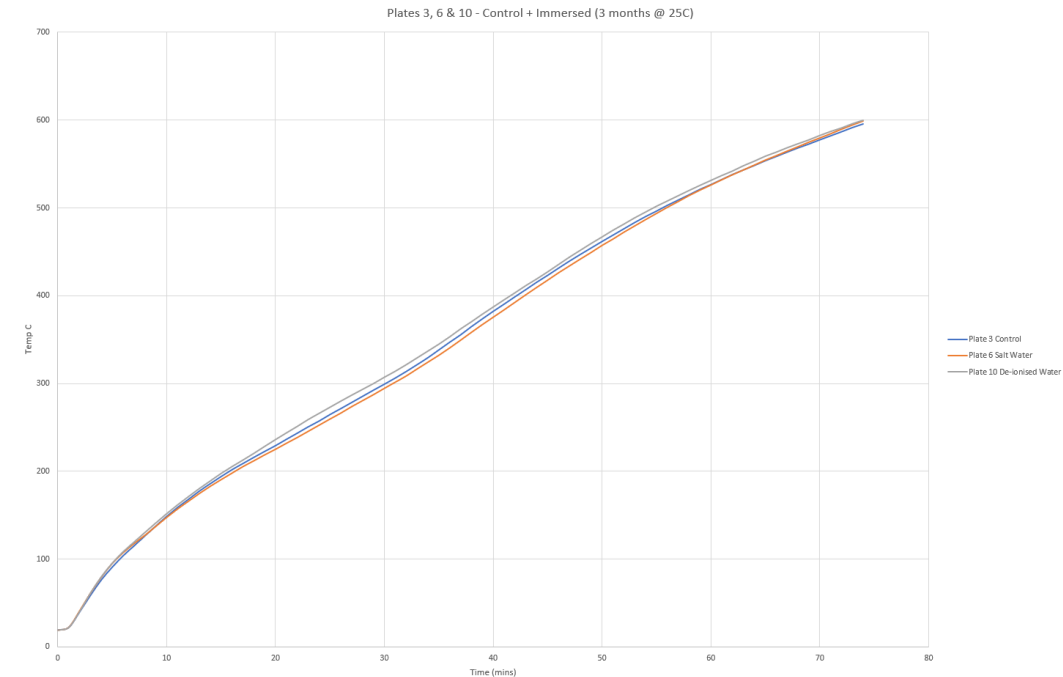
Graph comparing fire test results of immersed plates compared to control

**Interkote MP** tested under immersion conditions, 3 months in salt water (5% solution @25C) & de-ionised water (@25C) – no loss of fire performance against a control, zero water uptake
