Why Paint When You Can Patch?

Erik Broesder - Technology Director and Dinko Cudic – Business Line Director

Stopaq B.V.

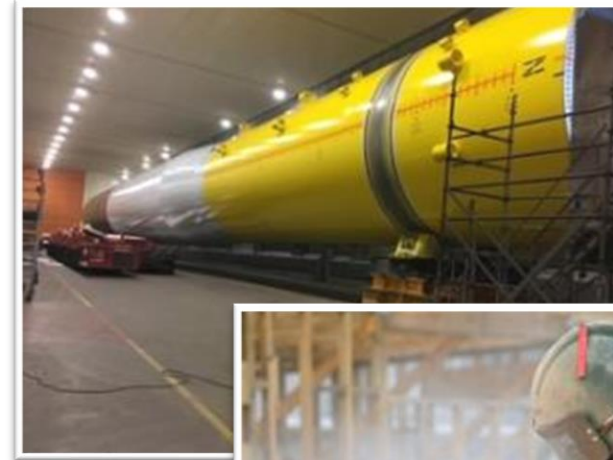
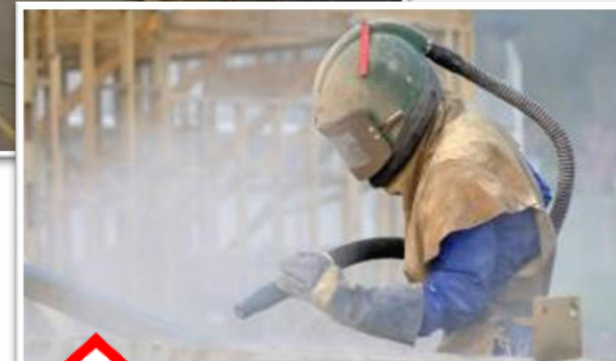
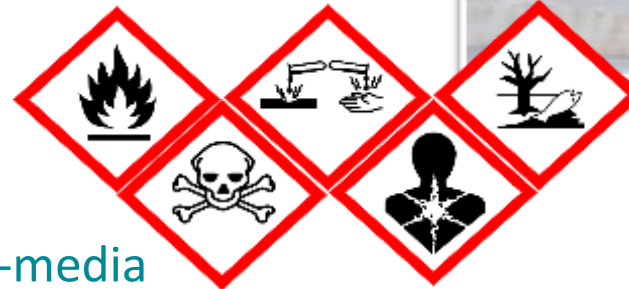
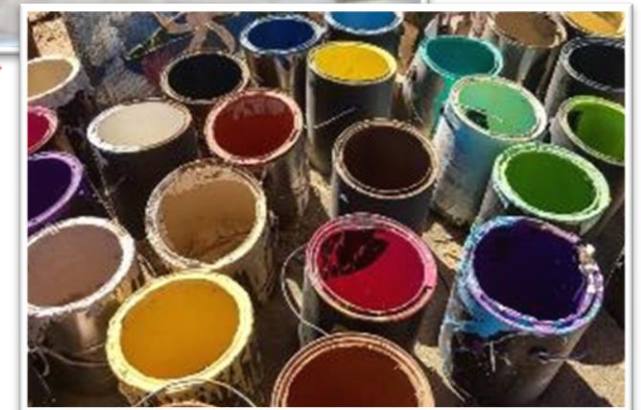
Offshore windfarms – Coating in workshop / at yard

- Traditional multi-layer 2-component paint systems:
 - Require high degree of steel surface cleanliness
 - Require minimum roughness profile of steel – peak density
 - Spray application of coatings
 - Require close control of ambient conditions during application and curing
- This process also creates
 - Release of hazardous substances
 - Generate hazardous waste like blast-media and buckets with paint and cleaner remnants
 - Energy and increase in CO2 emissions

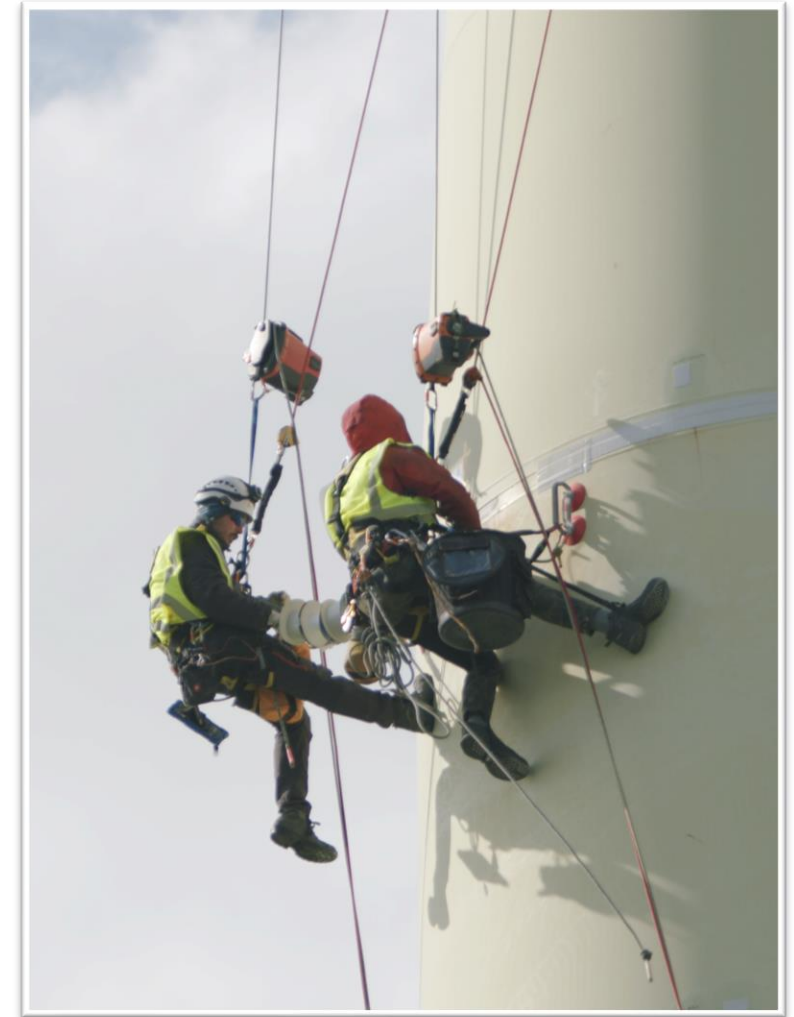
Offshore windfarms – Coating damages

- Factory-applied coating is prone to damages from hoisting, transport, installation, etc.
- Damage repair at site with same coating system is almost impossible:
 - Limited access, maintenance and repairs usually done by rope access
 - Surface preparation by blast cleaning:
 - Requires mobilization of equipment
 - Generates waste that must be collected
 - Control of application and curing conditions:
 - Exposure of steel surface to salt spray contamination is critical
 - Temperature and humidity control
 - Release of hazardous substances and paint spillage to environment must be avoided
 - Applicators have to return multiple times to same location (multi-coat systems require curing of each layer)

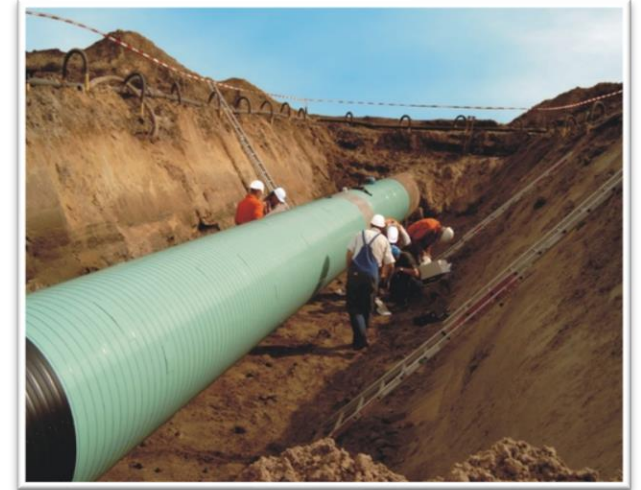
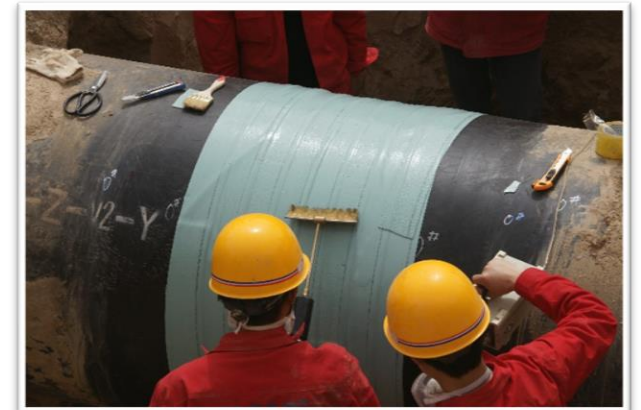
Development of repair coating – The idea

Coating based on pure homopolymer Polyisobutene (PIB)

- Successfully used for more than 2 decades in oil & gas industry as field joint coating, and as repair and rehabilitation coating
- Meets requirements of ISO 21809-3 coating type 13

- No sensitive chemical groups; Does not cure or harden; Harmless
- Liquid polyolefin with glass transition temperature – 65 °C
 - Cold flow properties; Absence of internal stresses
- Low permeability for water vapour and oxygen
- Adhesion based on vanderWaals forces
 - Surface preparation not critical for proper adhesion
 - Excellent adhesion to various substrates like blast-cleaned and wire-brushed steel, PE, PP, FBE, Neoprene, Liquid Epoxies, etc.

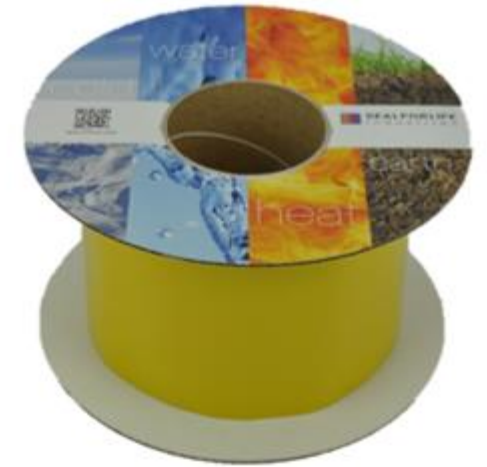
Development of repair coating – The product

Compound based on pure homopolymer Polyisobutene (PIB)

- Available in colours commonly used at wind farms (Yellow, Grey)
- Self-adhesive to many types of substrate

Hydrophobic transparent backing

- Repels water, dirt, marine growth
- High resistance to UV degradation

All layers in one in predefined thickness

- Primer and mid-coat: Compound
- Top-coat: Hydrophobic backing

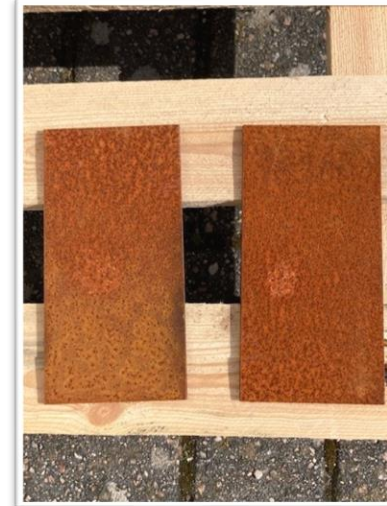
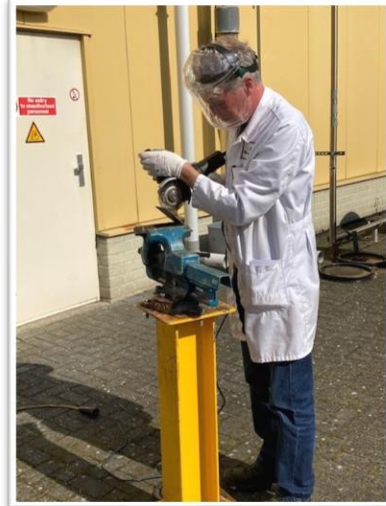
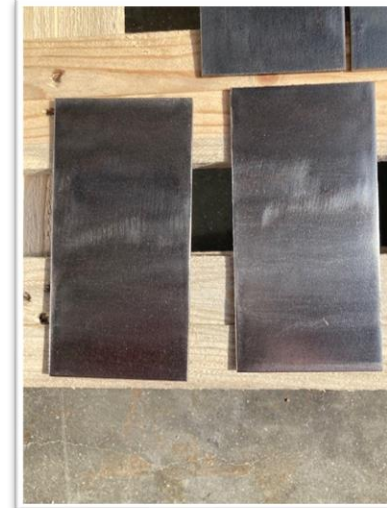
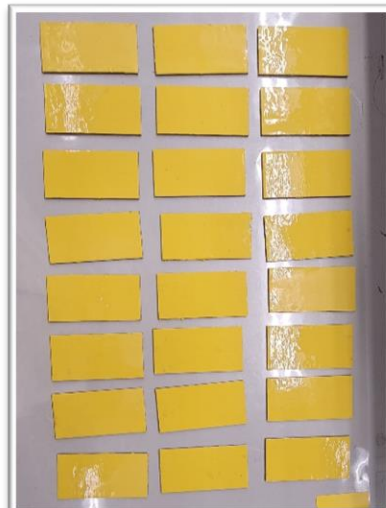
Experimental

- Carbon steel panels (EN 10025-2 type S355JR)
 - Initial rust grade C (ISO 8501-1)
 - Wire brush cleaning to cleanliness grade St 3 (ISO 8501-1)
 - Surface roughness 62 μm (ISO 8503-5 replica tape)
 - Salt contamination approx 30 mg/m^2 (ISO 8502-9)
- Coated with single coat of PIB-based coating

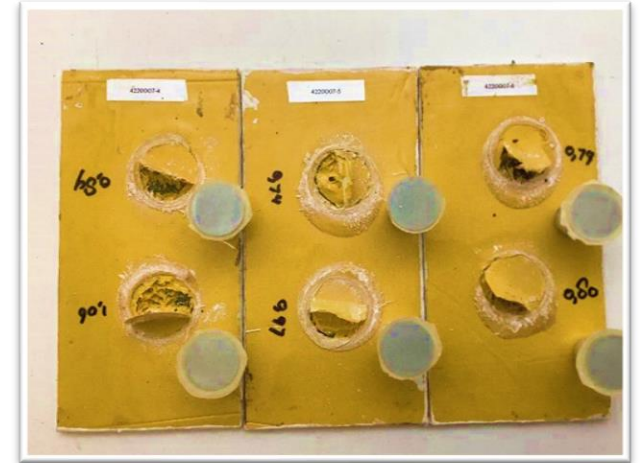
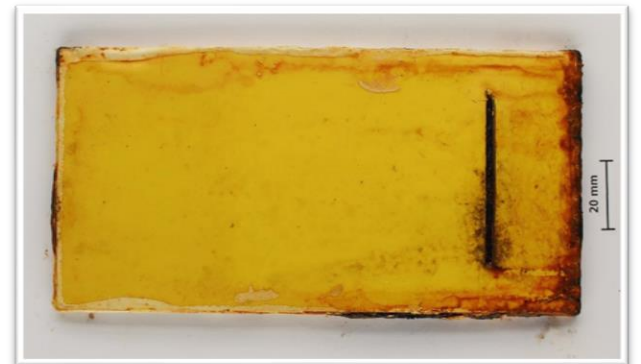
Unexposed coated panels were tested for adhesion (ISO 4624) and color (ISO 11664-4)

Three coated panels were scribed and exposed for 25 weeks to cyclic ageing test as specified in ISO 12944-9 Annex A:

- 72 hours of exposure to UV and condensation (ISO 16474-3 method A; cycle 1)
- 72 hours of exposure to neutral salt spray (ISO 9227)
- 24 hours of exposure to low temperature at -20 ± 2 °C

After termination of cyclic ageing, the panels were inspected for adhesion, color, blistering, rusting, cracking, flaking, and corrosion at scribe
